Wilson Road, Single Lane Bridge

## **MEMORANDUM**

Wilson Road Culvert over Wilson Tributary to Caulks Creek

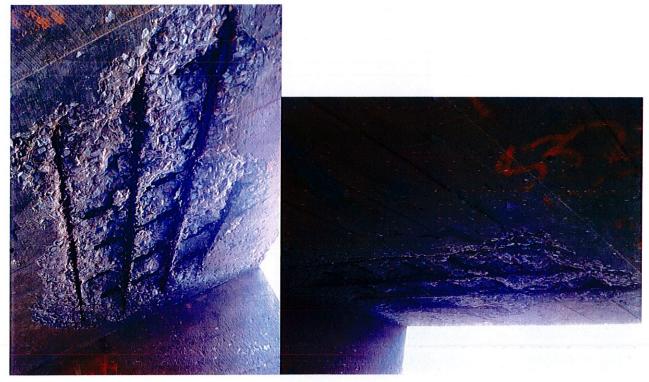
- 1. The top slab of the culvert on the east side of the structure is exhibiting advanced deterioration in an area about 4' wide by 7' long (PHOTOS C,D). The main reinforcing in this area has pack rusted, spalling out the surrounding concrete and exposing the transverse bars (which are also in an advanced stage of corrosion). Several of these main reinforcing bars are **no longer structurally effective**. We do not have construction plans for this culvert, and identification of the exposed reinforcing is not possible due to the advanced deterioration of the bars. Therefore, the reserve capacity of the section cannot be reasonably estimated. Since it is a single lane bridge, traffic tends to cross near the centerline, but the area of concern extends about 5' into the drive lane, so there is not enough room to add temporary barriers (similar to Timberlake Manor). I would expect that within 3-5 years the deteriorating condition of the bridge would require lowering the weight limit to a level at which **trash trucks would not be able to cross safely**.

PHOTOS C,D: ADVANCED DETERIORATION OF TOP SLAB OF CULVERT

Replace this structure with a double box or CONSPAN type culvert on the existing alignment. The new culvert should be of sufficient length to carry the full two lane section of Wilson. Extending the culvert to the east minimizes potential land acquisition as the City owns the adjoining parcel to the east. A 40' long precast box or CONSPAN would allow for traffic staging during construction. The project should also include the stabilization of the channel bottom in the scour areas, as well as replacing enough of the existing Wilson Road to tie back into a 24' typical pavement section.

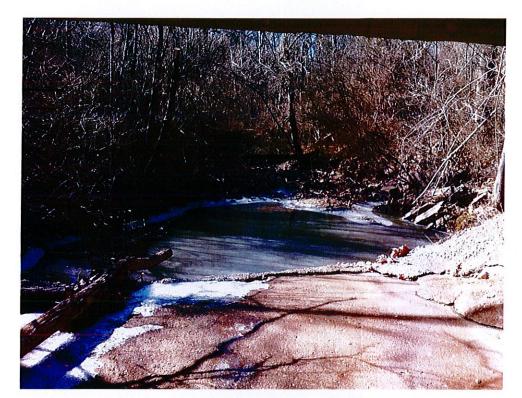
- 2. The culvert is inadequately sized. There are deep scour holes (up to 5' deep) both directly up and downstream of the culvert (PHOTOS G,H). The existing culvert floor is approximately one foot higher than where the natural channel bottom would be (PHOTOS E,F). This condition, if left unchecked, could **destabilize** the structure leading to a **washout**.

PHOTO E: VIEW DOWNSTREAM - INVERT TOO HIGH

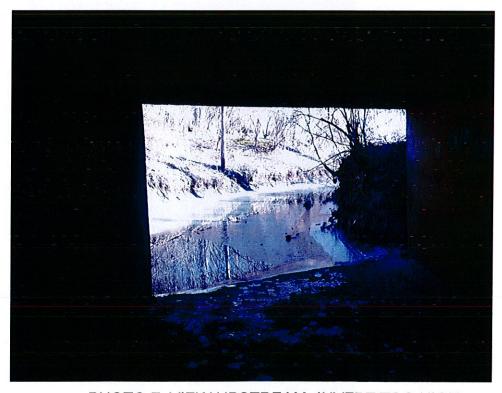
PHOTO F: VIEW UPSTREAM -INVERT TOO HIGH

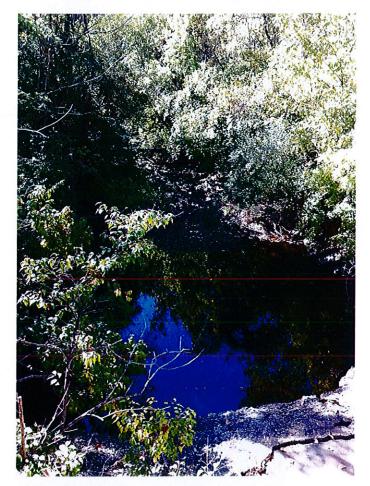
PHOTO G: DOWNSTREAM SCOUR HOLE

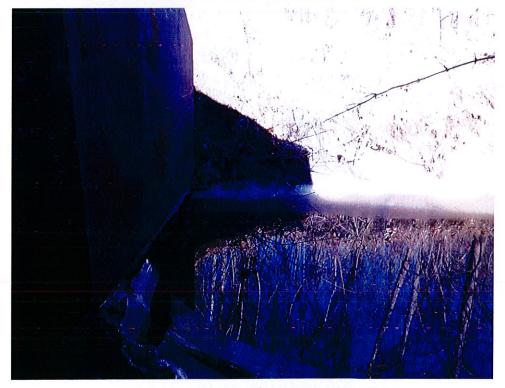
PHOTO H: UPSTREAM SCOUR HOLE
