RE: Concrete Pavement Report

City of Chesterfield

Concrete Pavement Report

June 2023

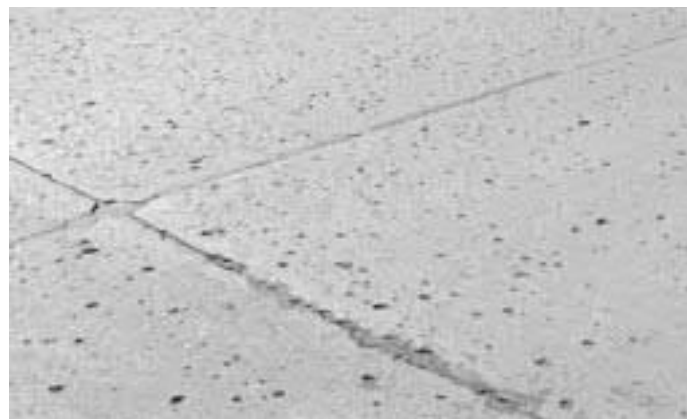
◀ **Extensive pop-outs of large aggregate from surface. Pop-outs alone have not affected pavement serviceability.**

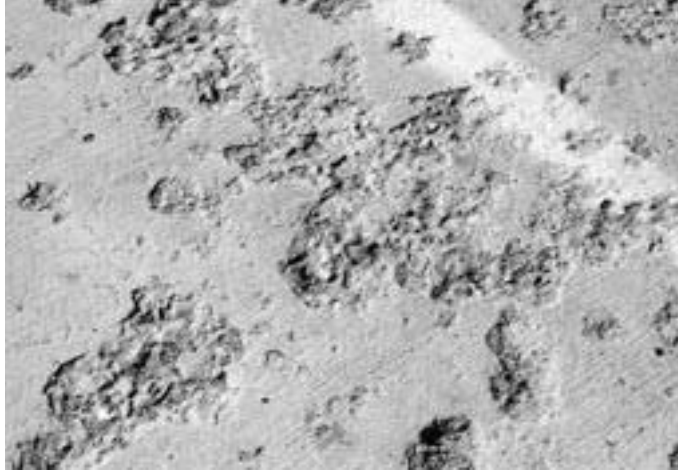
►
Moderate surface scaling. Loss of mortar and fines from the surface beginning to expose larger aggregate.

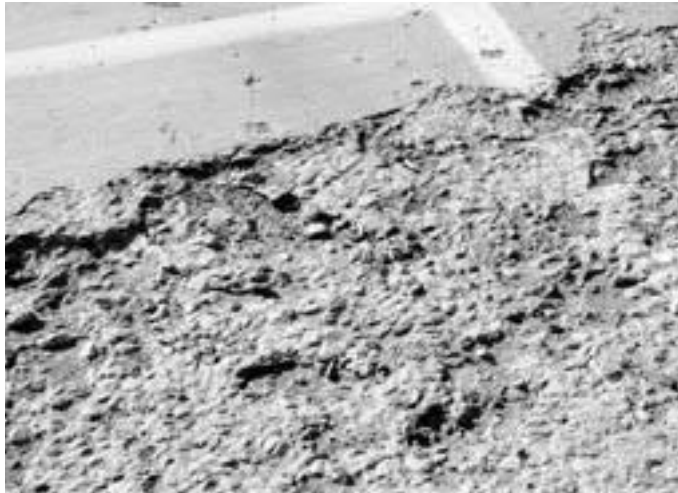
►
Severe scaling. Some larger aggregate is loose.

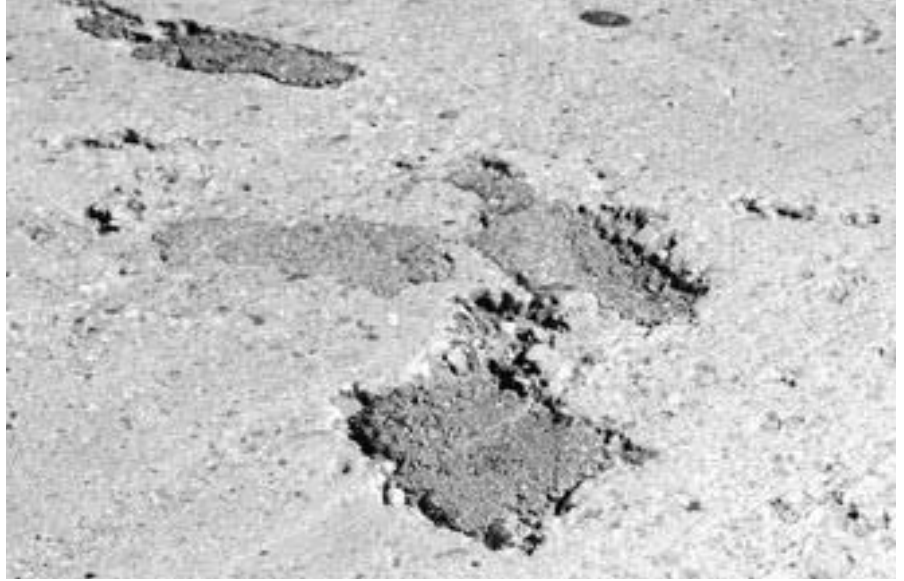
▶ Small surface spalls that have been patched.

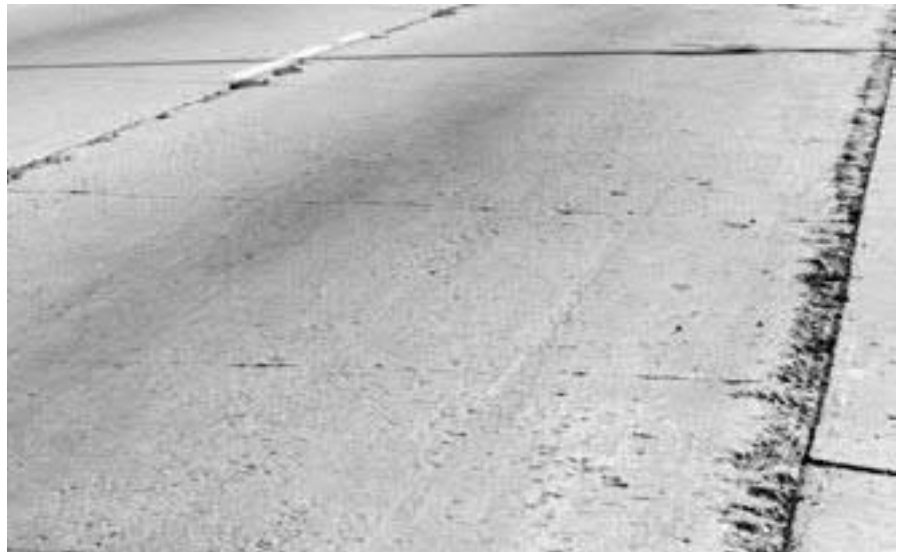
▶ Spalling along longitudinal joints.

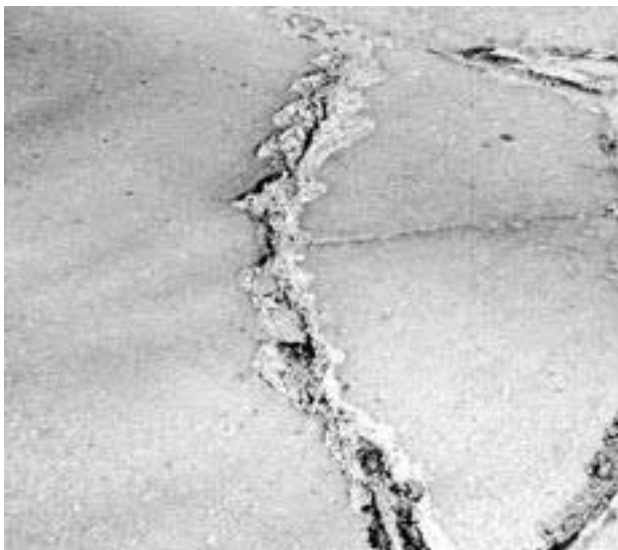
▼ A severely spalled crack.

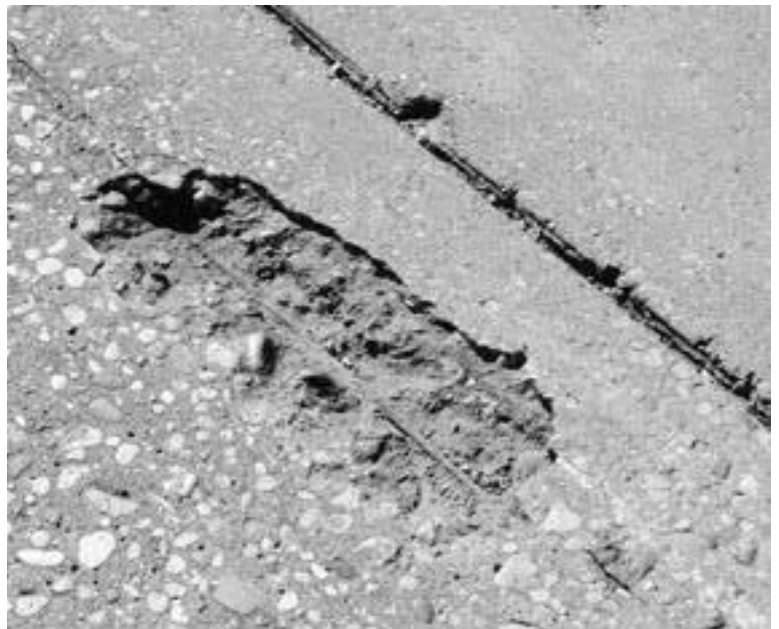
▶ Spalling over shallow reinforcing.

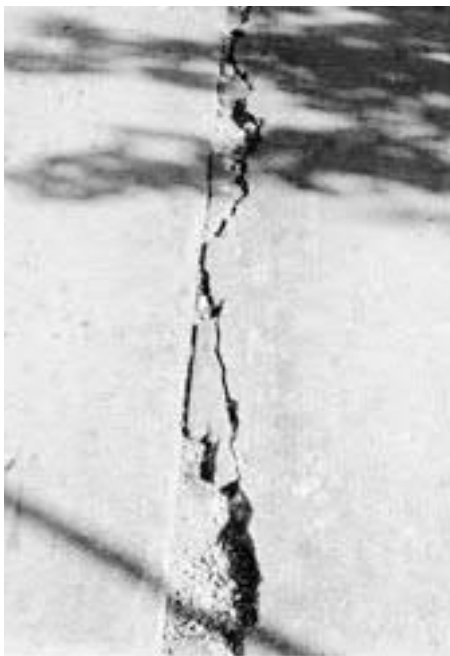
▲ Additional joint cracking, spalling, and broken pavement. Full depth repair is needed.

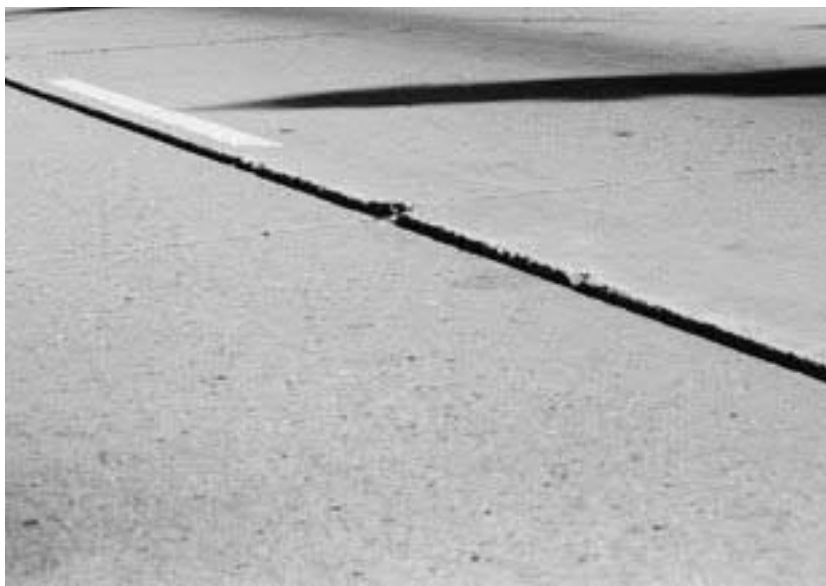
▲ Faulted longitudinal joint (over 1/2") with slight edge spalling.

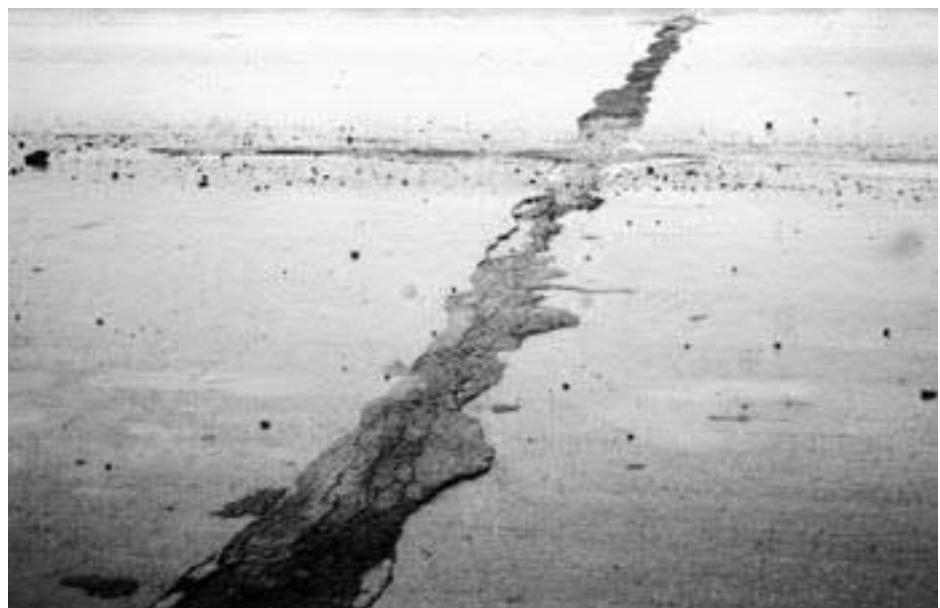
► **Severe spalling has required temporary patching. Complete joint replacement is necessary.**

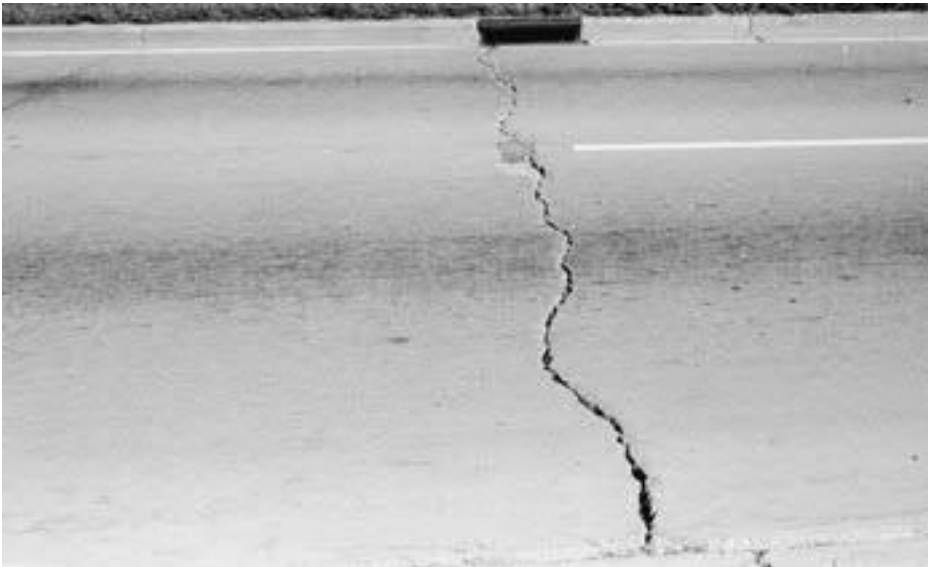
◀ **Transverse, open crack.**

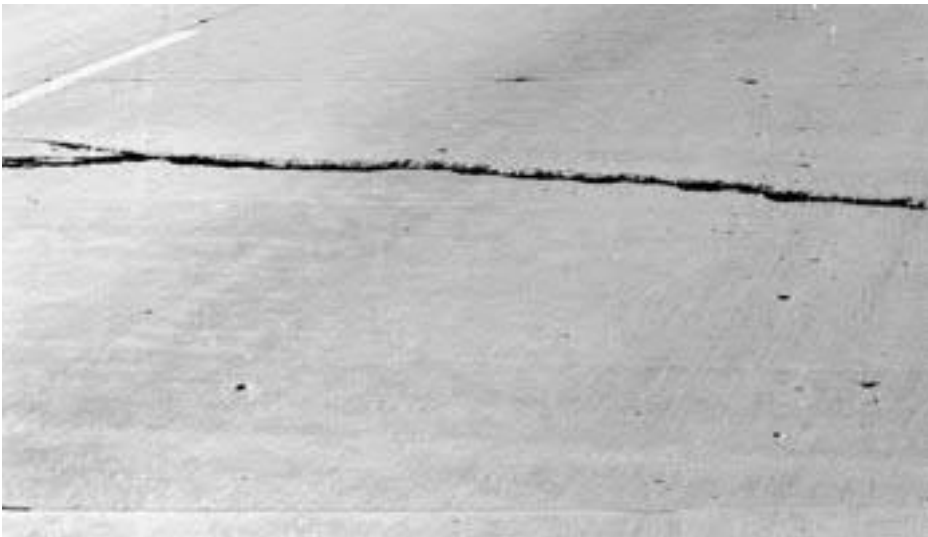
◀ **Faulted transverse crack with slight edge spalling.**

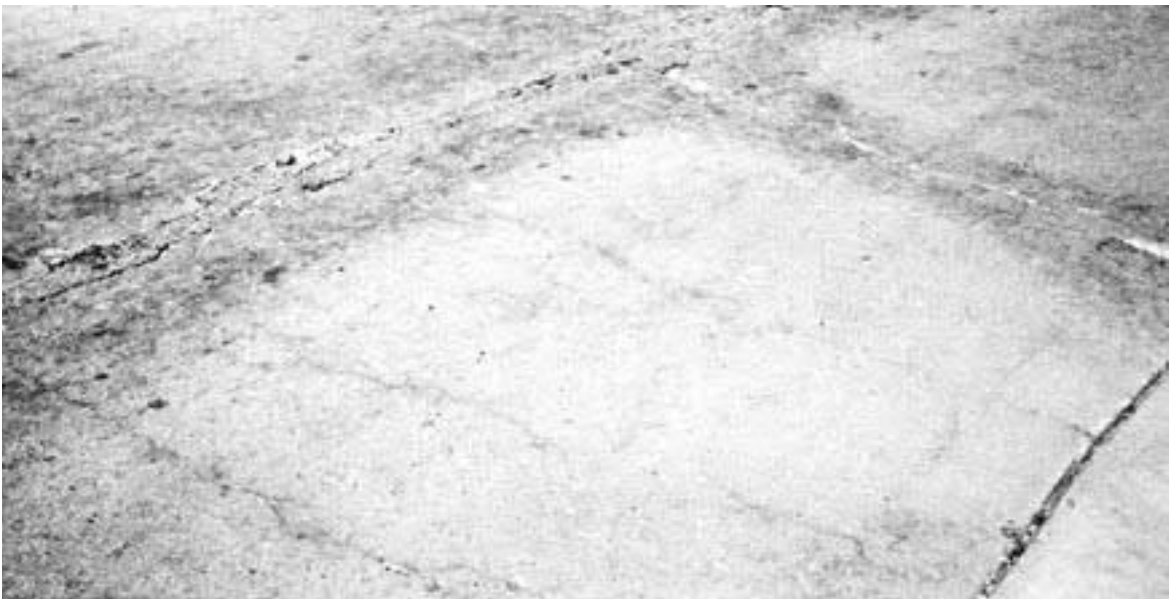
◀ **Closely spaced, hairline transverse cracks. Indicates slab is broken and in need of replacement.**

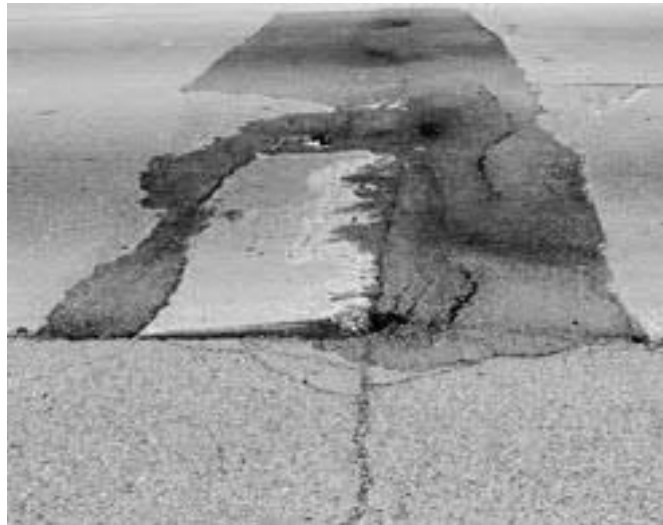
◀ Internal pressure has partially raised slab at the joint. Complete replacement is required.

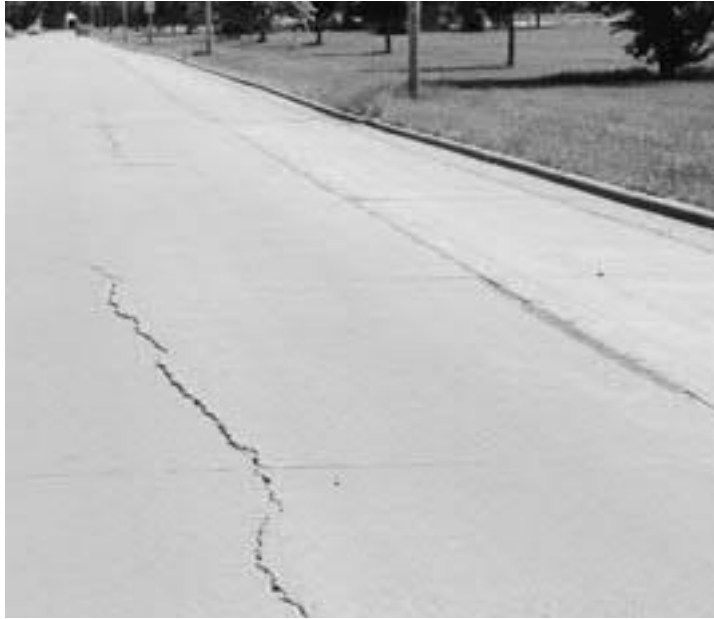
Extensive cracking and patching caused by settlement. Pavement was built on unstable subgrade soils.

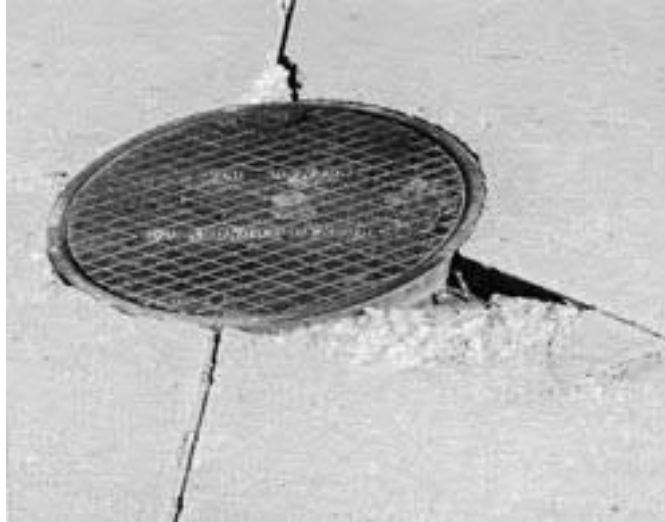
Two spalls at manhole in a new pavement. Partial depth patching would be beneficial. ◀

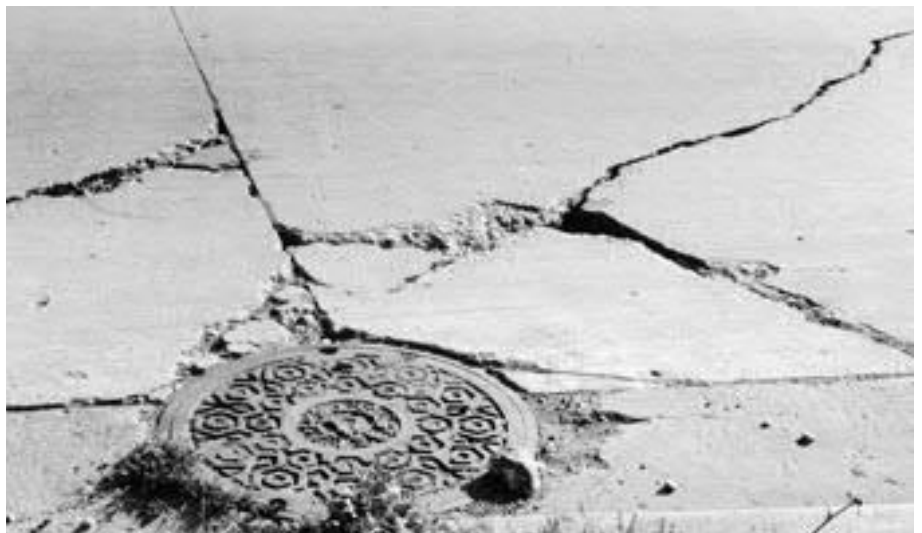
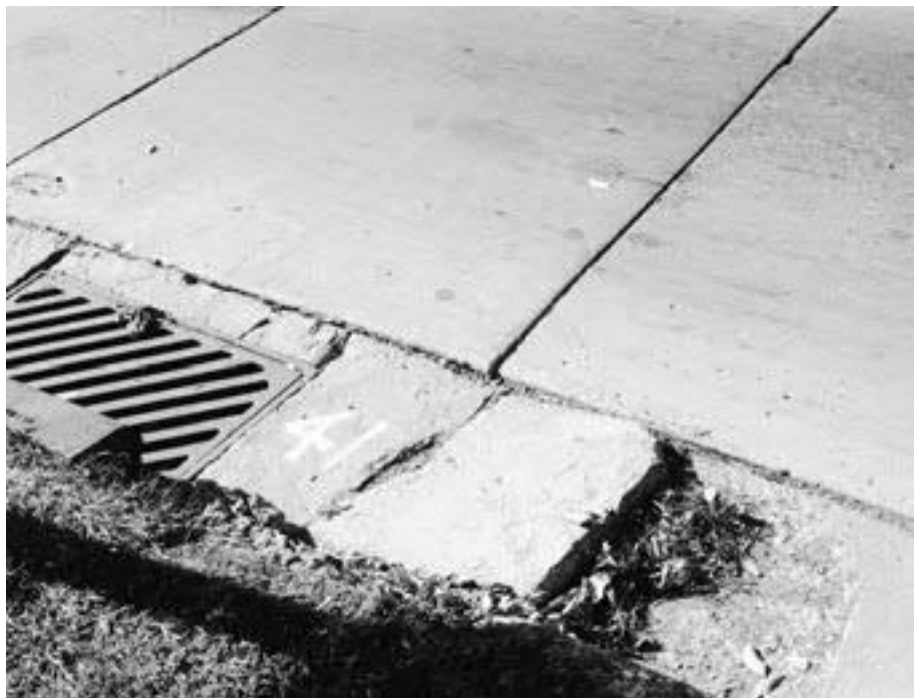
Extensive cracking and spalling at manhole requiring full depth repairs. ▼

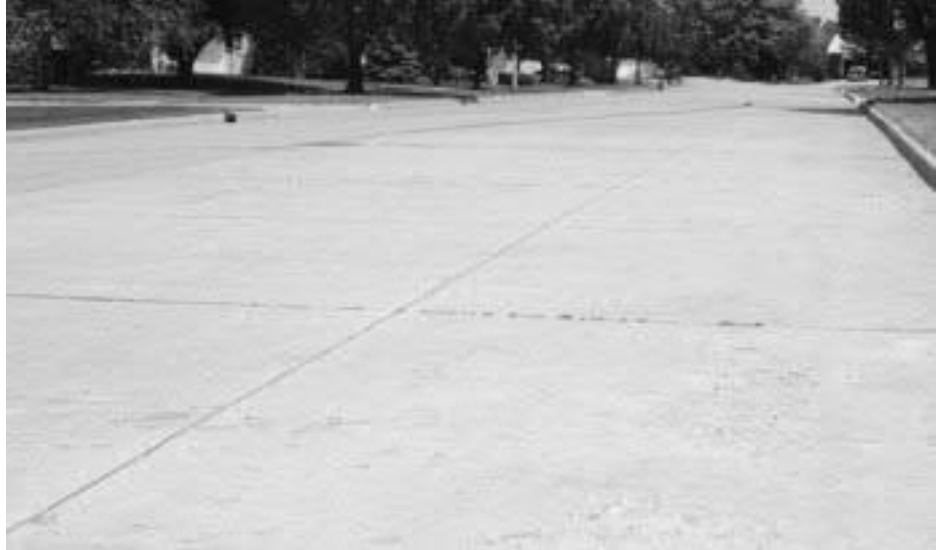
▶ Slight scaling.

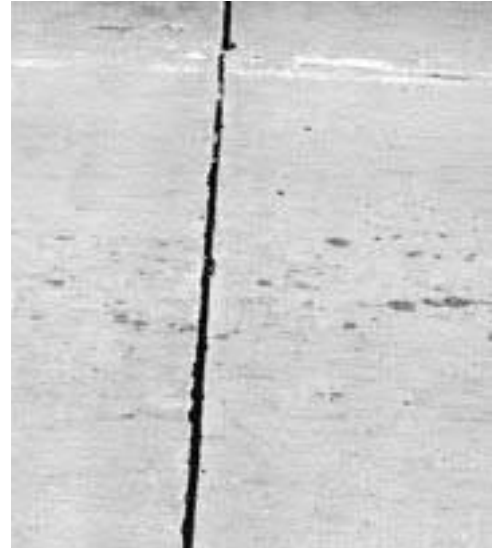
▲ Partial loss of joint sealant.

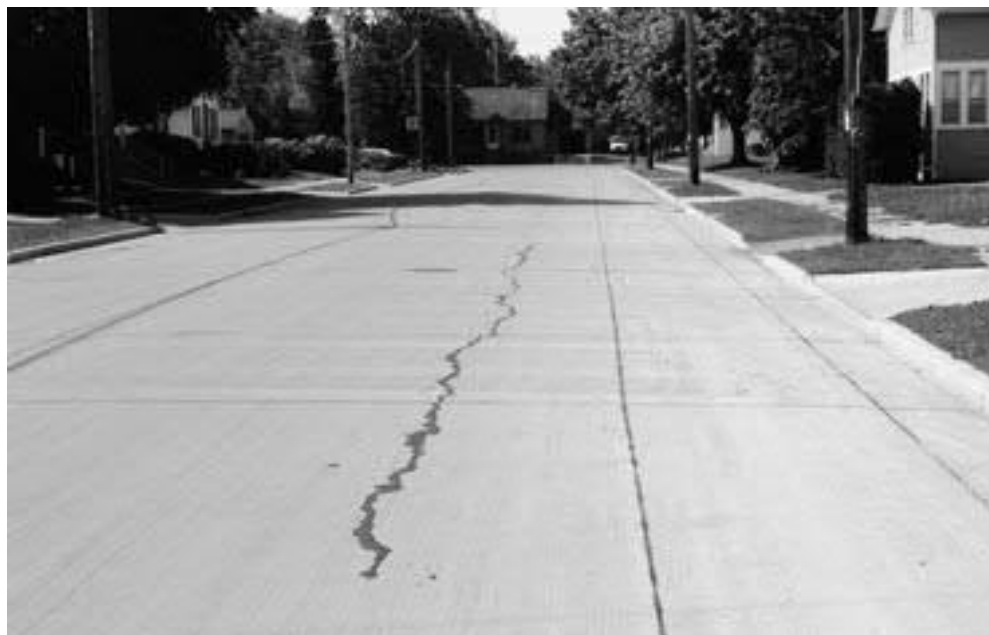
▶ Isolated meander crack, tight and well sealed.

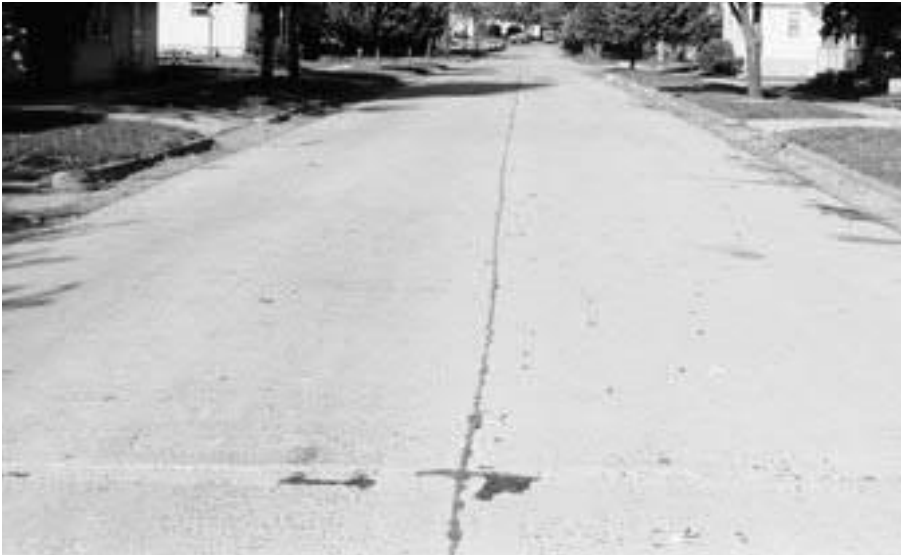
◀ **Extensive pop-outs. Pavement is unsightly but still provides good level of service.**

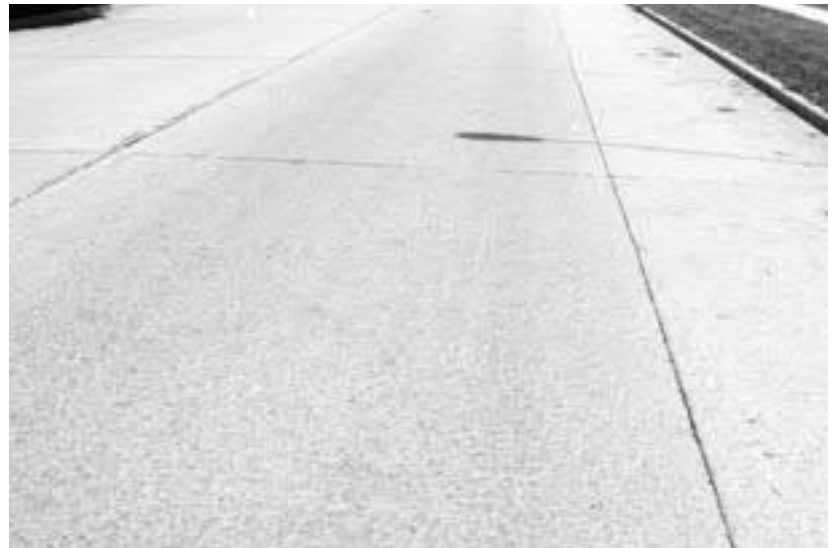
▲ First signs of corner cracks.

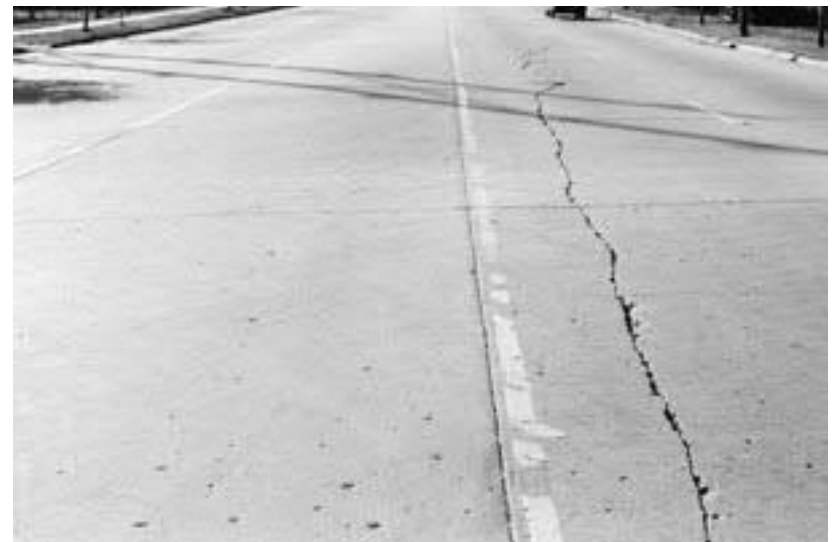
▲ Isolated, tight meander crack. Several pop-outs. Remaining joints and cracks all tight and sound.

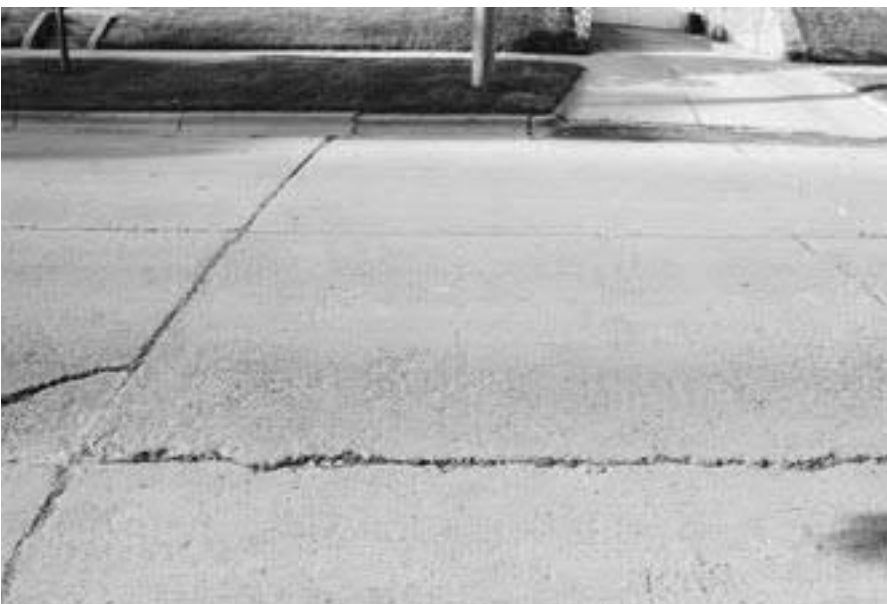
▲ Open cracks with edge spalling. Corner crack and broken corner piece.

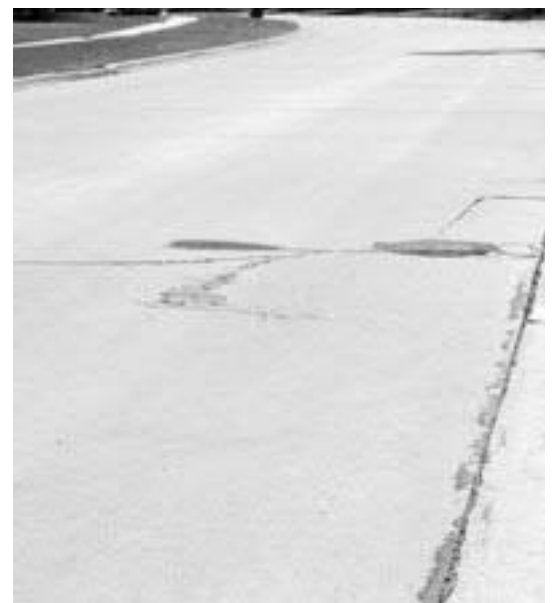
▲ Isolated manhole problems and joint spalling. Full depth repair required adjacent to manhole.

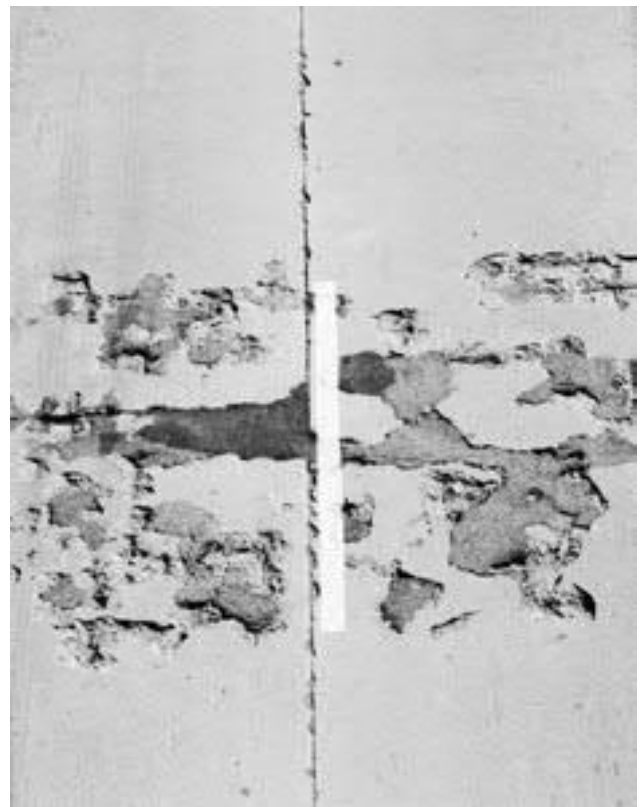
▲ Spalling caused by shallow reinforcing steel.
Temporary patching needs to be followed
by extensive partial depth repairs.

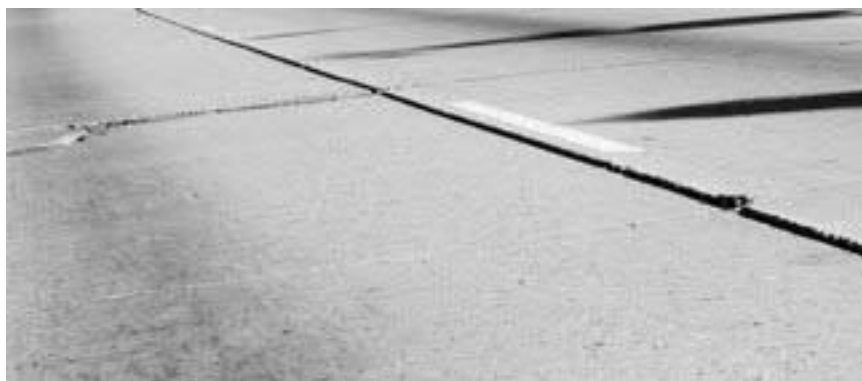
◀ **Moderate to severe longitudinal joint faulting. Transverse joint also has spalling.**

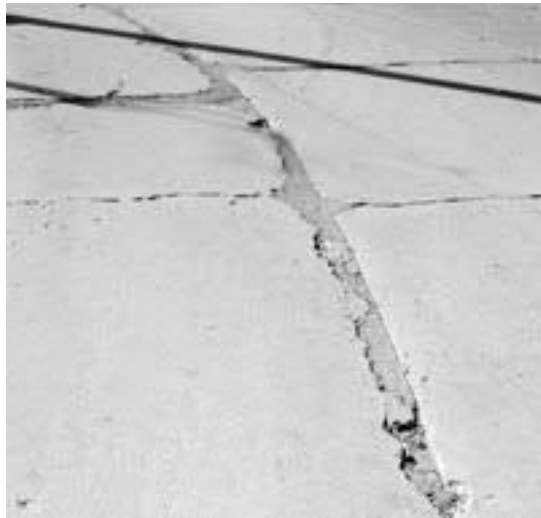
Multiple transverse cracks. Poor longitudinal joint with spalling. ▼

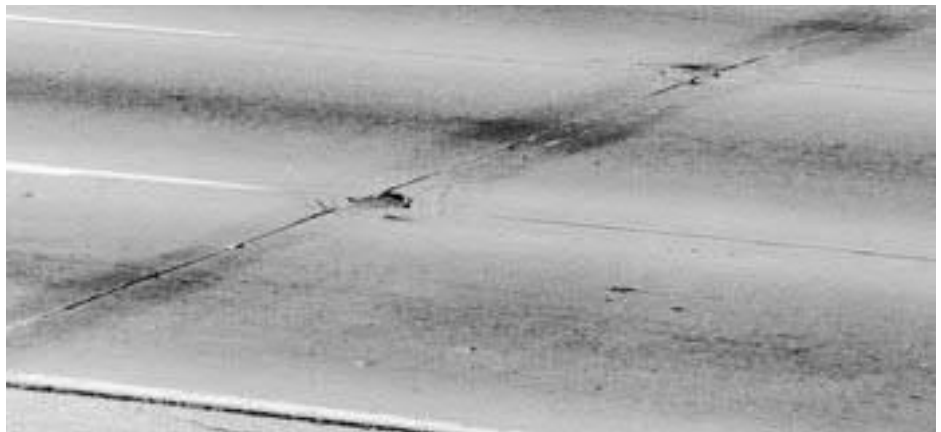
▶ **Discoloration at joints indicates D-cracking. Slab replacement needed.**

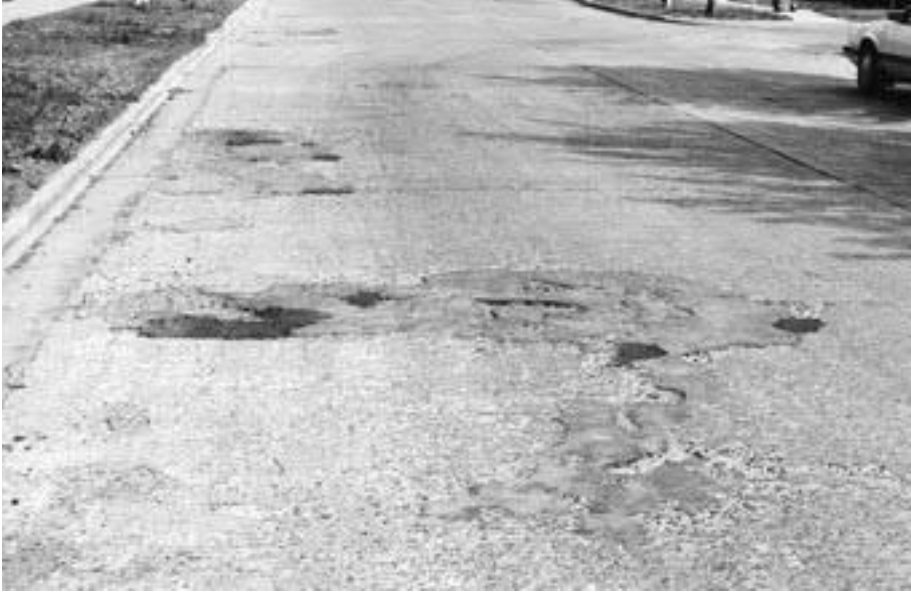
◀ Failed patches. Replace entire portion of lane.

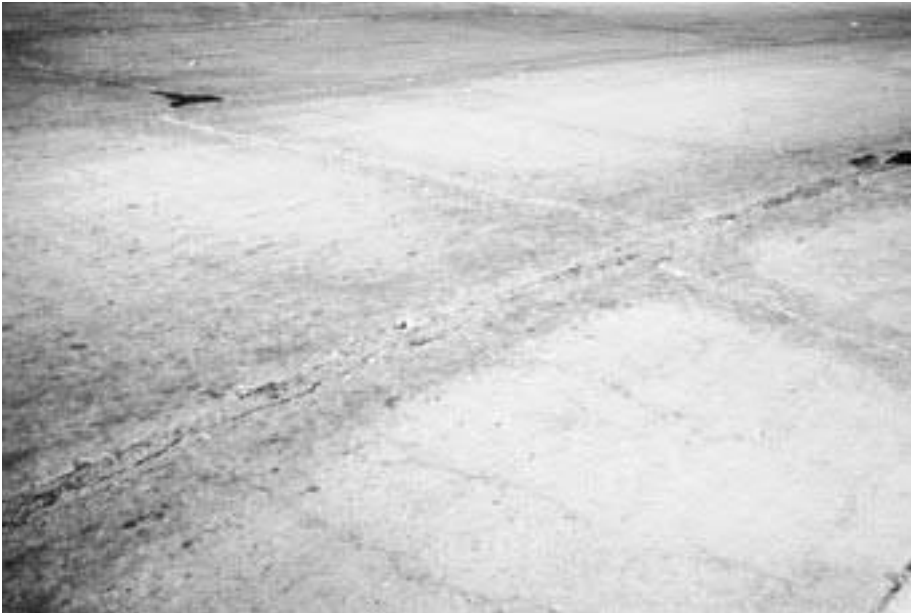
◀ Closely spaced transverse cracks and poor longitudinal joint. Replace slab.

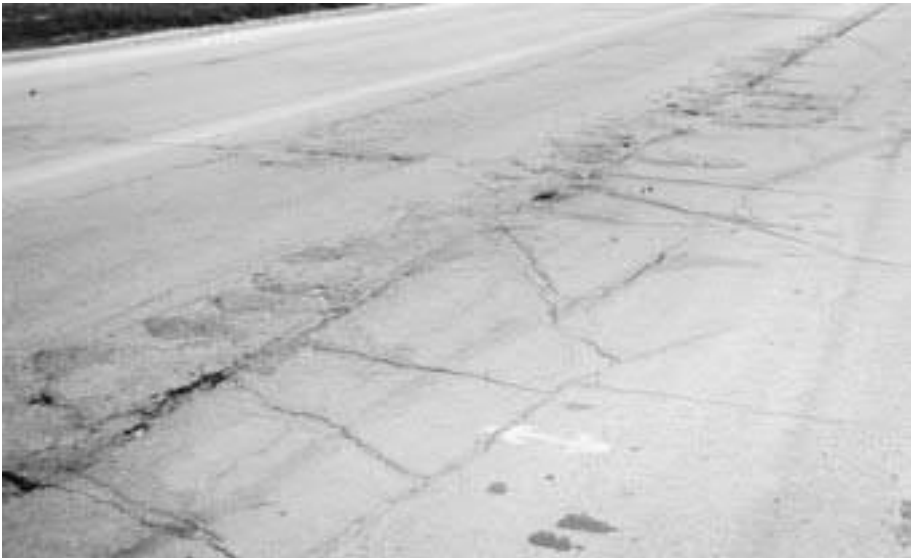
◀ Severe deterioration. Requires extensive reconstruction.

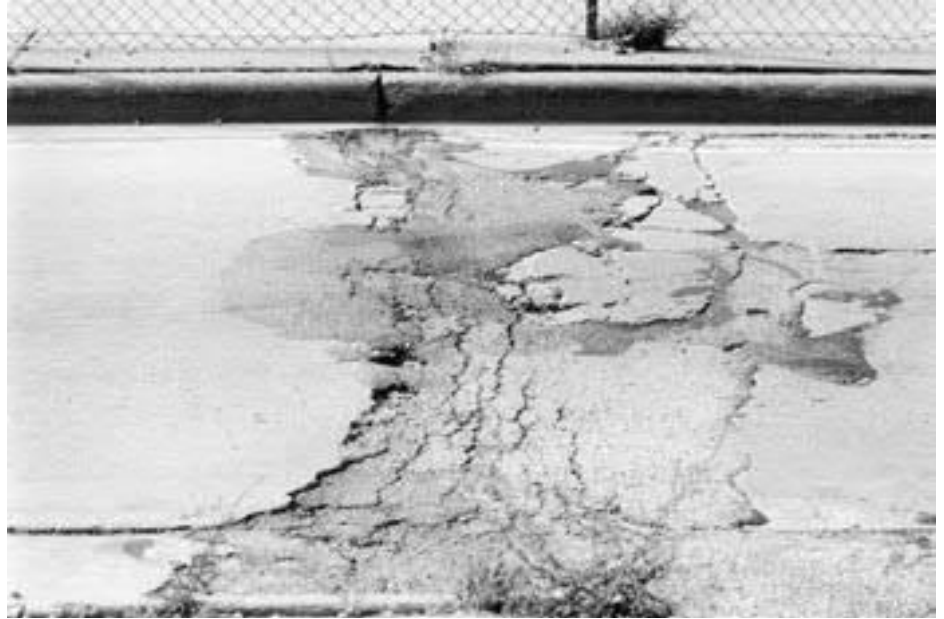
▶
Broken slabs require complete rebuilding.

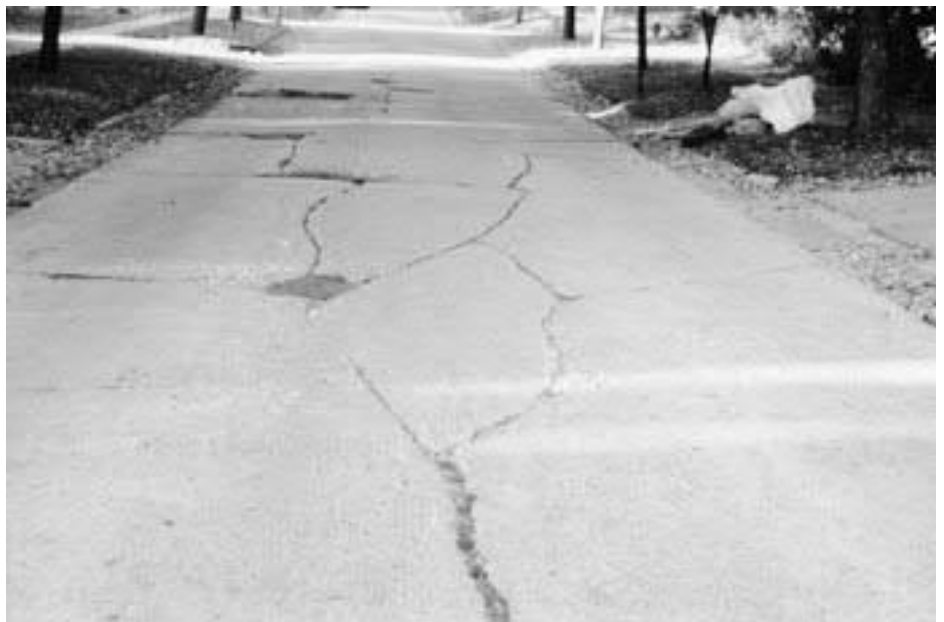
▶
Total failure.

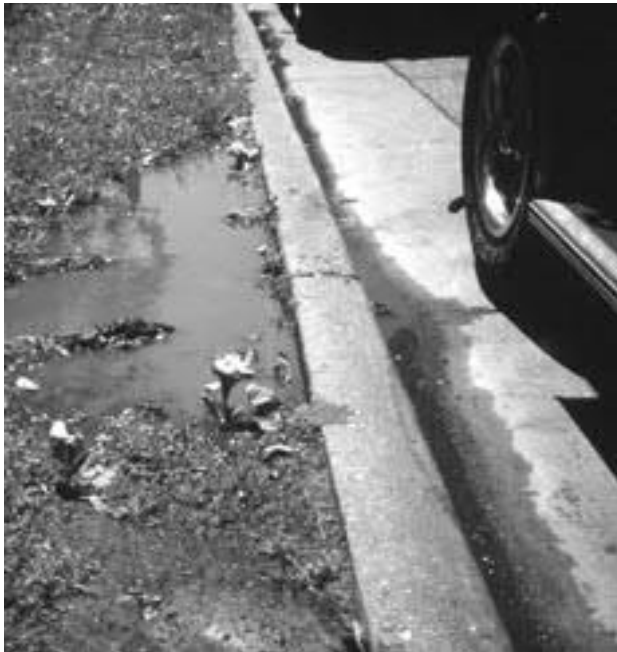
▲ Reshape terrace behind curb to restore drainage and prevent damage to curb and street.

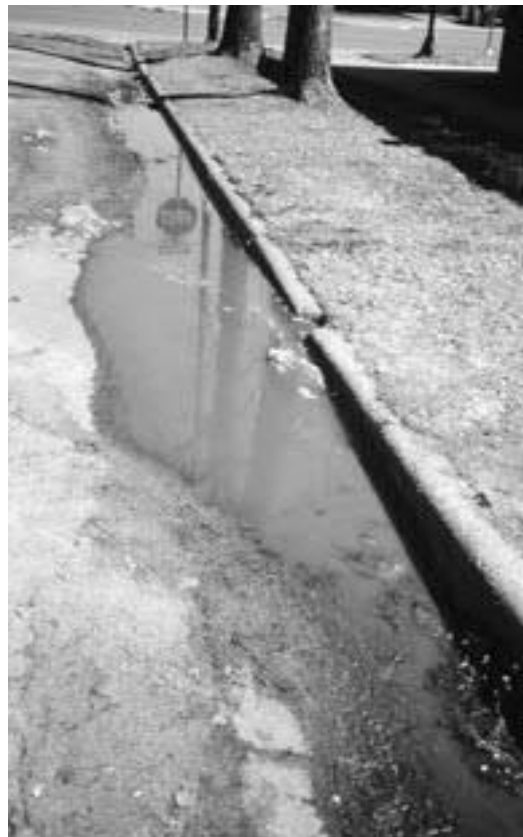
► Flooding. Curb and gutter need reconstruction.
