# Memorandum

## Department of Public Works

**RE:** Nooning Tree Court – Case Study

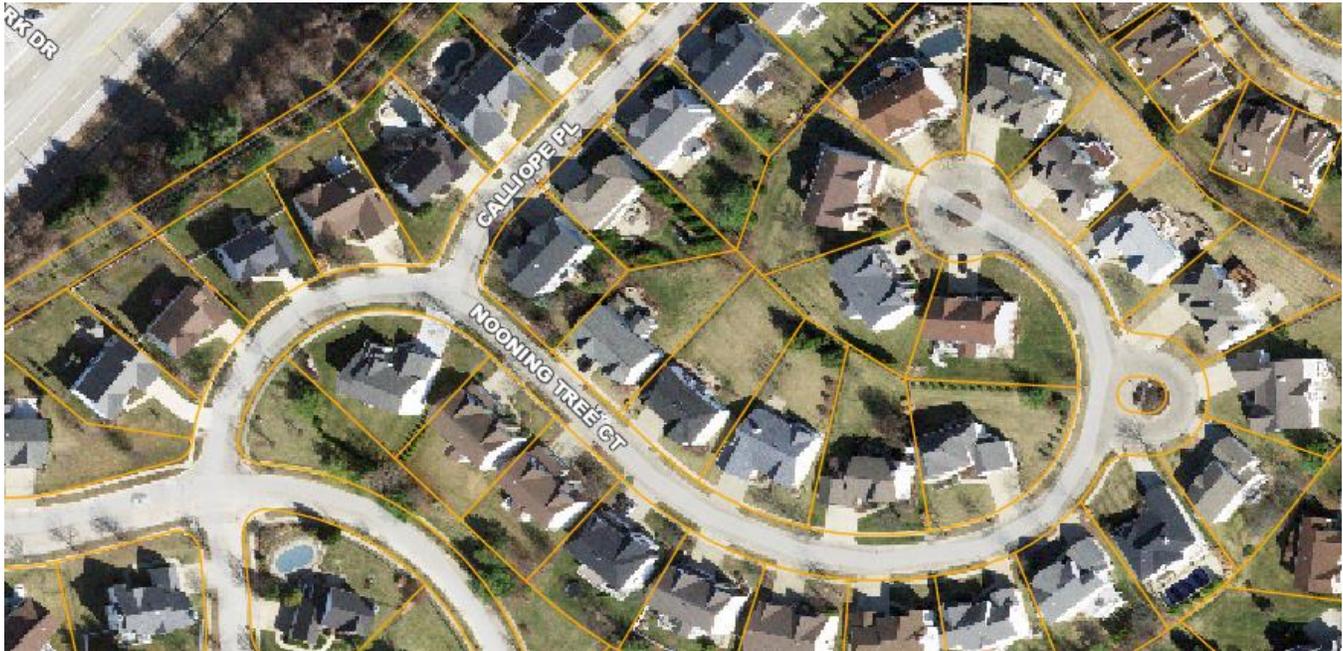
Nooning Tree Court is a residential street in the City of Chesterfield located within the Nooning Tree Addition Subdivision. The street is approximately 1,500 feet long and was constructed around 2002. It has an overall pavement condition rating of 7.8.

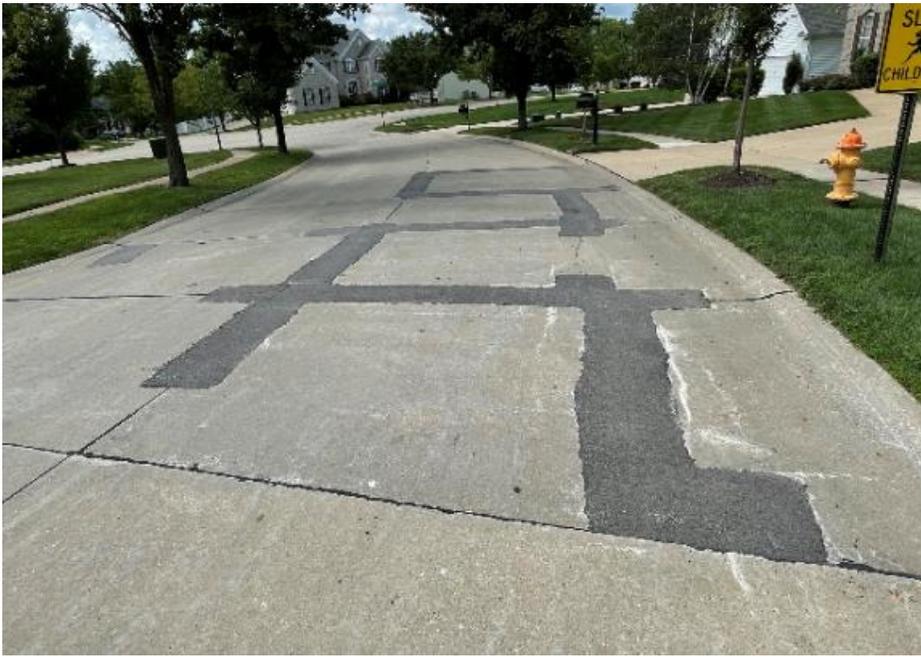
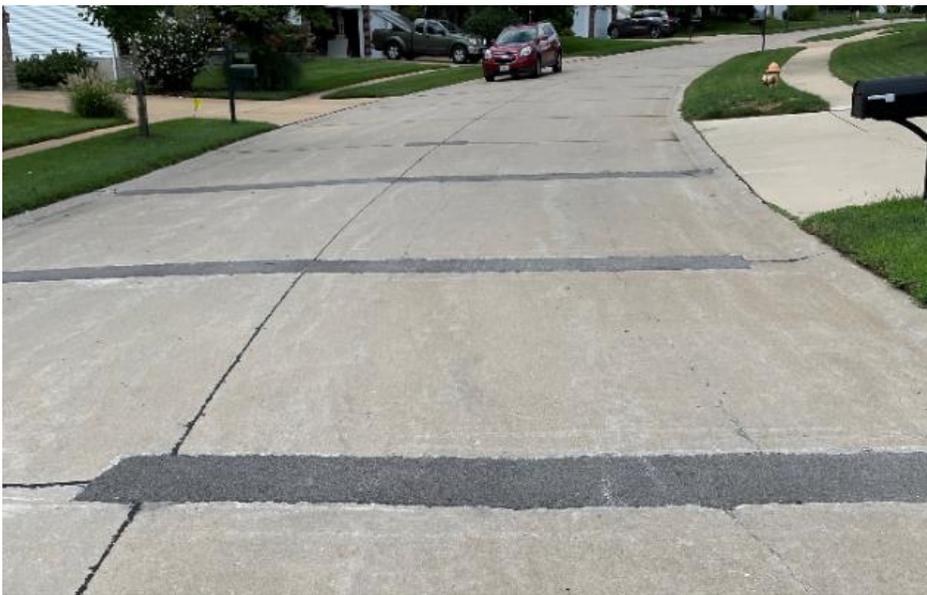
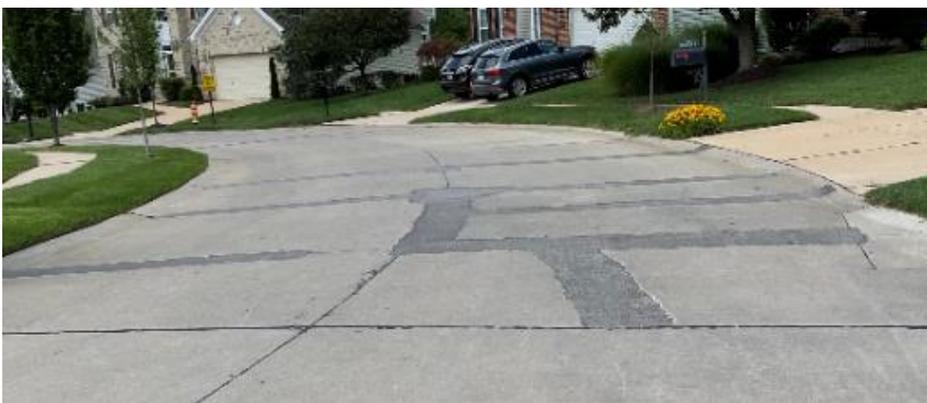
I am bringing this street to your attention because the City's Street Maintenance Division of the Public Works Department recently completed some isolated asphalt joint repairs on this street. This resulted in a number of complaints to the City related to the appearance of the street. Three photos of the patched areas are shown on the next page.

These asphalt joint repairs are very well done and, if allowed to remain, would extend the life of Nooning Tree Court. Additionally, they ensure that the street remains safe and passable. Unfortunately, their appearance is unacceptable to many City residents. Accordingly, the City's policy for a number of years has been to incorporate these streets into the concrete slab replacement program. That has been done in this case, and these slabs are scheduled for replacement later this year.

The asphalt repairs completed by the Street Maintenance Division were accomplished at a total cost of \$11,300 for 375 lineal feet of asphalt joint repairs. This cost includes labor (in-house), material (asphalt), and trucks / equipment. The cost we will spend later this year to replace these slabs is estimated at \$88,000. Not only is this substantially higher, but it begins a process whereby in five to ten years, when the rest of this street is replaced, the new slabs will be left to remain. These slabs will be beaten up / stressed during construction and never last as long as the new slabs, initiating an endless cycle on a street that now mostly looks like this:

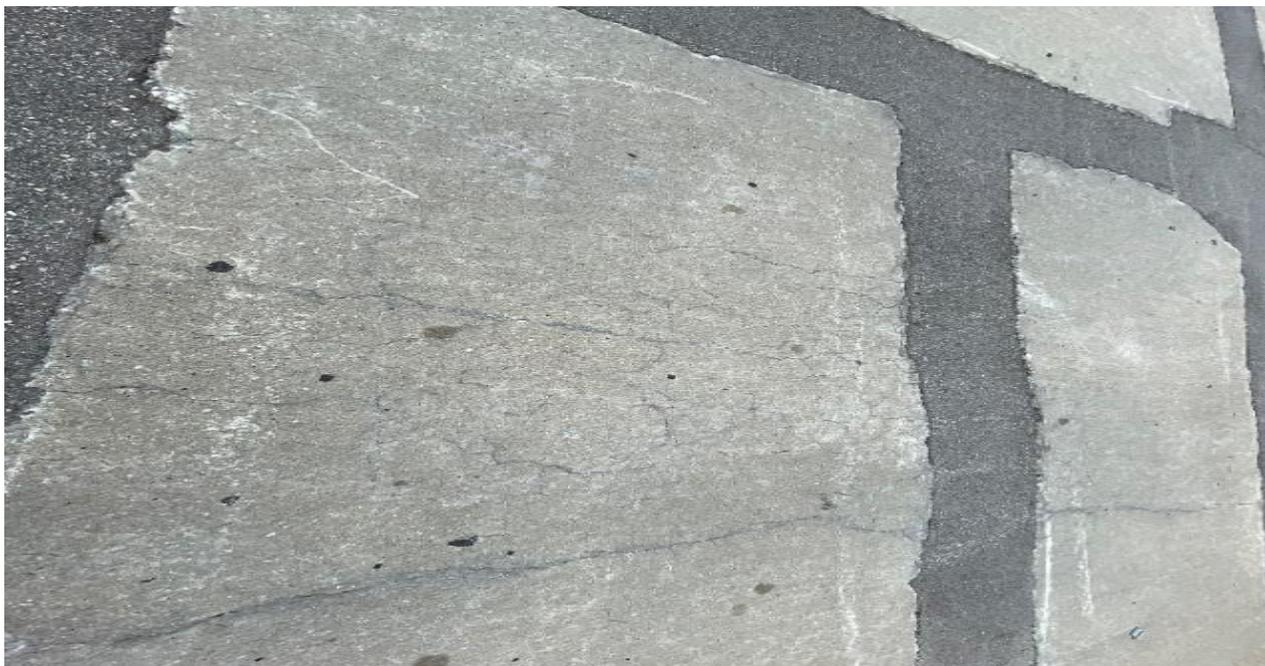
Before delving further into this topic, it is important to note that there are maintenance techniques which are acceptable to City residents. Most residents will accept concrete Partial Depth Repair (PDR) as it creates an appearance similar (although not identical to) the original concrete. PDR is an effective maintenance treatment that has been used throughout the City to address joint deterioration. While the limits of PDR treatment are similar to asphalt joint repair it is roughly three times more labor-intensive and can be considered as a "permanent repair." **Unfortunately, PDR is NOT effective on all concrete deterioration.** The concrete on Nooning Tree Court is beginning to fail, most likely due to an alkali silica reaction (ASR) or an alkali carbonate reaction (ACR) within the concrete. These types of reactions manifest themselves by the fine lines within the concrete shown below.

If the City were to attempt to address joints / slabs like this via PDR the old concrete would “pull away” from the new concrete repairs, creating more joint deterioration. Instead, we use asphalt because it has flexible properties which can retard the impacts of the concrete “pulling away” from the joint repair. This creates a safe and passable joint for a longer period of time – at a cheaper price.

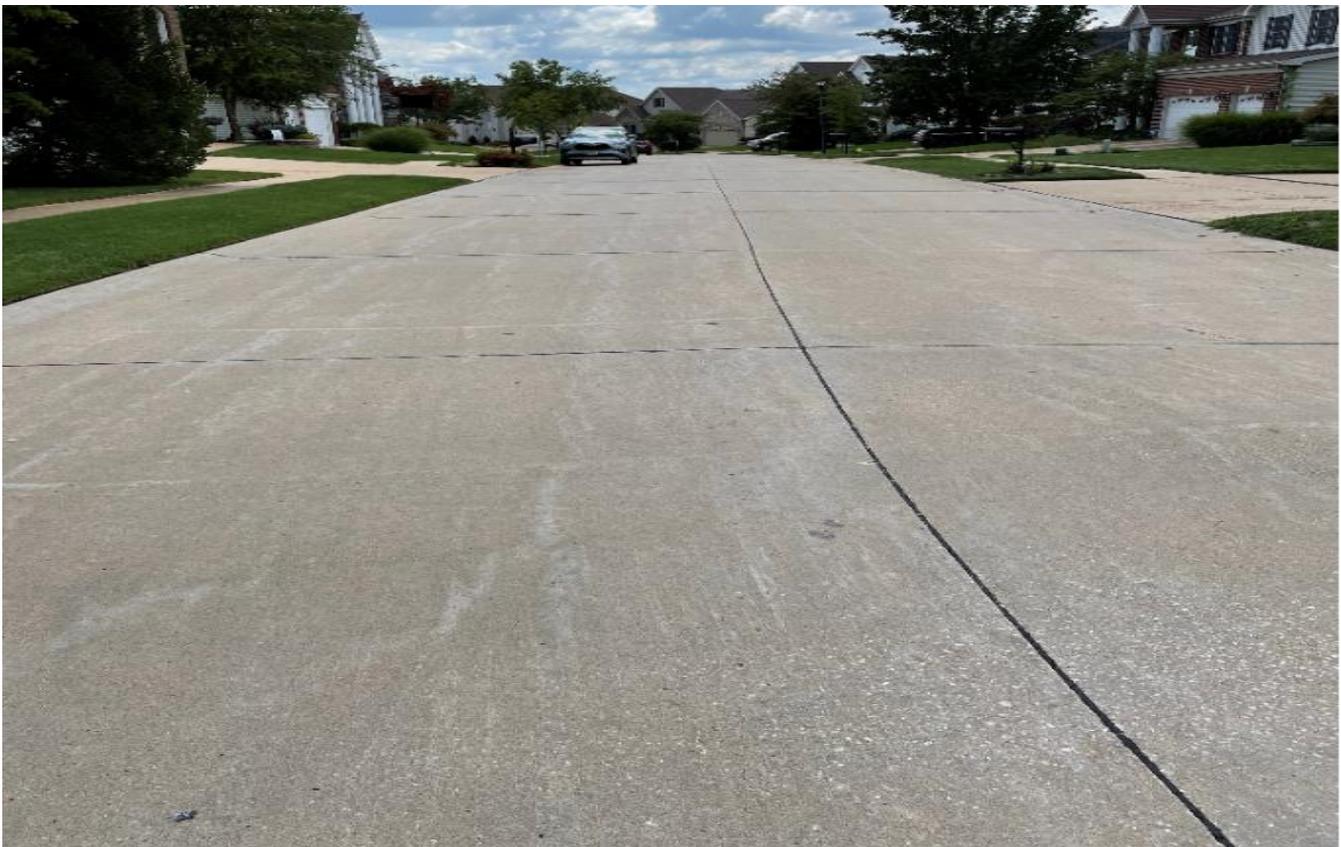
Additionally, the other slabs on Nooning Tree Court, which are at an earlier stage of ACR / ASR, will also need to be replaced. If the street were allowed to progress through its intended life we would be able to make additional asphalt repairs. Instead, this street will likely need to be programmed for replacement, sooner than necessary, to avoid additional asphalt repairs.
