SUBJECT: Stop Sign Request – Chesterfield Commons Drive at Frontage Road

RE: Chesterfield Commons Drive Intersection Control Analysis

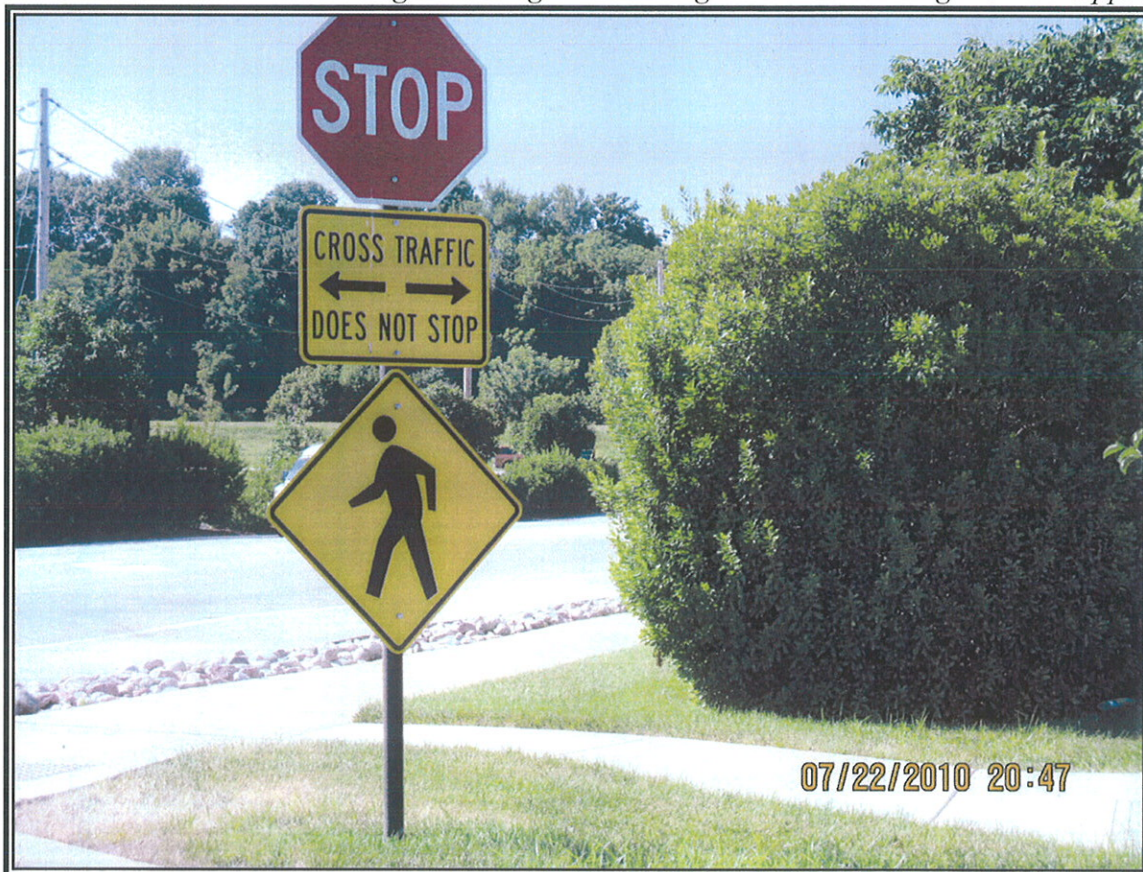
*Figure 2: Vegetation in Sight Distance Triangle on WB Approach*

1. Landscaping along the perimeter of the intersection is creating a sight barrier. Vehicles entering the intersection on both the EB and WB frontage approaches must pull ahead of the painted stop bars to determine if vehicles are present on NB and SB Chesterfield Commons Drive. The driver view of the STOP sign for EB exiting vehicles is blocked by an ornamental tree. These concerns are illustrated below in Figure 2, Figure 3, and Figure 4.

1. Inform THF that landscape pruning, trimming or removal is necessary to restore view of the EB STOP sign and sight distance for WB and EB movements into the intersection.
2. Recommend City Council authorization for a multi-way (4-way) stop on Chesterfield Commons Drive at the intersection with this frontage road..
3. Recommend THF consider YIELD sign control at the Walmart Outdoor Living entrance in lieu of STOP sign control.

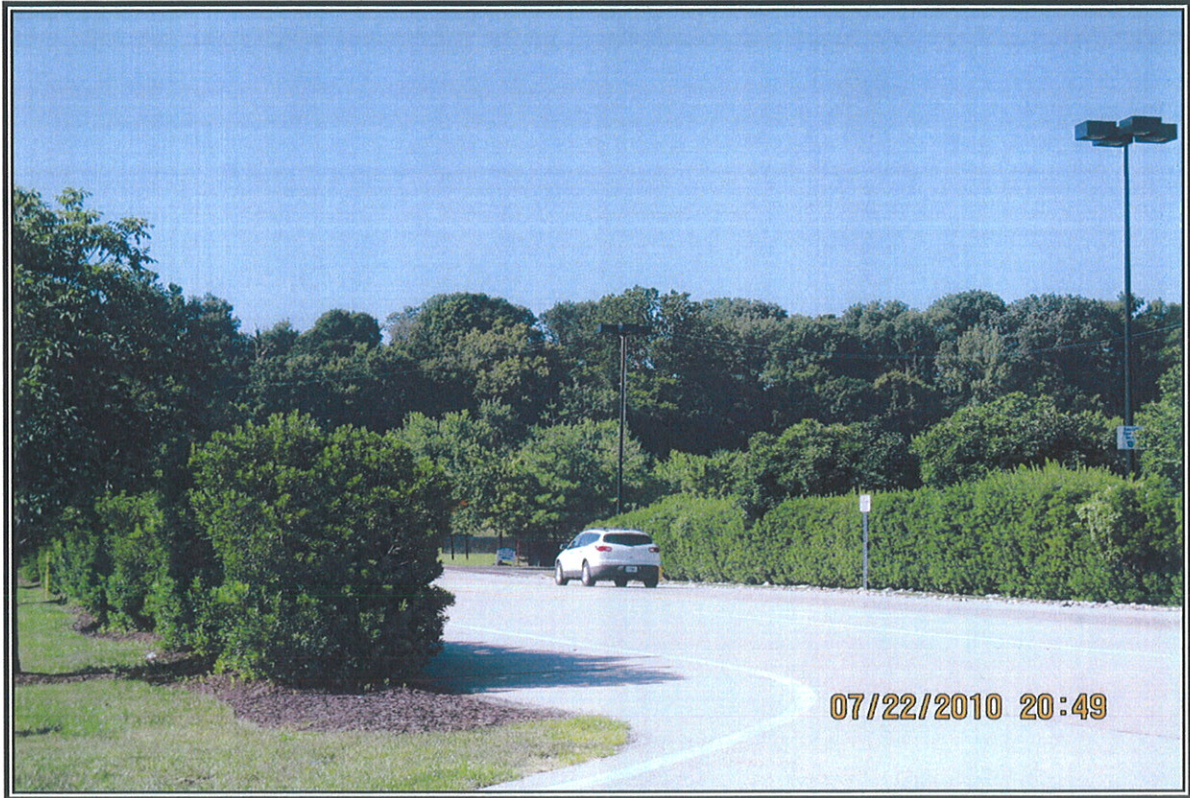
Figure 3: Vegetation in Sight Distance Triangle on EB Approach

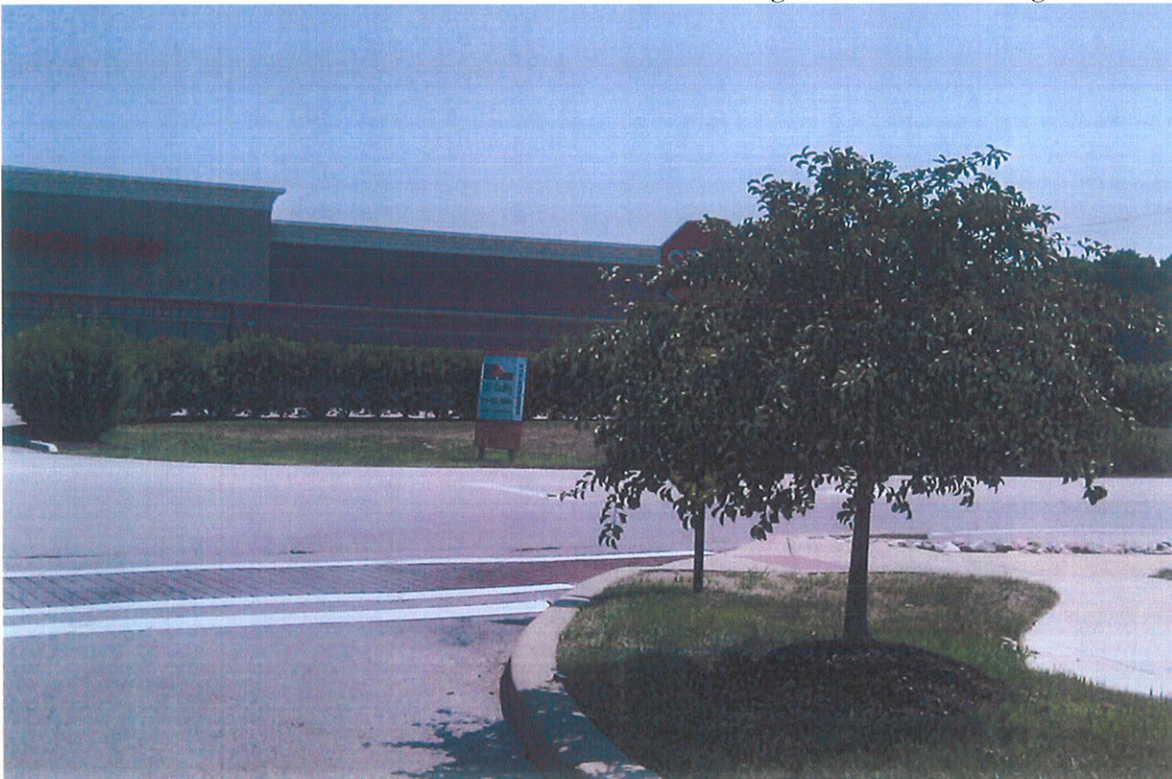
Figure 4: Tree Blocking EB STOP sign

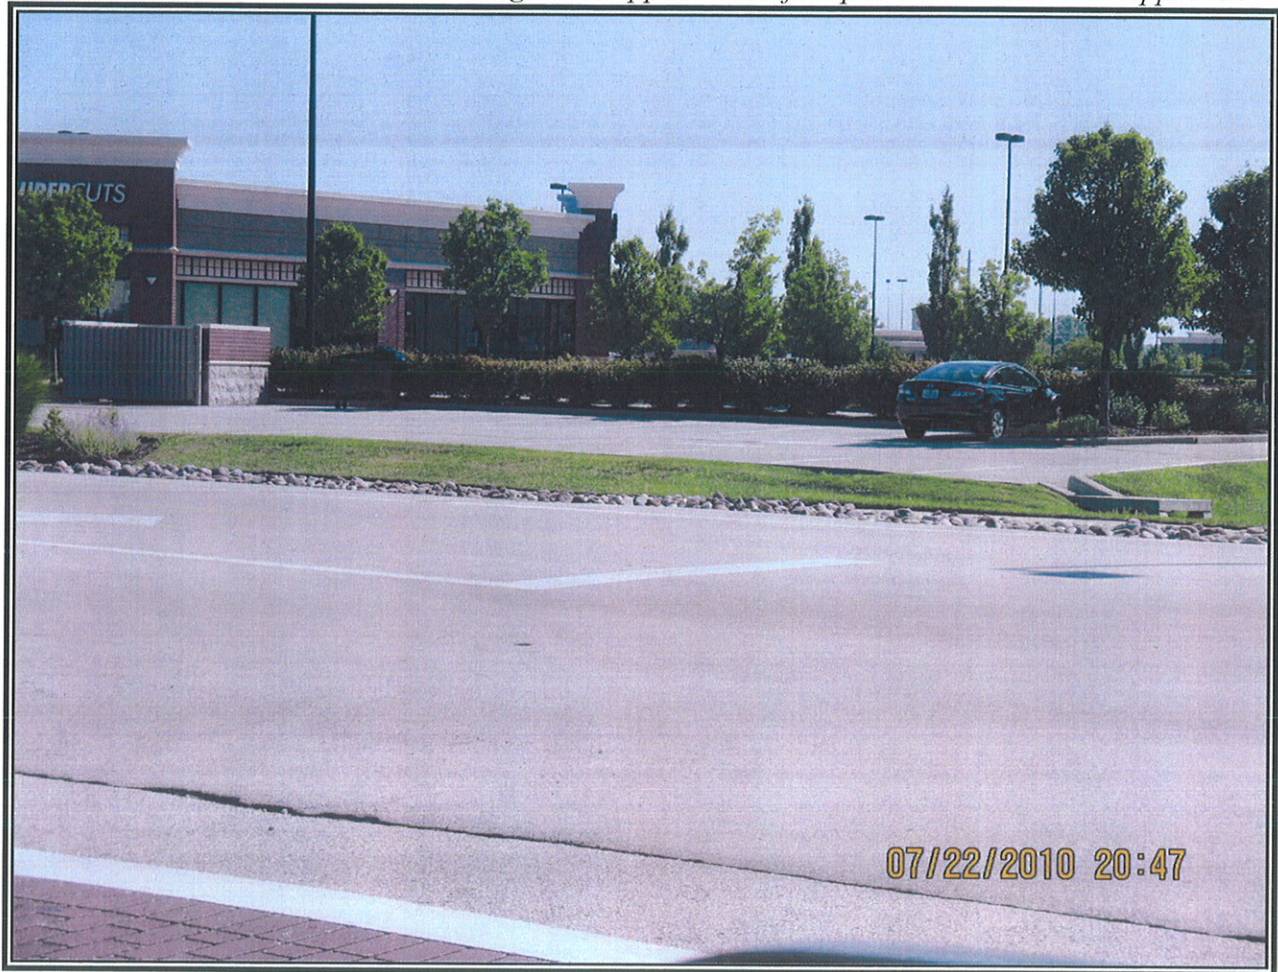
*Figure 5: Appearance of Stop Bar on Southbound Approach*

2. A number of drivers entering the intersection from the frontage road erroneously interpret the intersection as a multi-way (4-way) stop. We believe this interpretation is most likely due to the painted white stop bars on the left turn bays of Chesterfield Commons Drive. These stop bars create the appearance of a multi-way stop control at this intersection. (see Figure 5).

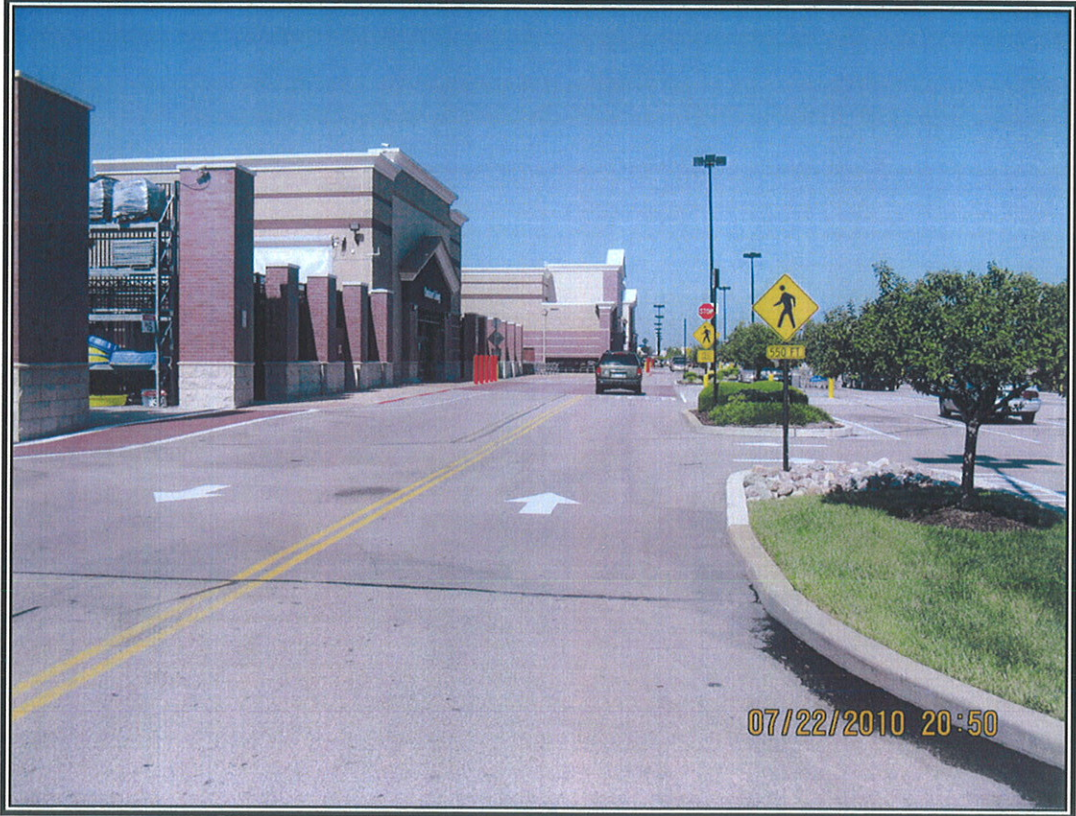
Figure 6: STOP Sign Located Within Private Lot

3. Due to high WB traffic volume along the frontage road and the stop controlled pedestrian crossing at the Walmart Outdoor Living entrance, vehicle queues were observed during peak hour that backed up into and interfered with traffic on Chesterfield Commons Drive. Figure 6 shows the proximity (150') of the intersection and the Outdoor Living entrance STOP sign in the Wal-Mart Supercenter parking lot. It was also noted that the white painted YIELD pavement markings at each of the Walmart store entrances conflict with the posted STOP signs, shown in Figure 7. As these Walmart entrance STOP signs contribute to a back-up of traffic on the frontage road, consideration should be given to replacement of the STOP signs with YIELD signs.

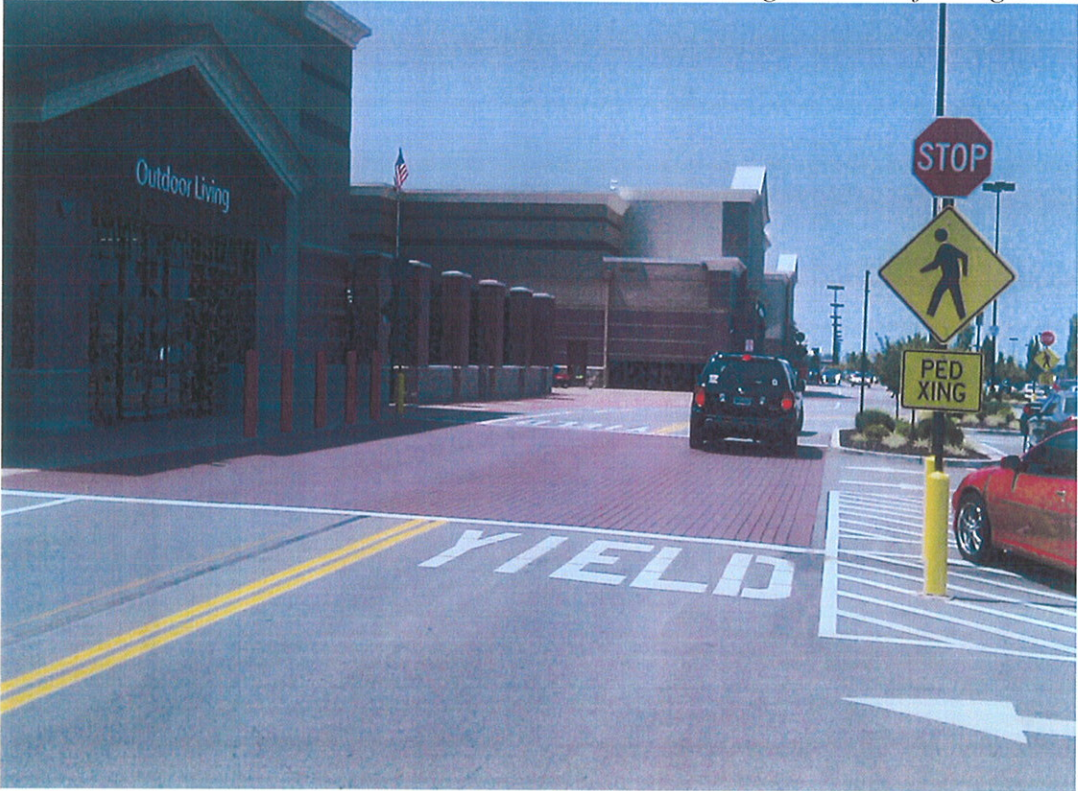
Figure 7: Conflicting YIELD and STOP
