## CHAPTER ONE – SITE & FACILITY INVENTORY & ANALYSIS

As part of the Comprehensive Master Plan, the Chesterfield Parks, Recreation and Arts Department (City) desired an inventory and assessment of the parks system. In April 2018, PROS Consulting visited all Chesterfield City parks and facilities. This assessment establishes a base-line understanding and “snapshot” of the system’s existing conditions and amenities. This assessment will be utilized with other technical research reports to assist with the final Comprehensive Master Plan including recommendations and action strategies.

## 1.4 SITE ASSESSMENT SUMMARIES

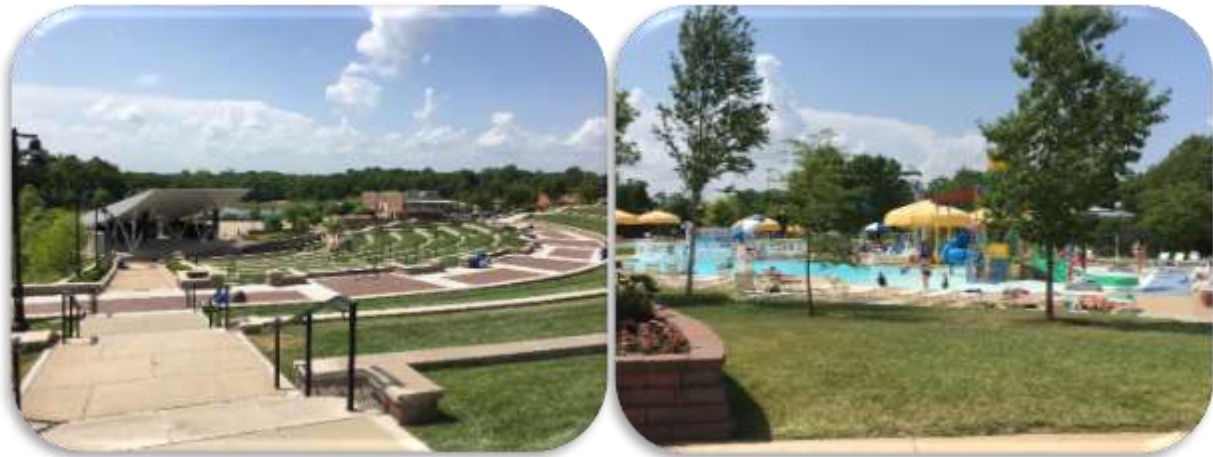
- Environmental fabric visible along the creek that drains the pool area above.
- Bare area of turf that needs over-seeding.

- Add more boulders to cover the fabric along the drainage leading to the creek.
- Expand the concrete at the pathway to the trail to support small maintenance vehicles.
- Add topsoil and nutrients to the area along the pathway to establish quality turf that matches the standard in all the other areas of the park.
- Add a crushed stone border along the pathway wall that matches other areas of the park and decreases maintenance in weed control along the edge.
- Acquire adjacent property to increase parking.
- Future redevelopment of the mall may potentially be part of a solution for parking with adequate walkways to Central Park.

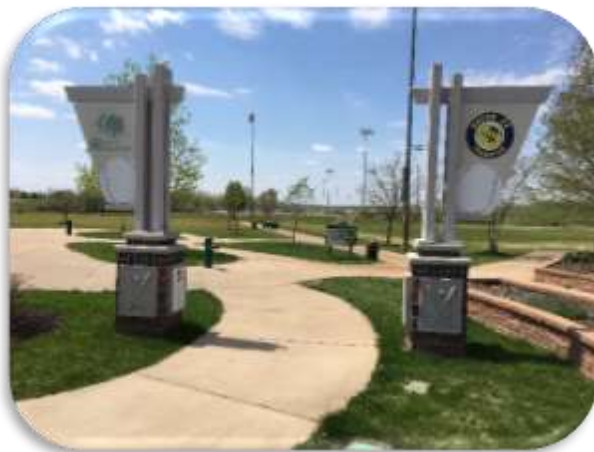
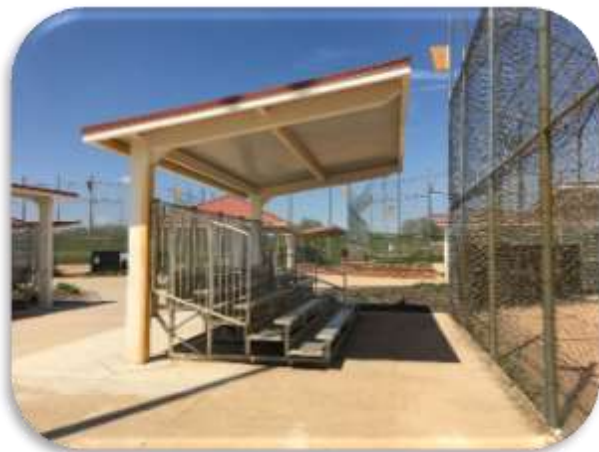
- Well water leaves iron stains which are considerably impacting the visual quality of the facility.
- Ruts are created along the walkways from time to time due to the equipment and soil conditions.

- Research all options for iron removal and/or filtration system.
- Fix ruts as time allows or expand the width of the walkways to support the width of equipment and equipment turn radius.
- Thirty undeveloped acres on the east side of the property for future recreation facilities based on the Priority Investment Rating.

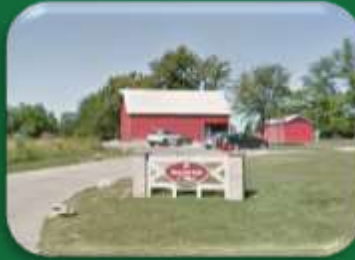
## Eberwein Park

- Gravel / concrete parking lot transition is uneven.

- Consider paving the trail in the park.
- Consider paving gravel section of parking lot unless it affects the storm water collection and release rate.
- Repurpose shuffleboard court (consider pickleball court, picnic shelter, a playground and/or a natural play area).
