Memorandum Department of Planning & Public Works

RE: Eberwein Park Development Farmhouse and Barn Report

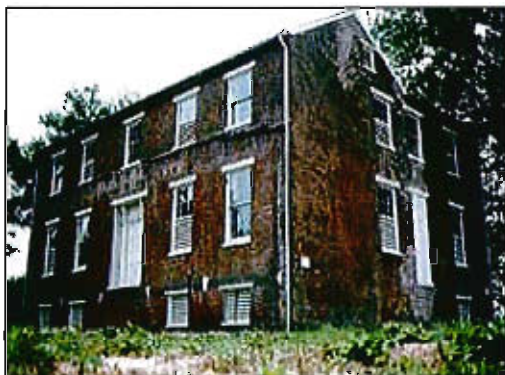
This building has been successfully mothballed for 10 years because the roof and walls were repaired and structurally stabilized, ventilation louvers added, and the property maintained. Photo: NPS files.

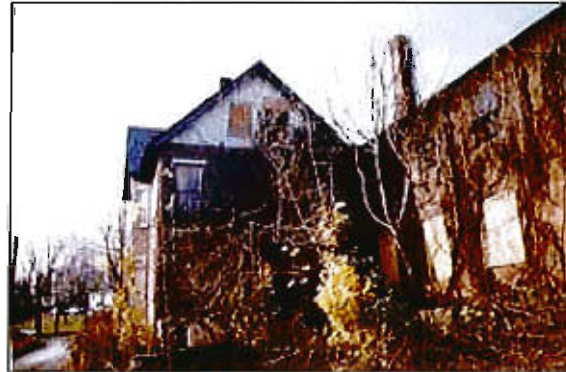
Boarding up without adequate ventilation and maintenance has accelerated deterioration of this property. Photo: NPS files.

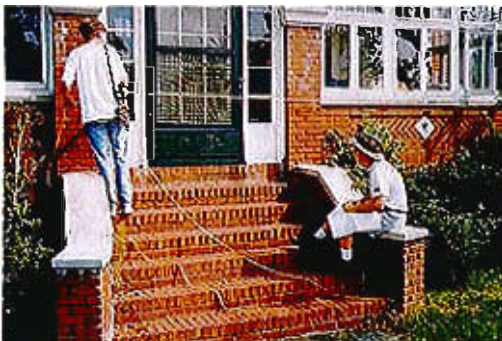
Documenting a building's history and assessing its condition provide information to set priorities for stabilization and repair, prior to mothballing. Photo: NPS files.

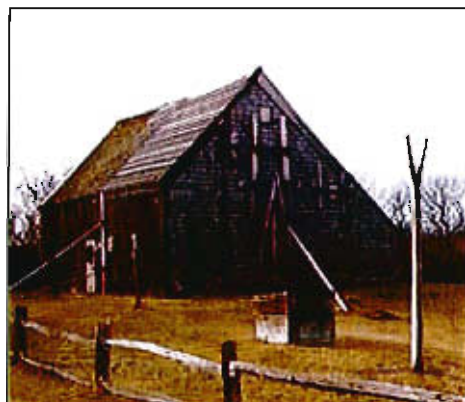
Buildings seriously damaged by storms or deterioration may need to be braced before architectural evaluations can be made. Photo: John Milner Architects. Photo: NPS files

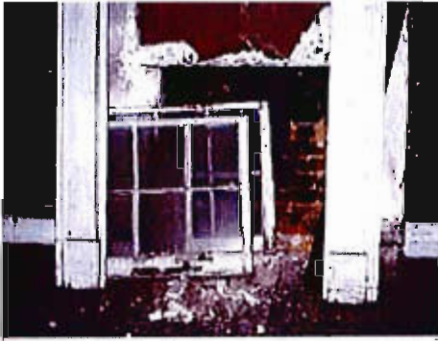
Loose or detached elements should be identified, tagged and stored, preferably on site. Photo: NPS files

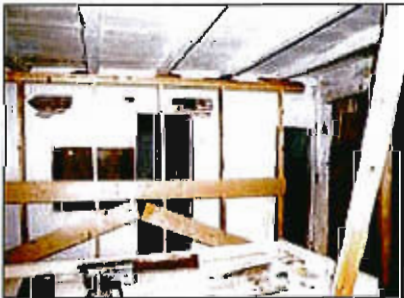
Interior bracing which will last the duration of the mothballing will protect weakened structural members. Photo: John Milner Architects.

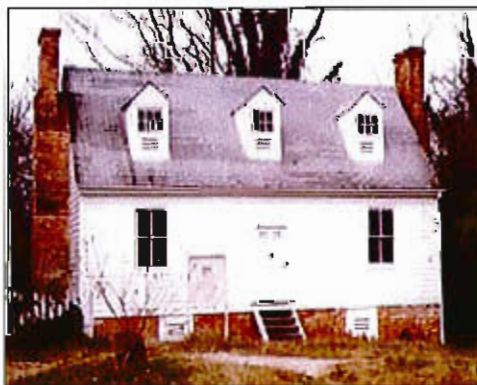
Regrading has protected this masonry foundation wall from excessive damp during its 10-year mothballing. Note the attic and basement vents, temporary stairs, and interpretive sign. Photo: NPS files.

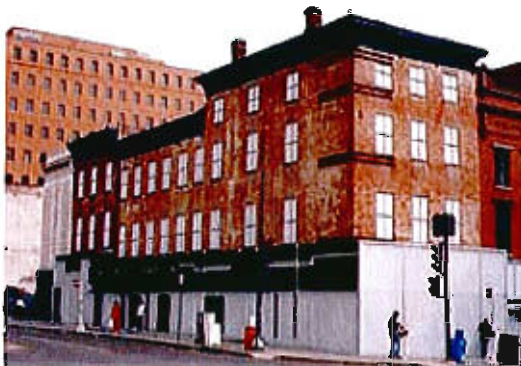
Urban buildings often need additional protection from unwanted entry and graffiti. This commercial building uses painted plywood panels to cover its glass storefronts. The upper windows on the street sides have been painted to resemble 19th century sash. Photo: NPS files.

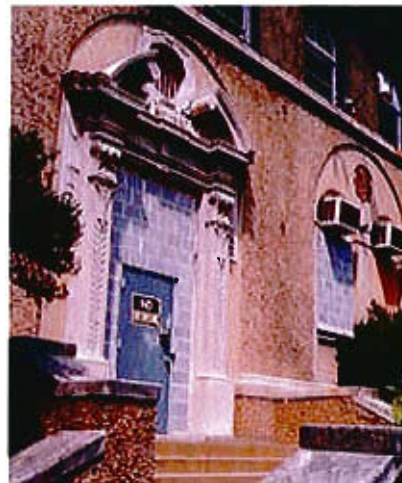
The first floor openings of this historic building have been filled with cinder blocks and the doors, window sash, and frames removed for safe keeping. The security metal door features heavy duty locks. Photo: NPS files.

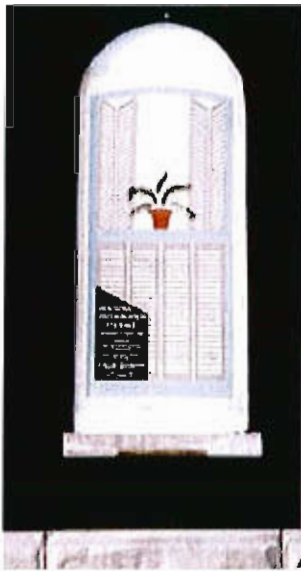
This painted trompe l'oeil scene on plywood panels is a neighborhood-friendly device. Photo: NPS files.

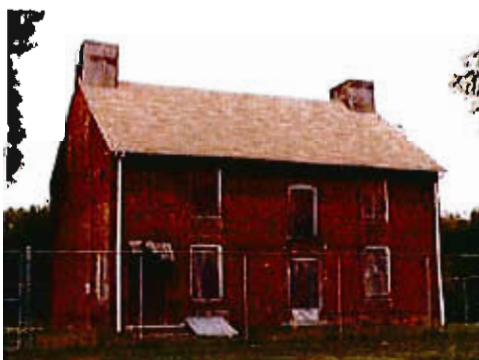
A view showing the exterior of the Brearley House, New Jersey, in its mothballed condition. Photo: Michael Mills, Ford Farewell Mills Gatsch, Architects.

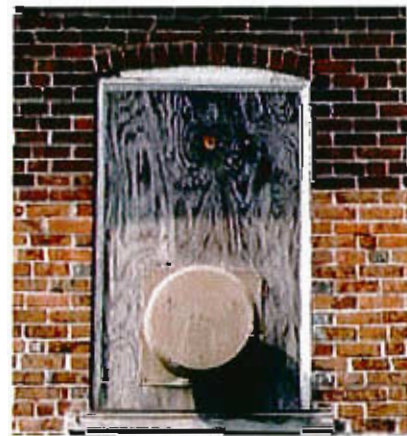
This exhaust fan has tamper-proof housing. Photo: Michael Mills, Ford Farewell Mills Gatsch, Architects.

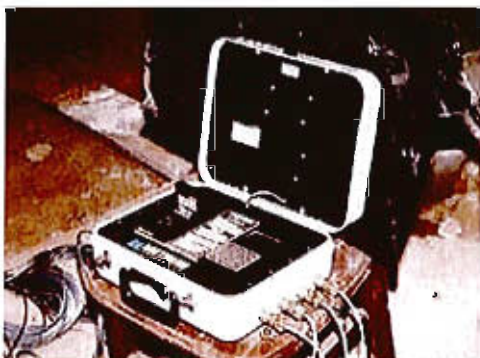
Portable monitors are used to record temperature and humidity conditions in historic buildings during mothballing. Photo: NPS files.
