RE: Concrete Pavement Report

City of Chesterfield

Concrete Pavement Report

June 2023

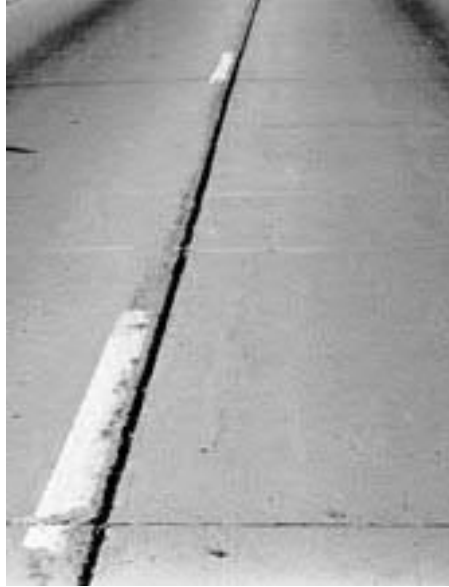
▲ Joint open about 1/2".

Maintaining a tight joint seal can prevent intrusion of water and reduce freeze-thaw damage and pumping. Severe joint deterioration may require full depth patching and replacement of the joint.

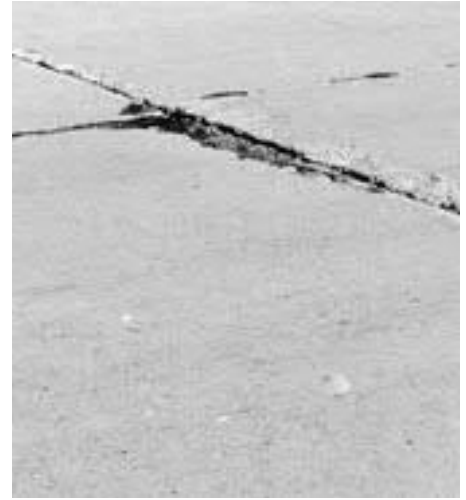
▼ **Transverse joint has slight faulting and spalling.**

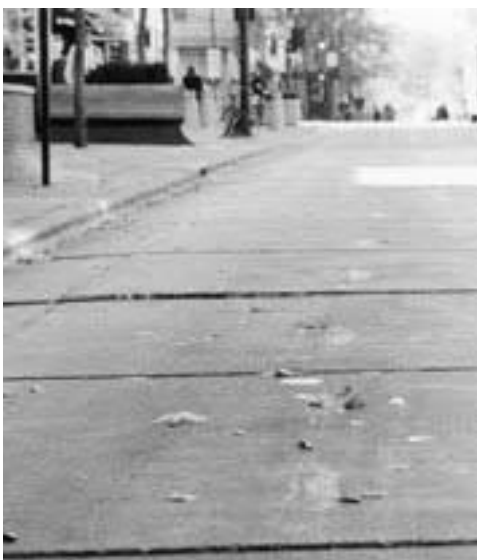
▲ Minor faulting of transverse joints. Aggravated by heavy traffic. Surface grinding will improve ride.

Faulting creates a poor ride and may cause slab deterioration. Minor faulting can be corrected by surface grinding. Voids can be subsealed, or slabs mud jacked back to level position. Severe cases may need joint replacement.

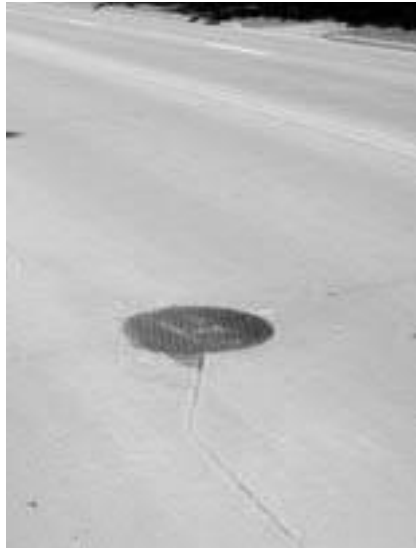
▶ Isolated spall at manhole.

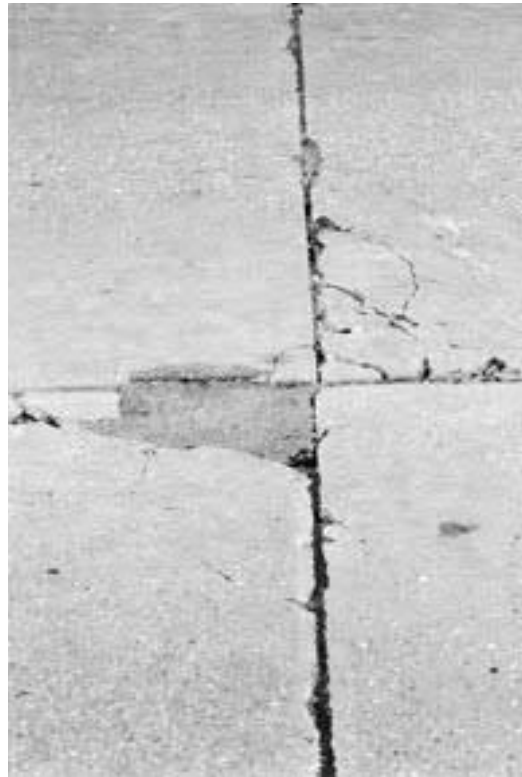
▶ Broken corner
pieces. Some
joint spalling.

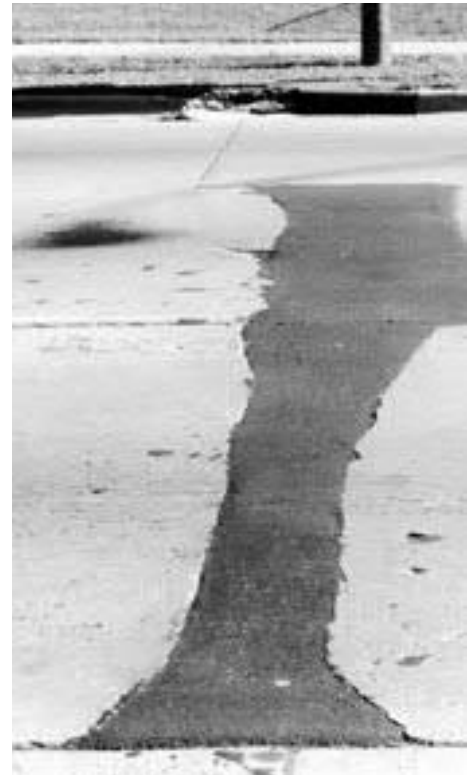
Patching in
▼ fair condition.

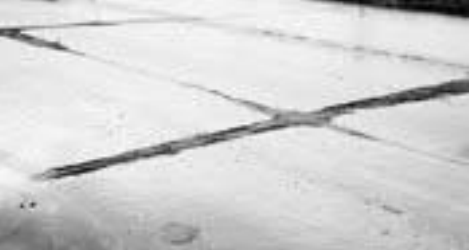
▲ Extensive joint failure. Major rehabilitation or complete replacement needed.
