**RE:** Concrete Pavement Report

**Concrete Pavement Report**

**June 2023**

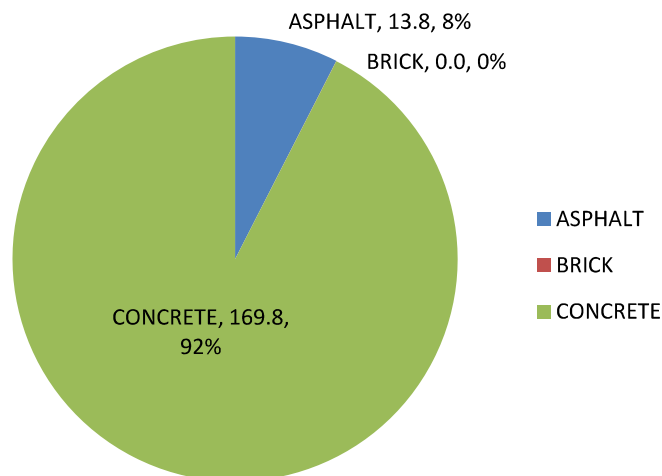
Figure 1

The City’s pavement data is maintained by the GIS Division of the IT Department in collaboration with the Public Works Department. Appendix A includes a table of pertinent concrete pavement data that will be updated annually. Most of the City’s pavement system, approximately 92% or 170 miles, is concrete pavement. The remainder of the City’s pavement system, approximately 8% or 14 miles, is asphalt pavement. There is one small brick paver street segment on Appalachian Trail. As stated above, this report will focus on concrete pavement.

Road Mileage by Pavement Type

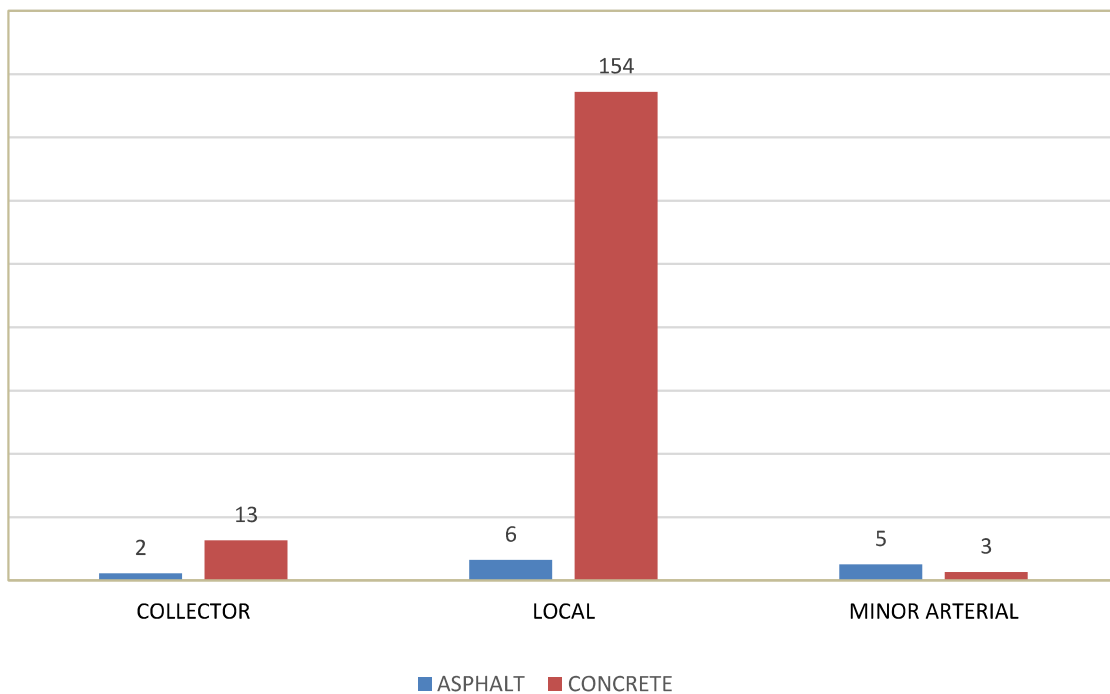
The City’s roadways are classified into three categories: local, collector, and minor arterial. Local roads generally serve individual residences and include internal subdivision streets. Collector roads, as the name implies, collect traffic from local roads, provide connectivity into the arterial road system, and have fewer direct access points compared to local roads. Collector roads include Wildhorse Parkway, Greentrails Drive South, and Highcroft Drive. Minor arterial roads serve to efficiently move traffic through an area, typically with even fewer direct access points than collector roads. City maintained minor arterial roads are Edison Avenue, Ladue Road, Hog Hollow, and Schoettler Road. Figure 2 below shows the current street classification and total miles of City streets in each category. The City’s current Street Classification Map is included as Appendix B.

### Road Mileage by Classification

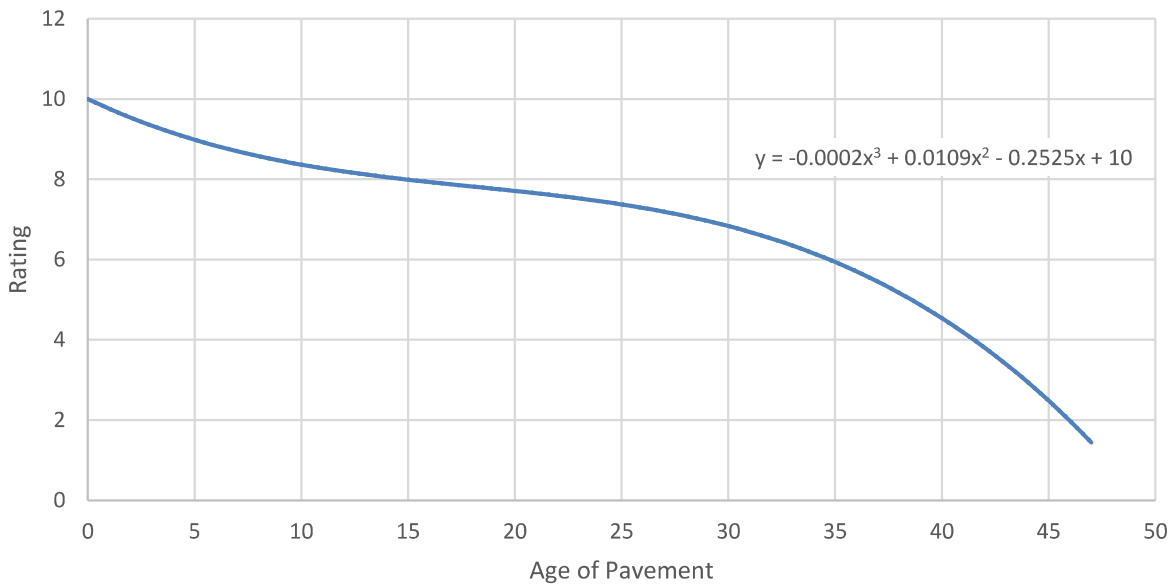
Figure 7 below shows the theoretical pavement deterioration curve for the City’s pavement. New pavement is rated a 10 and according to the current prediction curve it would normally deteriorate to a PASER rating of around 6 by year 35. As stated previously, a rating of 6 generally corresponds to the condition that residents find unacceptable. The equation in the top right portion of the chart is a polynomial regression reflecting the relationship between City’s pavement ratings (y) and pavement ages (x).

Pavement Rating versus Age -  
Condition Prediction Curve

City Engineering Staff analyzed historic pavement age and condition ratings to create a condition versus age curve specific to the City’s concrete pavement. Additional data will be added annually to continually refine the condition versus age curve. The City’s pavement condition data is based on a pavement sample size of streets with known age and condition ratings.

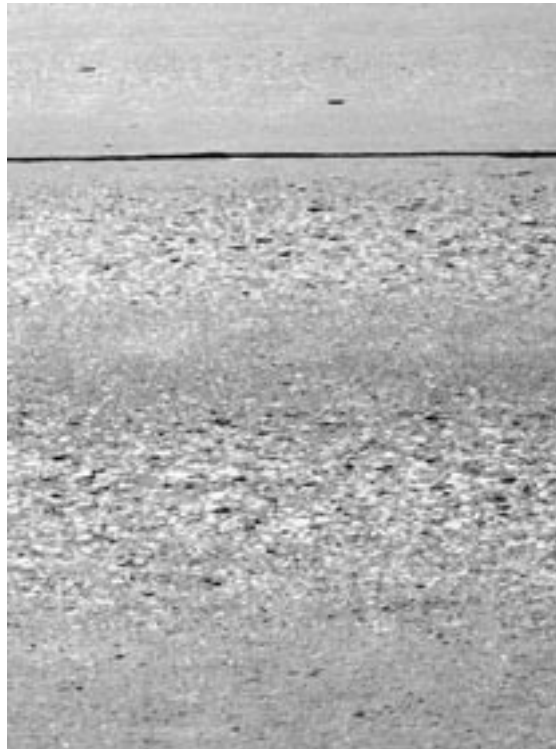
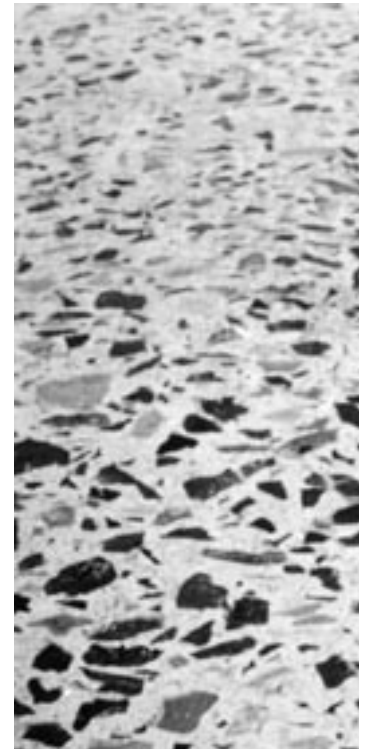
A worn or polished surface may appear from traffic wearing off the surface mortar and skid resistant texture. Extensive wear may cause slight ruts where water can collect and cause hydroplaning. Sometimes traffic may polish aggregates smooth, causing the surface to be slippery. An asphalt overlay or grinding of the concrete surface can restore skid resistance and remove ruts.

▶ **Surface mortar worn away exposing larger aggregate. Accidents or friction testing may indicate a slippery surface in need of improved texture.**

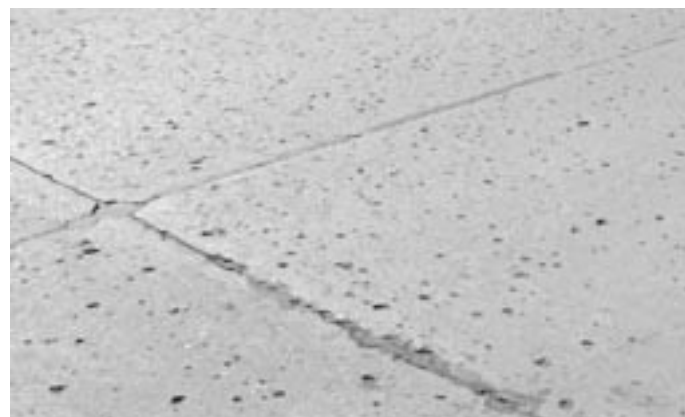
◀ **Hairline surface cracks, probably shallow in depth. May not cause any long term performance problems.**

◀ **Extensive pop-outs of large aggregate from surface. Pop-outs alone have not affected pavement serviceability.**

Individual pieces of large aggregate may pop out of the surface. This is often caused by chert or other absorbent aggregates that deteriorate under freeze-thaw conditions. Surface patching can be done temporarily with asphalt. For severe areas, a more permanent partial depth concrete patch may be necessary.

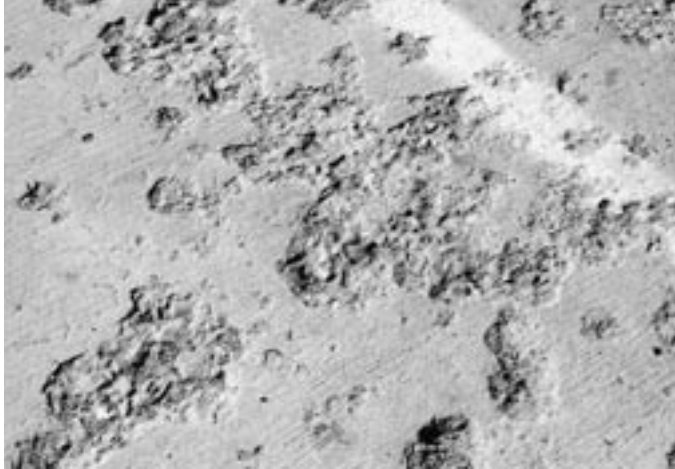
► Moderate surface scaling. Loss of mortar and fines from the surface beginning to expose larger aggregate.

Scaling is surface deterioration that causes loss of fine aggregate and mortar. More extensive scaling can result in loss of large aggregate. Often caused by using concrete which has not been air-entrained, the surface becomes susceptible to freeze-thaw damage. Scaling is also aggravated by the use of deicing chemicals.

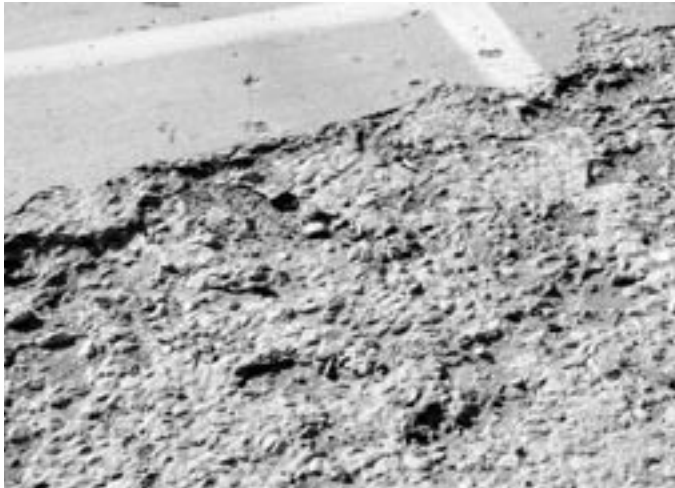
► Severe scaling. Some larger aggregate is loose.

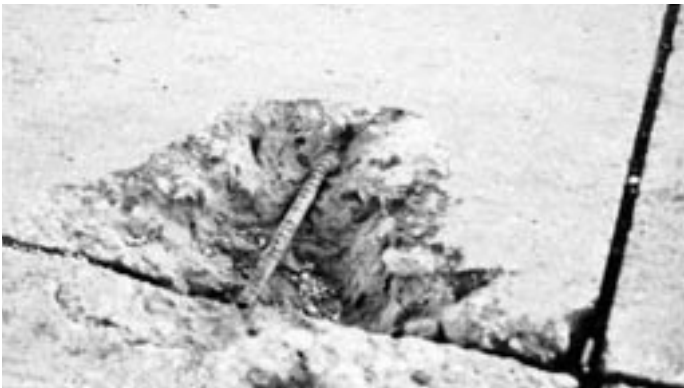
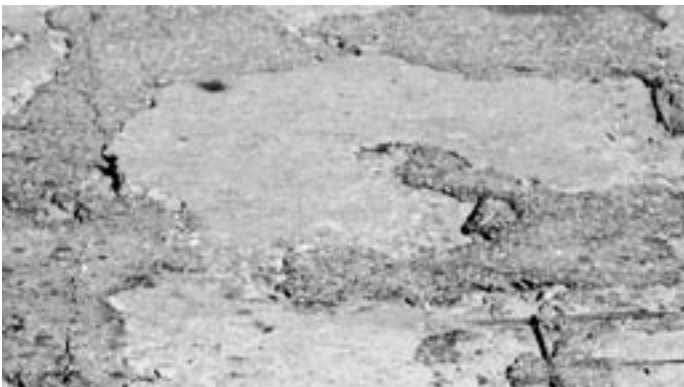
Reinforcing bar exposed. Shallow concrete cover caused large spall to develop around it. ▼

If the steel reinforcing bar or mesh is placed too close to the concrete surface it will lead to concrete spalling. Corrosion of the steel creates forces that

break and dislodge the concrete. Often you can see rust stains in the surface cracks before spalling occurs. Can be temporarily patched with asphalt. Permanent repairs are difficult and usually involve replacing the steel and making a partial depth or full depth concrete repair.

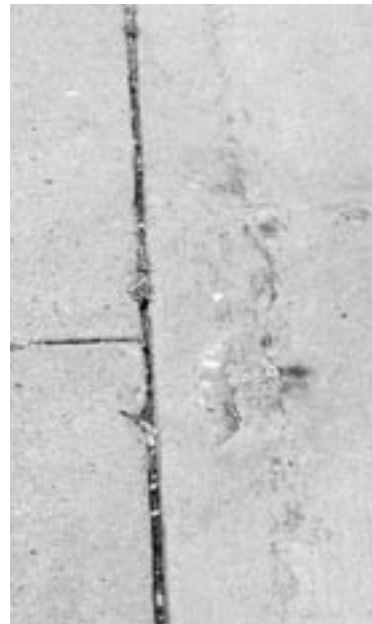
◀ Surface stain parallel to joint. Indicates reinforcing steel too close to surface.

◀ Wire reinforcing mesh placed close to surface. Corrosion of the reinforcing steel causes the surface mortar to spall. Very difficult to patch and repair.

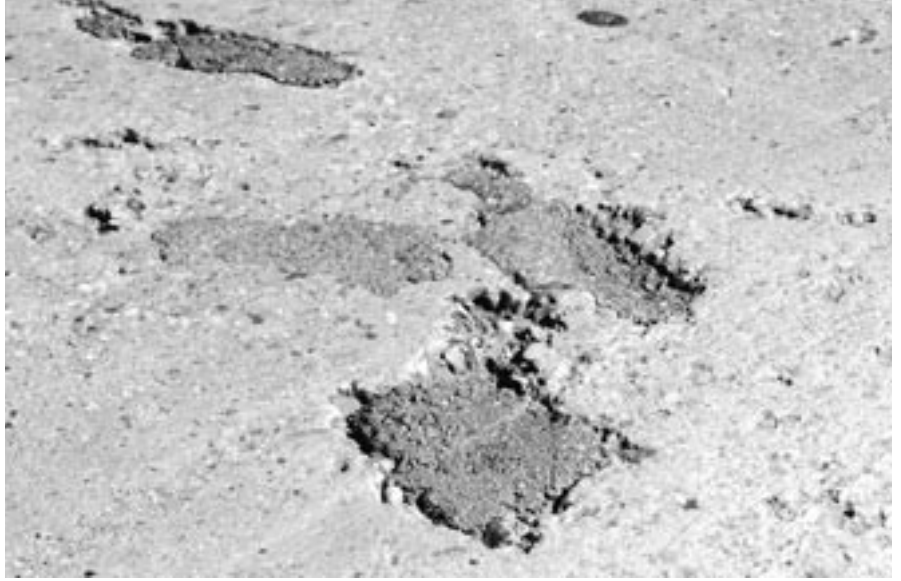
▶ Small surface spalls that have been patched.

Repair will depend on the cause. Small spalled areas are often patched. Spalling at joints may require full depth joint repair.

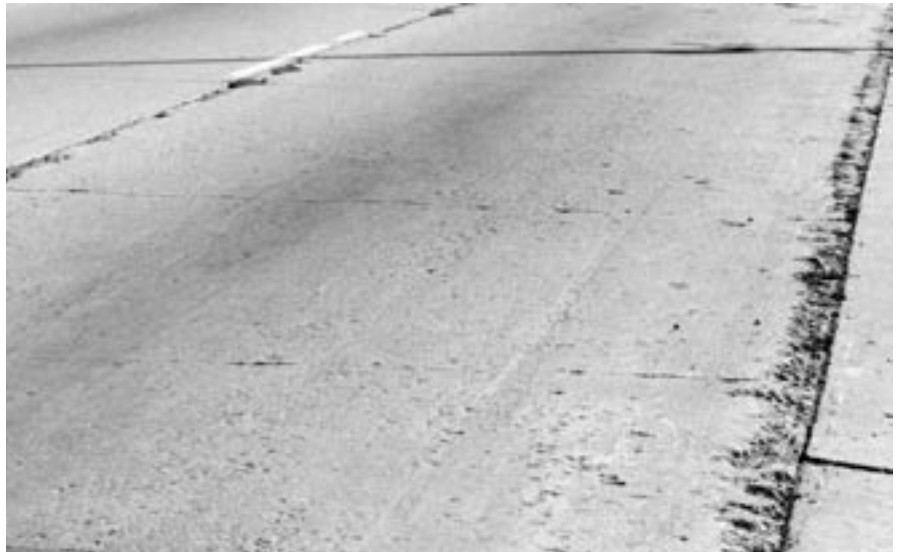
▶ Spalling along longitudinal joints.

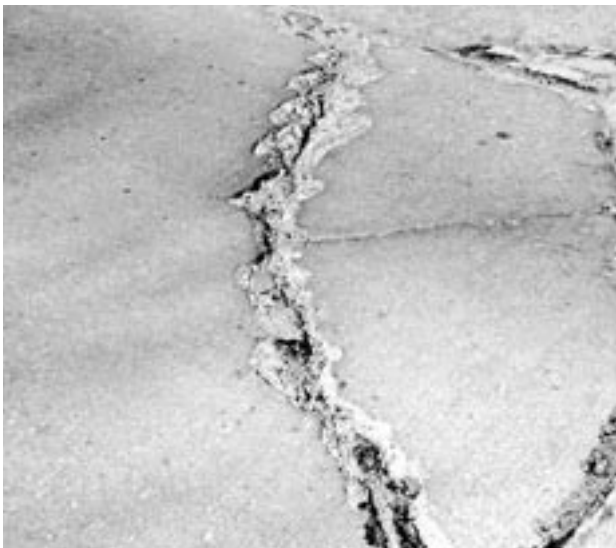
▼ A severely spalled crack.

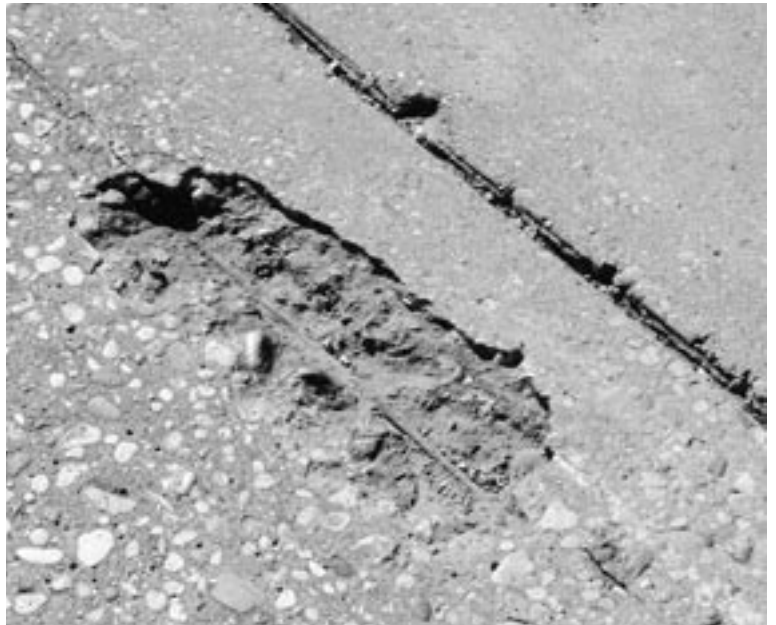
▶ Spalling over shallow reinforcing.

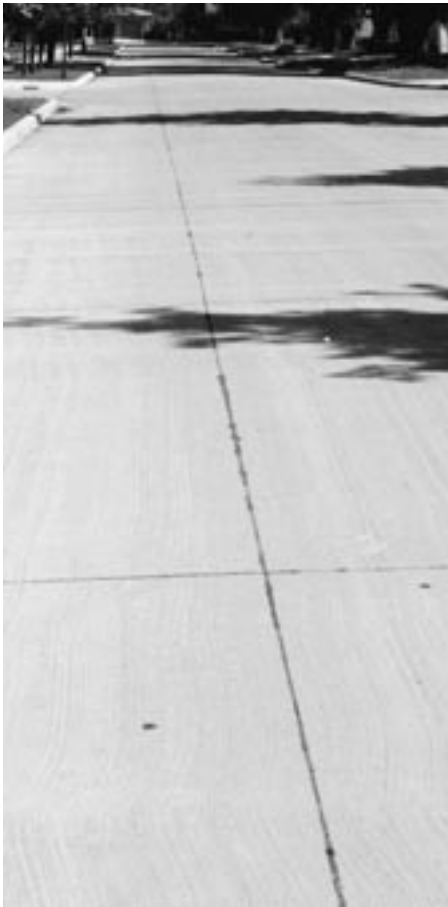
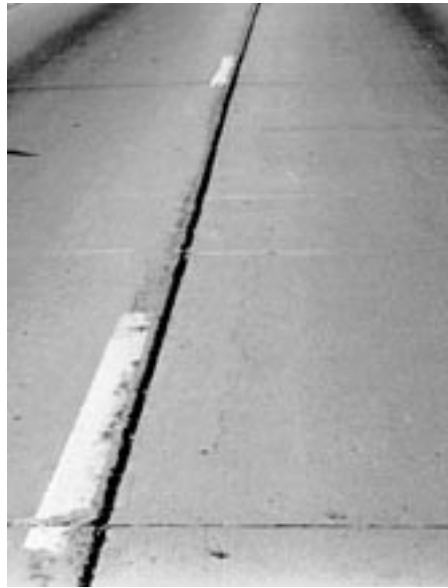
▲ Joint open about 1/2".

◀ New, well-sealed longitudinal joint.

Longitudinal paving joints are constructed to be narrow in width and usually well sealed. As pavements age and materials deteriorate, joints may open and further deteriorate. Cracks parallel to the initial joint may develop and accelerate into spalling or raveling of the longitudinal joint. Settlement, instability, or pumping of the subgrade soil can cause longitudinal joints to fault. One common cause of cracks parallel to the longitudinal joints is waiting too long after the pour to saw the joint. Then, during initial cure the slab will crack roughly parallel (but not exactly) to the sawn joint.

Maintaining a tight joint seal can prevent intrusion of water and reduce freeze-thaw damage and pumping. Severe joint deterioration may require full depth patching and replacement of the joint.

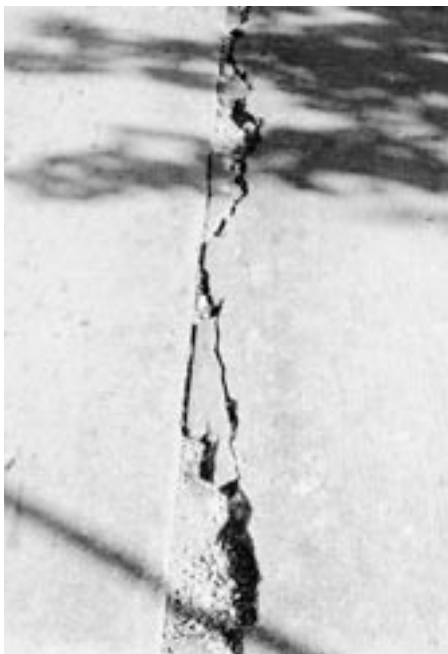
▲ Additional joint cracking, spalling, and broken pavement. Full depth repair is needed.

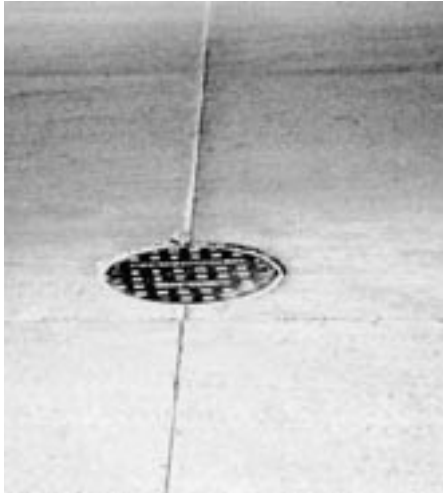
▼ **New, well-sealed transverse joint.**

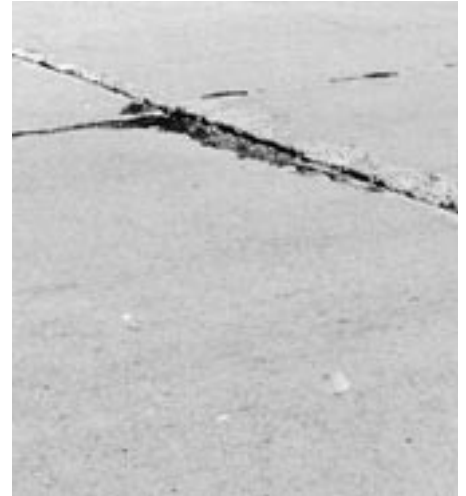
▼ **Transverse joint has slight faulting and spalling.**

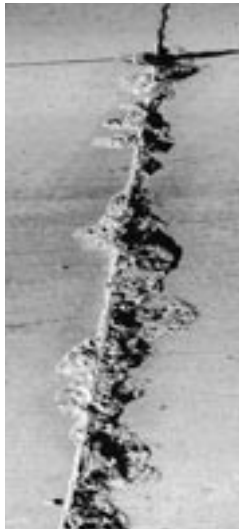
▶ **Severe spalling of a transverse joint.**

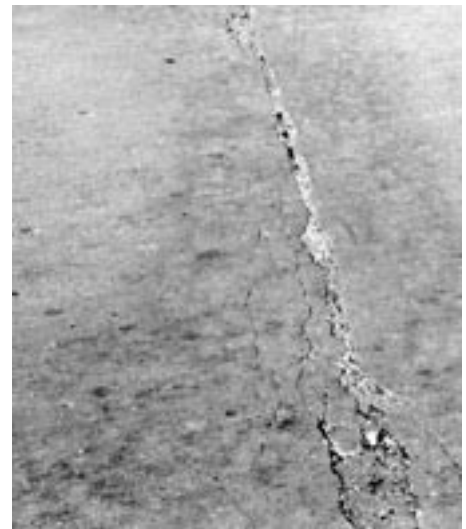
▶▶ **Cracks parallel to joint. Dark color next to transverse joint likely indicates D-cracking and additional deterioration. Full depth repair required.**

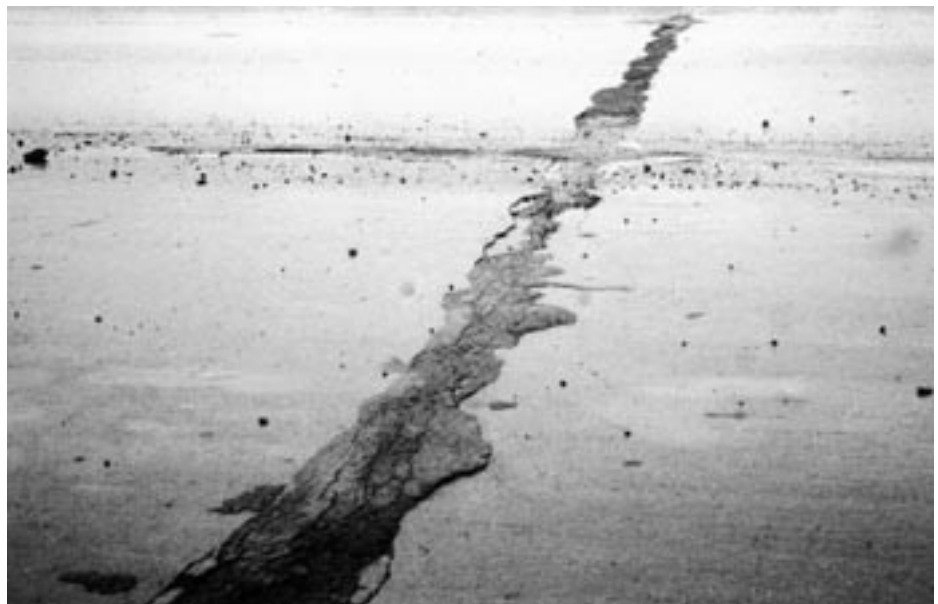
▶ **Severe spalling has required temporary patching. Complete joint replacement is necessary.**

Overall, lack of joint maintenance and rehabilitation is a common problem. Maintaining a tight, well sealed joint can reduce water intrusion and thereby reduce freeze-thaw damage, pumping, blow-ups, D-cracking, and spalling. Early repair of minor defects can often reduce the need for complete joint repair or replacement.

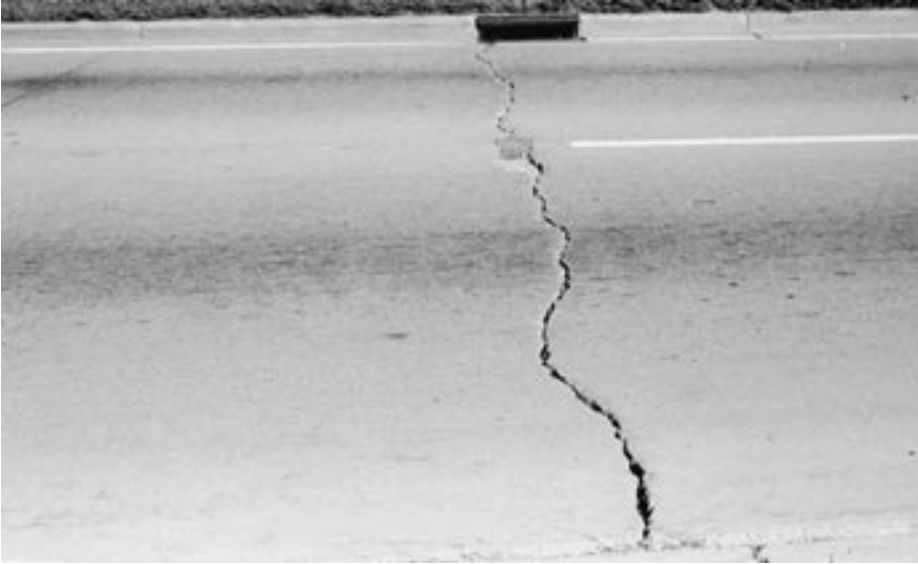
**Transverse,  
open crack.**

As with joints, these cracks may deteriorate further if not sealed well. Slabs can fault at cracks which can spall and develop additional parallel cracking. Severe deterioration may require patching individual cracks. Multiple transverse cracks in individual slabs indicate further deterioration. Extensive transverse cracking indicates pavement failure and the need for complete replacement.

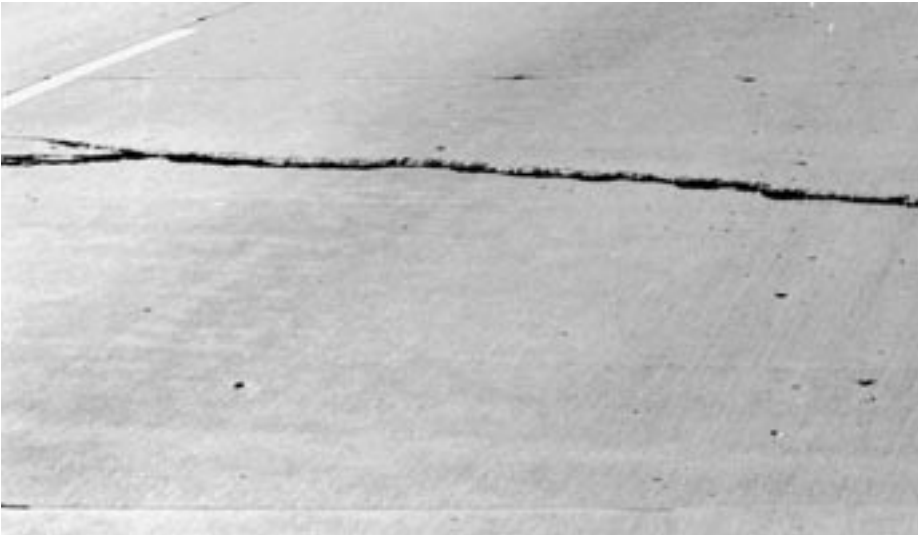
**Faulted transverse  
crack with slight  
edge spalling.**

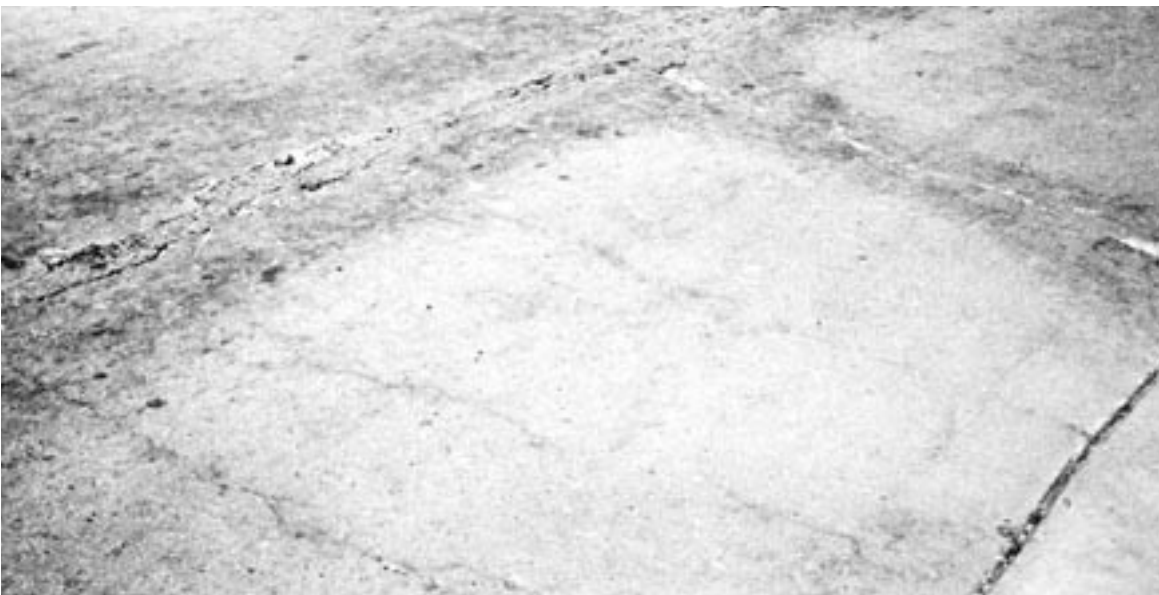
**Closely spaced,  
hairline trans-  
verse cracks.  
Indicates slab  
is broken  
and in need of  
replacement.**

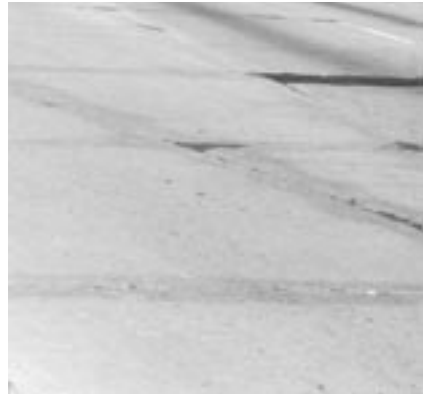
Surface discoloration near joints and cracks indicates D-cracking and severe slab deterioration.

Occasionally, severe deterioration may develop from poor quality aggregate. So called D-cracking develops when the aggregate is able to absorb moisture. This causes the aggregate to break apart under freeze-thaw action which leads to deterioration. Usually, it starts at the bottom of the slab and moves upward.

Fine cracking and a dark discoloration adjacent to the joint often indicate a D-cracking problem. Once this is visible on the surface the pavement material is usually severely deteriorated and complete replacement is required.

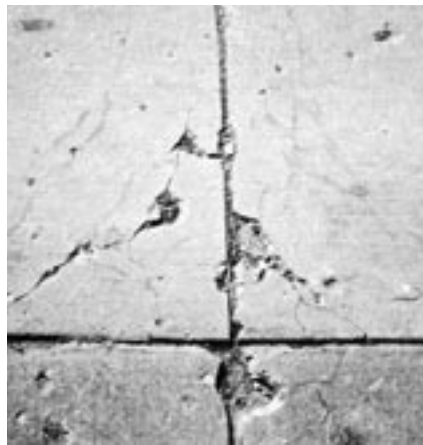
Multiple crack patterns adjacent to joints. Common D-cracking pattern.

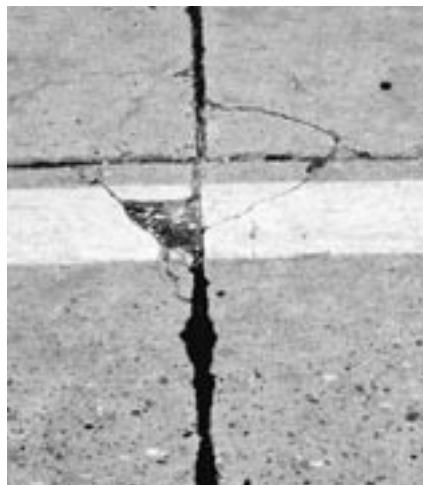
Corner cracking with broken concrete pieces.

First signs of corner cracking.

Diagonal cracks near the corner of a concrete slab may develop, forming a triangle with a longitudinal and transverse joint. Usually these cracks are within one foot of the corner of the slab. They are caused by insufficient soil support or concentrated stress due to temperature related slab movement. The corner breaks under traffic loading. They may begin as hairline cracks.

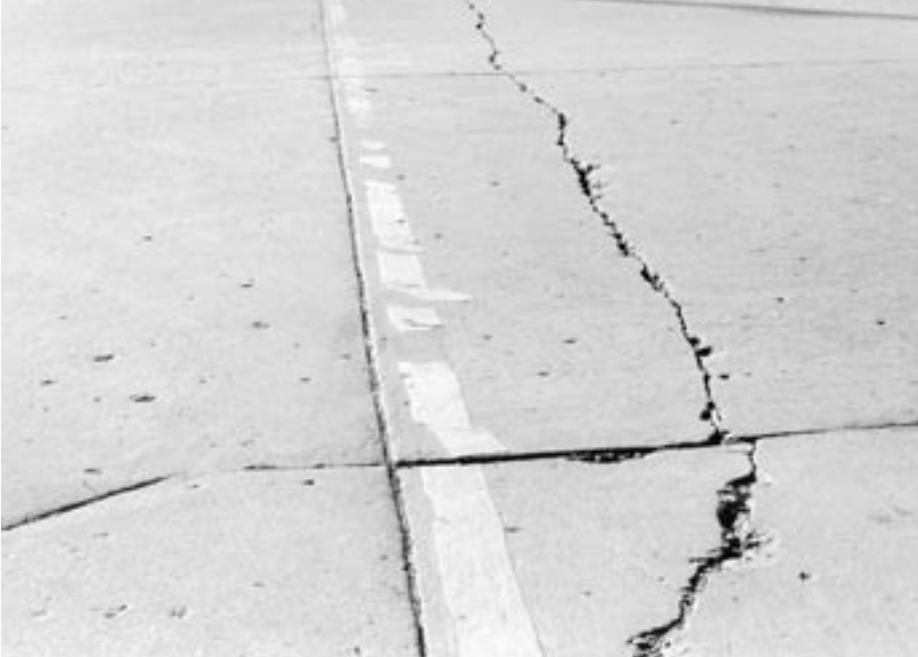
◀  
**Meander crack roughly parallel to longitudinal joint.**

Some pavement cracks appear to wander randomly. They may cross a slab diagonally or meander like a serpent. Meander cracks may be caused by settlement due to unstable subsoil or drainage problems, or by utility trench settlement. Frost heave and spring thaw can also cause them. They are often local in nature and may not indicate general pavement problems.

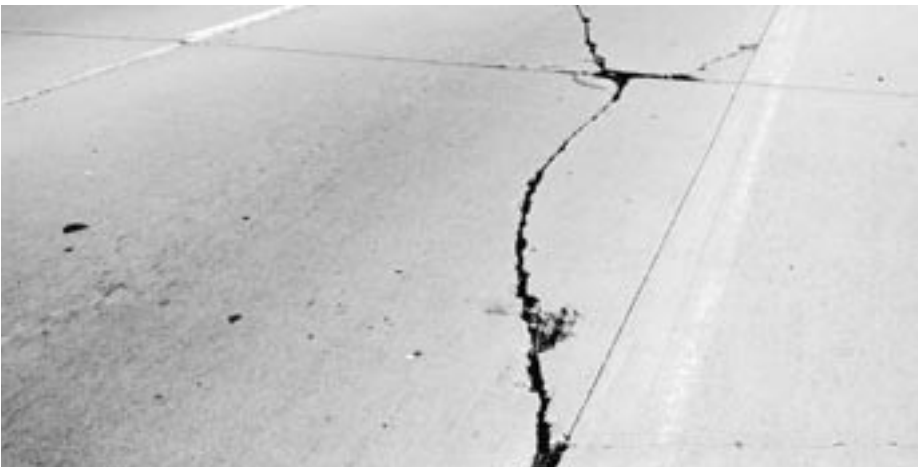
◀  
**Meander crack caused by settlement. Lack of maintenance allows water to intrude and debris to collect in crack.**

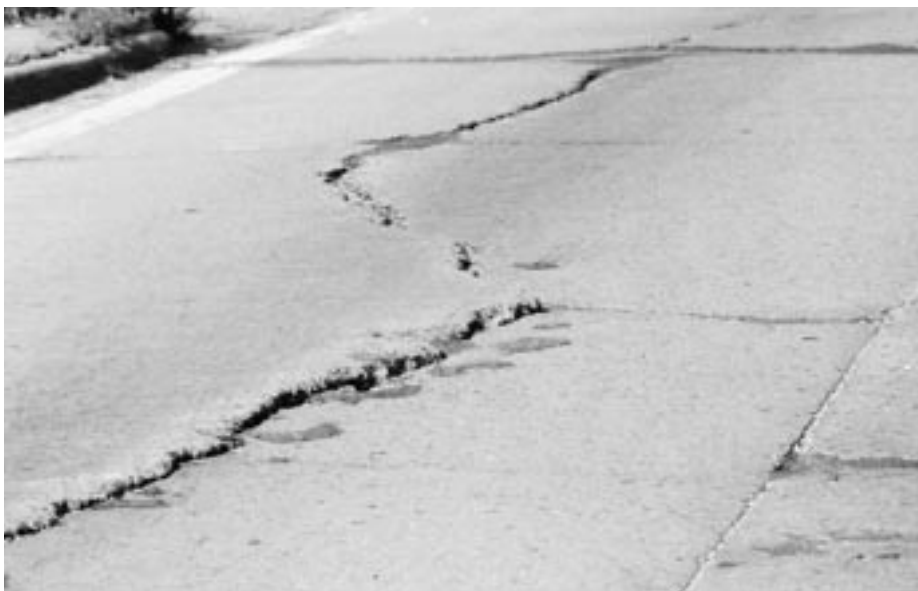
◀  
**Faulting and spalling of a meander crack.**

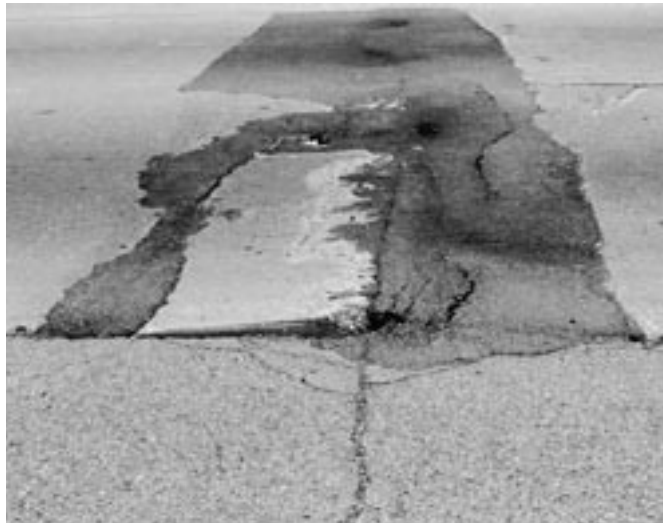
◀ Internal pressure has partially raised slab at the joint. Complete replacement is required.

Concrete slabs may push up or be crushed at a transverse joint. This is caused by expansion of the concrete where incompressible materials (sand, etc.) have infiltrated into poorly sealed joints. As a result, there is no space to accommodate expansion. It is more common in older pavements with long joint spacing. Pressure relief joints can be installed and blowup areas must be patched or reconstructed.

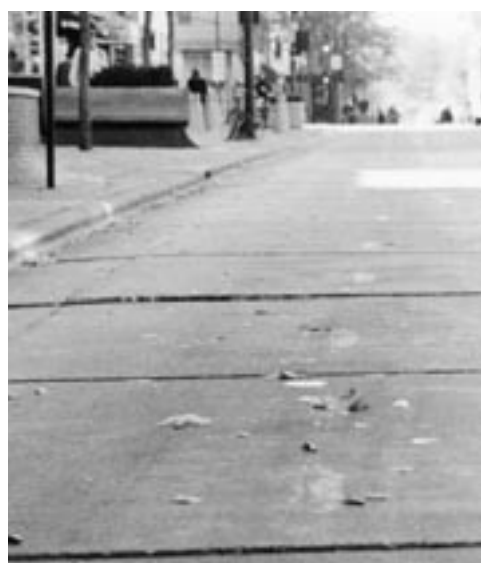
▲ Minor faulting of transverse joints. Aggravated by heavy traffic. Surface grinding will improve ride.

Faulting creates a poor ride and may cause slab deterioration. Minor faulting can be corrected by surface grinding. Voids can be subsealed, or slabs mud jacked back to level position. Severe cases may need joint replacement.

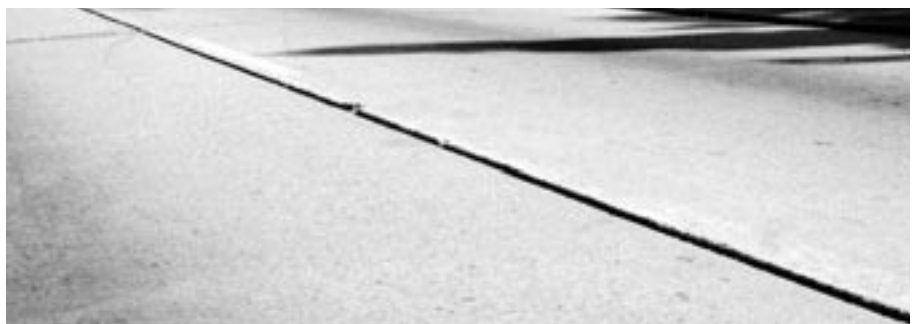
▲ Faulted longitudinal joint.

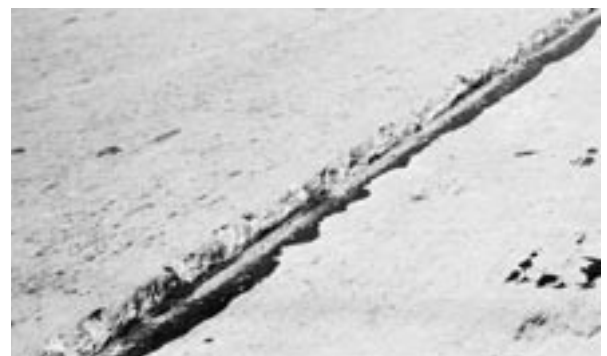
► Settlement caused meander crack with faulting.

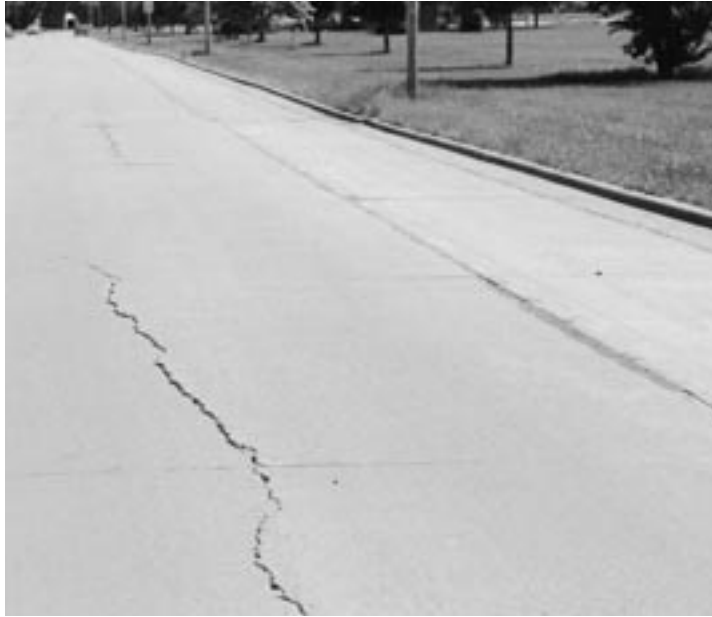
Extensive cracking and patching caused by settlement. Pavement was built on unstable sub-grade soils.

Unstable or poorly drained subgrade soils may cause pavements to settle after construction. Poorly compacted utility trenches may also settle. This may be a gentle swale or a fairly severe dip.

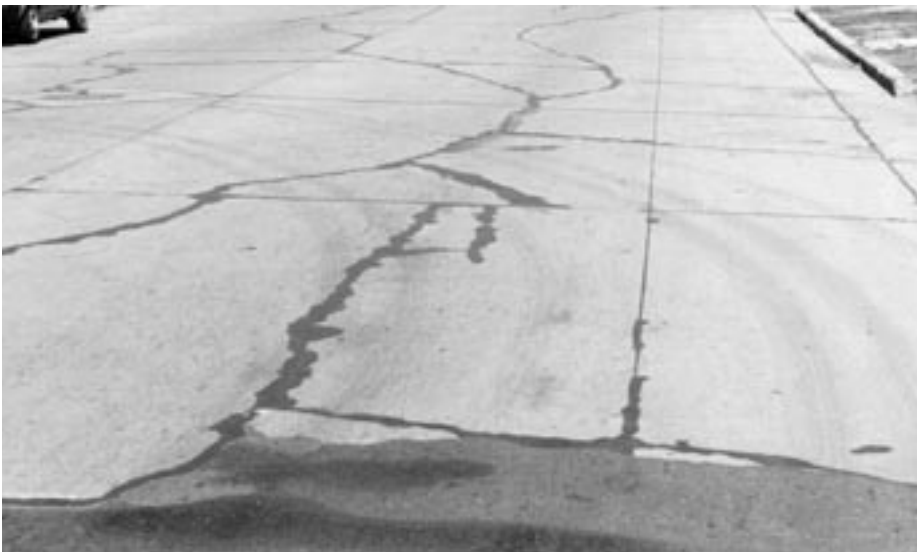
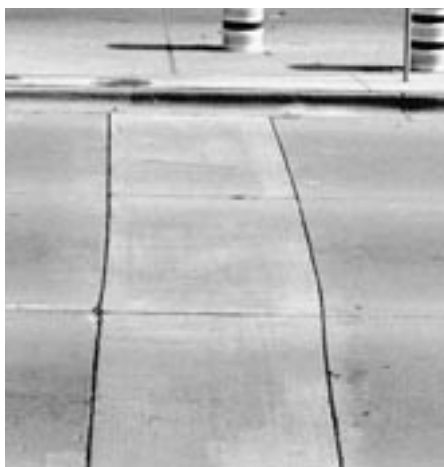
▲ Utility repair or full depth joint repair. Very good condition.

Replacement or repair of utilities will require cuts or utility openings. When repaired these pavement patches may show settlement, joint deterioration, or distress under continued traffic loading. Patches from previous repairs may perform like original pavement or experience joint deterioration or settlement.

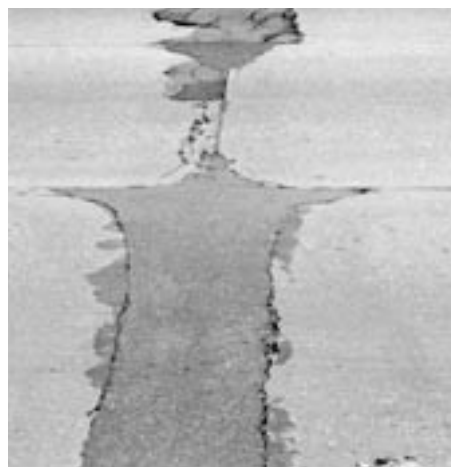
▲ Asphalt patches. Poor (top) and fair (bottom) condition.

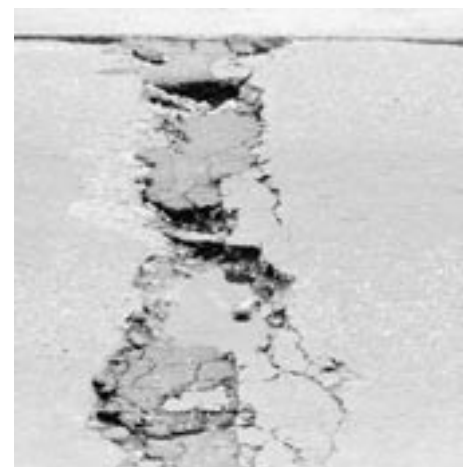
▲ Potholes caused by severe joint deterioration. Need repair.

Localized failures of materials or subgrade soil can cause individual potholes. Surface spalling or other material defects may develop into localized potholes. Full depth patching is usually required.

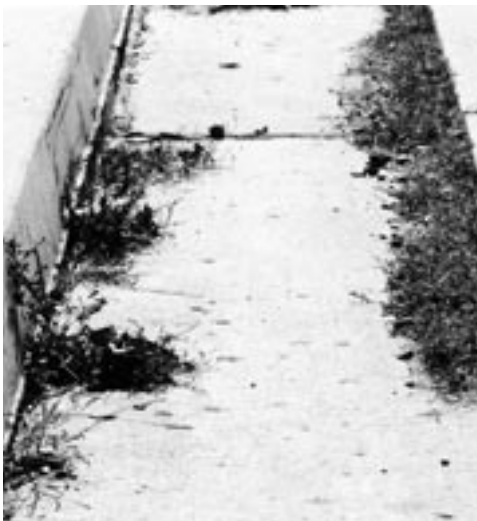
**Settled gutter and joint filled with debris. Joint maintenance is needed. ▼**

Concrete curb and gutter, or paved concrete shoulders, may separate from or settle along the main pavement. The longitudinal joints between the pavement and curb or shoulder may open, fault, or deteriorate like other longitudinal joints. When severe enough to disrupt drainage, the curb and gutter need to be replaced. Shoulder deterioration may require patching or replacement.

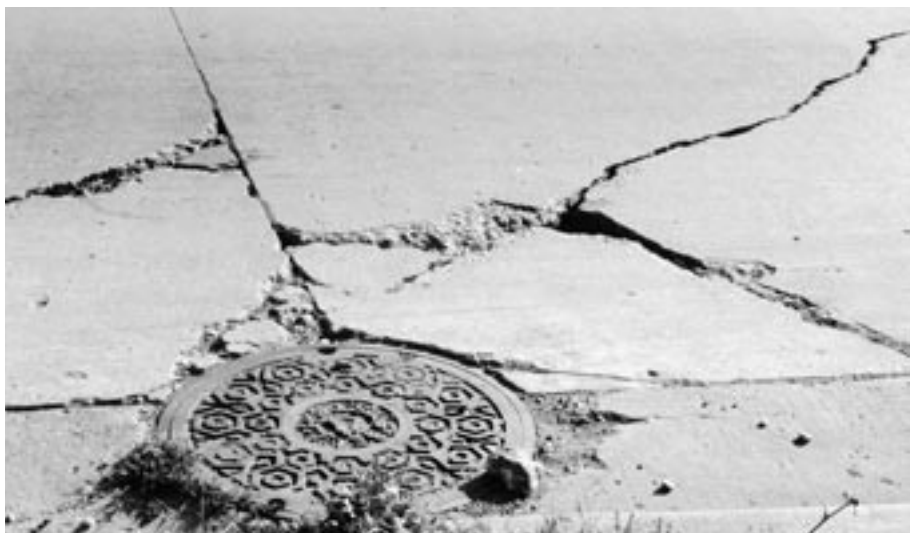
**Two spalls at manhole in a new pavement. Partial depth patching would be beneficial. ◀**

Normal pavement movement due to frost heaving and movements due to changes in temperature often cannot be accommodated in the pavement adjacent to a manhole or a storm sewer inlet. Cracks and faulting may develop and the concrete slab may deteriorate further. These are often localized defects that may not indicate a general pavement problem. Sealing and patching may slow the deterioration. Eventually full depth repairs may be required.

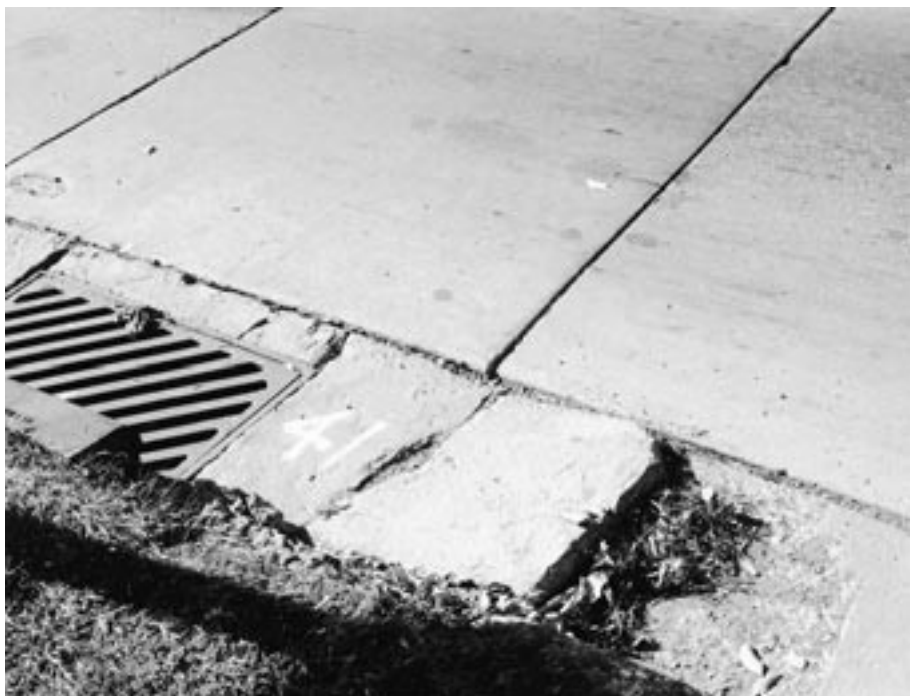
**Extensive cracking and spalling at manhole requiring full depth repairs. ▼**

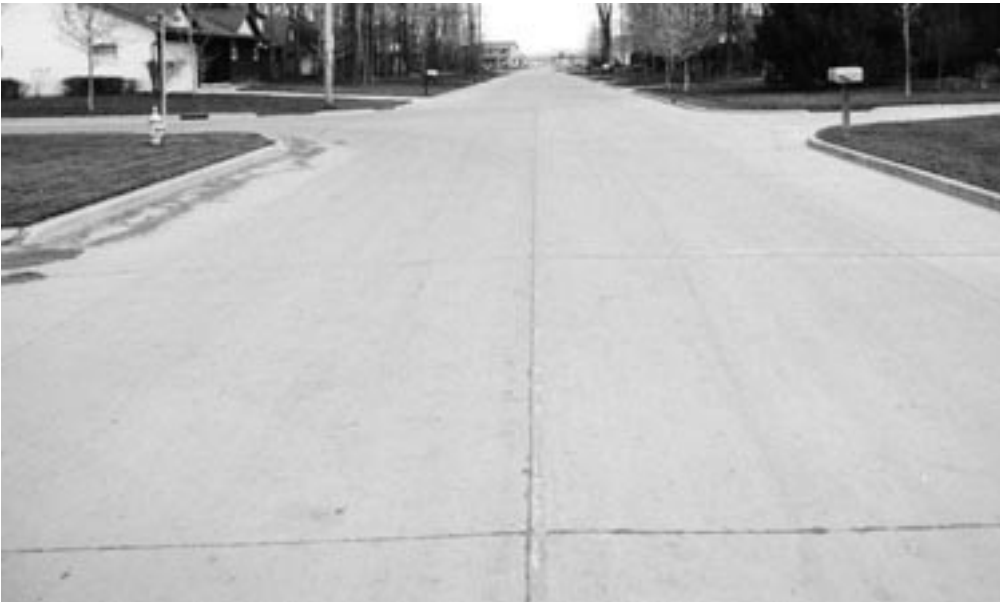
#### RATING 10 New pavement with integral curb.

**COC Notes 10 - No cracks, asphalt patches or partial depth patches. No displacement, scaling or popouts. May have minor imperfections in the original pouring of the slab (e.g. rough edges from surface scrapes, rounded corners that show no sign of continuing wear.**

Rating 10 is for new pavement. Rating 9 is used for recent concrete rehabilitation or like-new condition. Some traffic wear. Slight map cracking or pop-outs. No maintenance required.

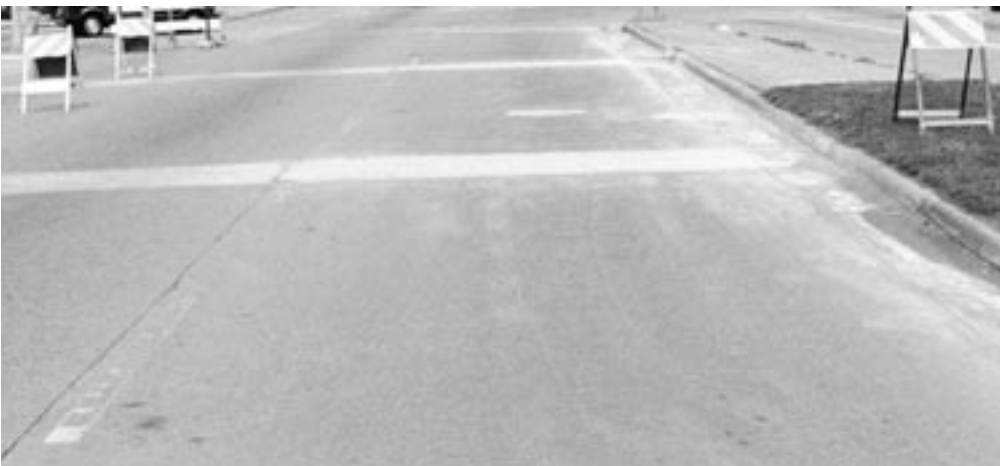
#### RATING 9 Like new condition.

**COC Notes 9 - The slab may have one minor hairline crack and no asphalt or partial depth patch. Minor imperfections are allowed such as minor scaling or few popouts. No raveling of the joints.**

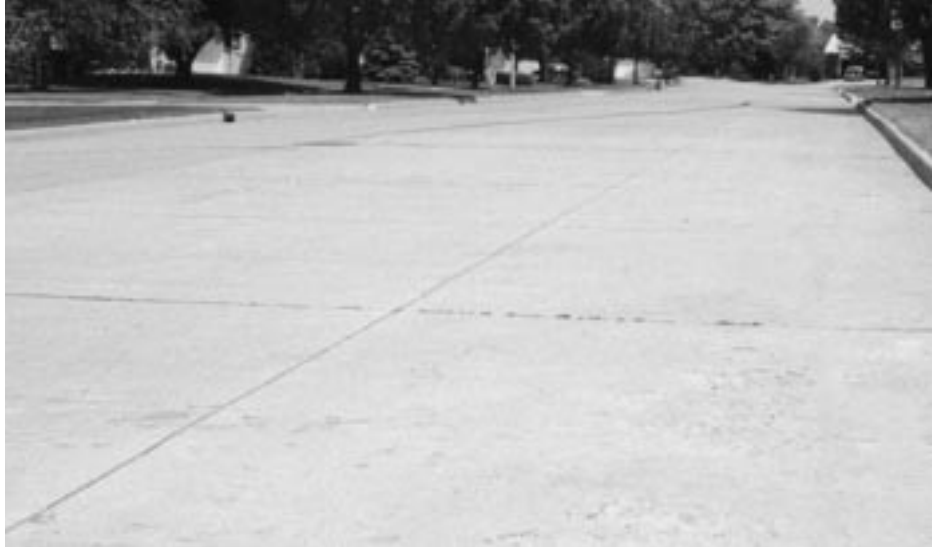
▶ Slight scaling.

COC Notes 8 - The slab may have one minor crack separating it into two pieces, but no displacement. May have partial depth patch in excellent condition, but no asphalt patches. Some minor scaling allowed or few

More surface wear, or slight defects showing in lanes. Pop-outs, slight surface scaling, partial loss of joint sealant, or isolated meander crack. Isolated manhole distress. Little or no maintenance required.

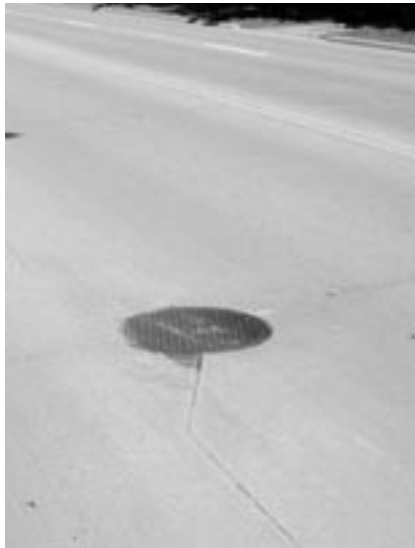
▶ Isolated spall at manhole.

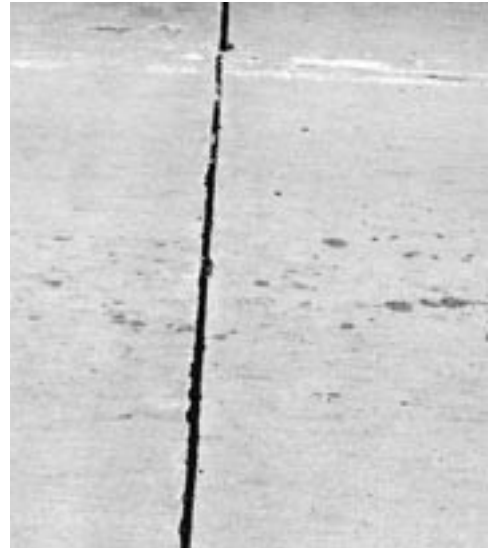
▲ Partial loss of joint sealant.

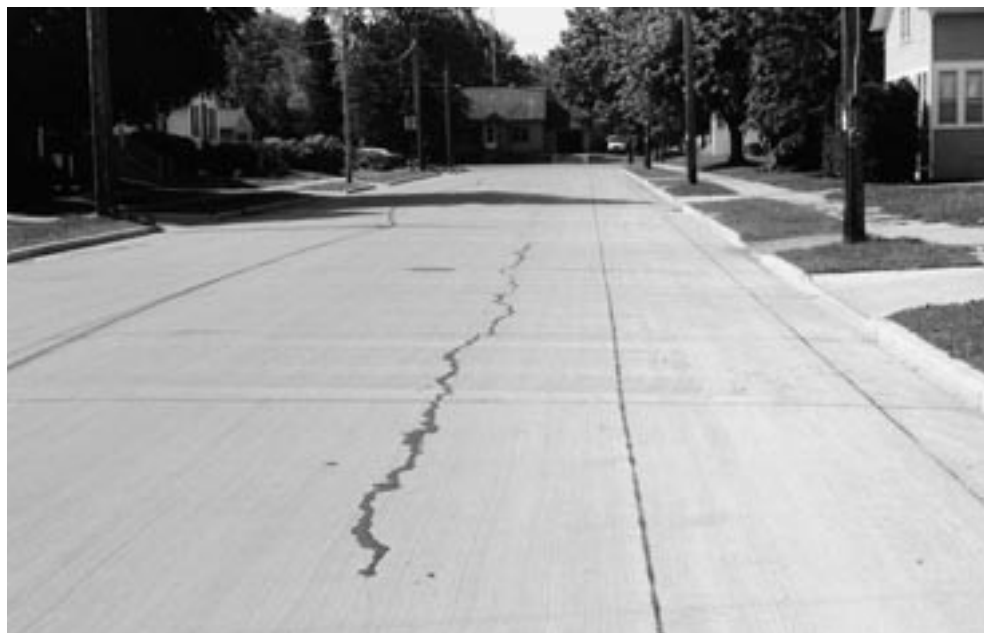
▶ Isolated meander crack, tight and well sealed.
