**RE:** Concrete Pavement Report

**Concrete Pavement Report**

**June 2023**

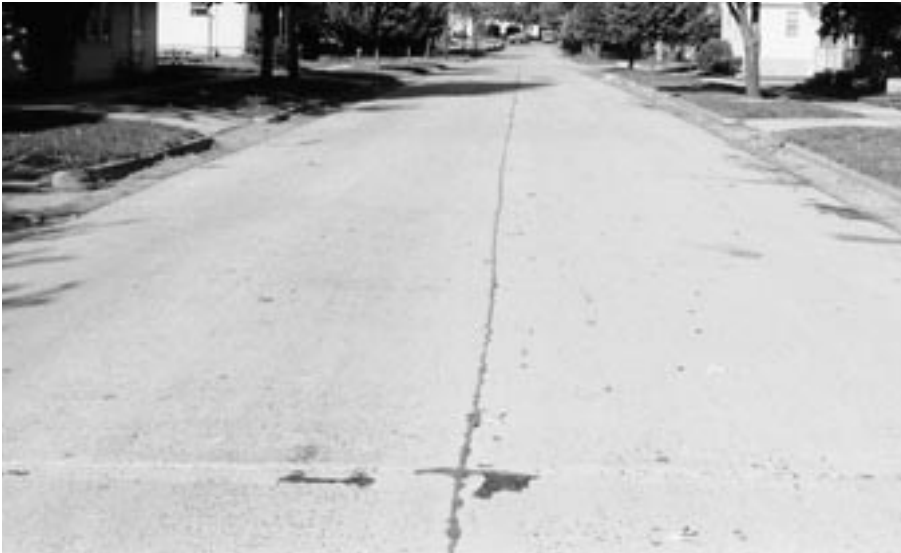
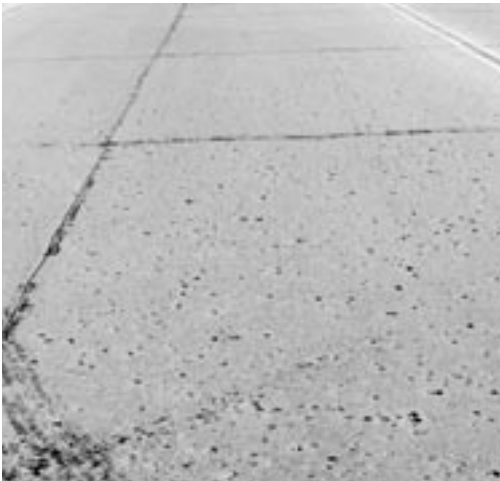
◀ **Residential street pavement in good condition after many years of service. May only need periodic joint sealing maintenance.**

◀ **Extensive pop-outs. Pavement is unsightly but still provides good level of service.**

First signs of transverse cracking, patching or repair; more extensive pop-outs or scaling; some manhole displacement, isolated heave or settlement. May need some sealing or routine maintenance.

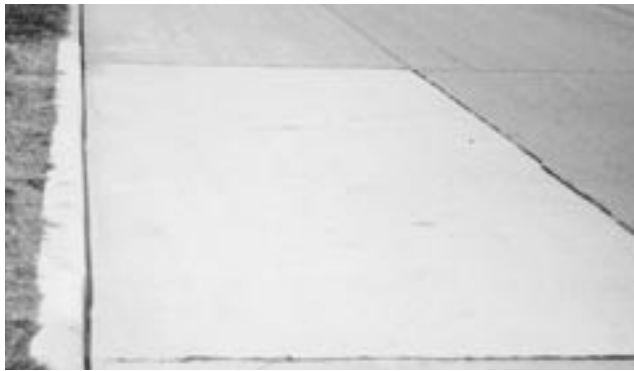
◀ **Recent full depth pavement repair. In very good condition.**

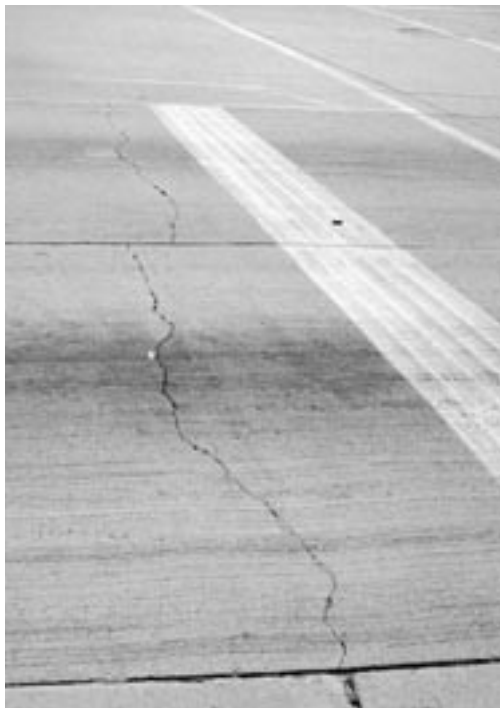
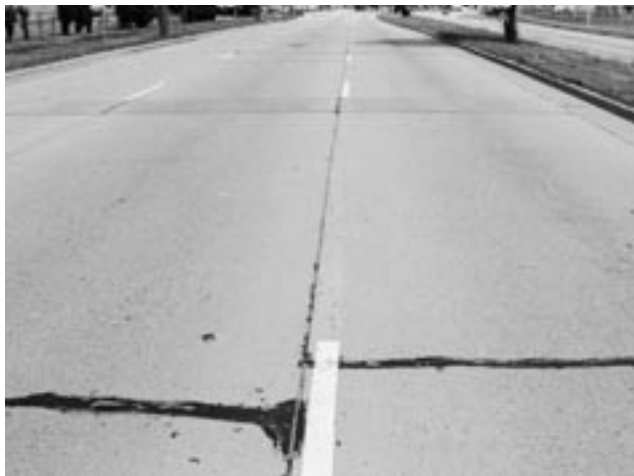
◀ **Well sealed transverse crack. Joint repairs in good condition.**

◀ **Transverse crack. Tight, sound pavement.**

**COC Notes 7 - Slab may have one crack separating it into two pieces. Joints may have asphalt patching, but not more than 2" wide. May have partial depth patches in good condition. No patches inside the slab.**

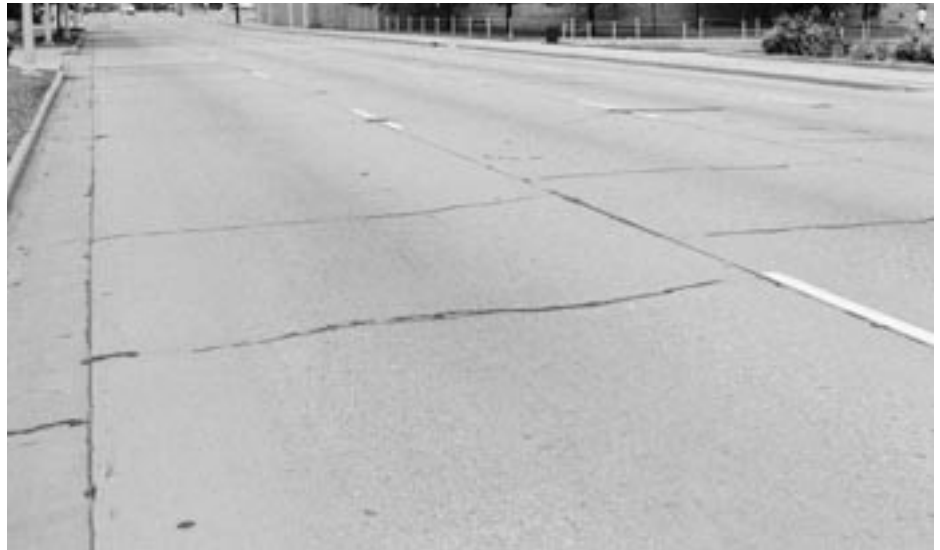
▶ Several transverse cracks. Tight or well sealed.

First signs of corner cracking or shallow reinforcement. More frequent transverse cracks. Open (1/4") joints and cracks. Moderate scaling. Needs joint and crack sealing.

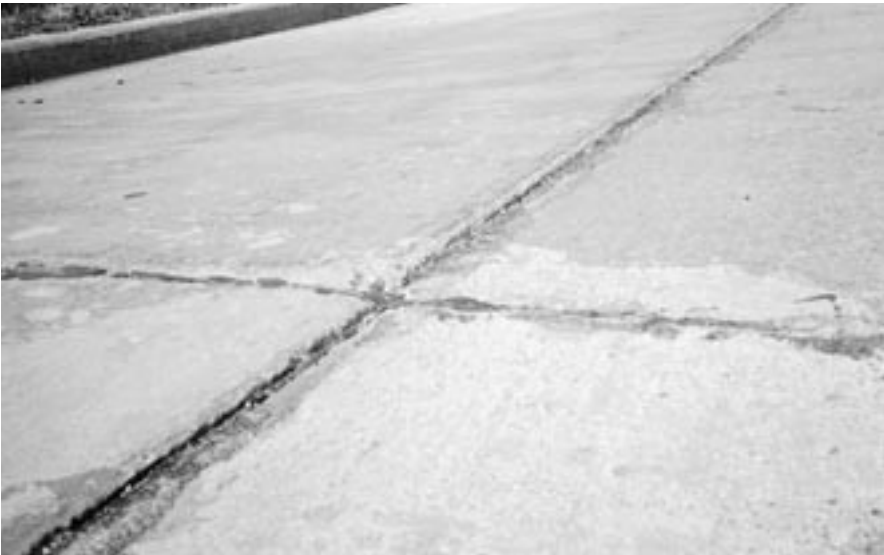
▲ Isolated, tight meander crack. Several pop-outs. Remaining joints and cracks all tight and sound.

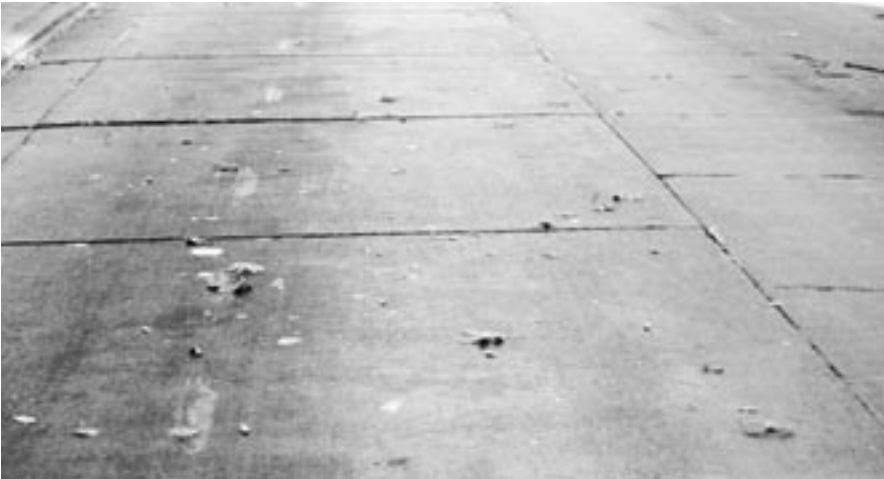
**Faulting at longitudinal joint and spalling along joint edge.**

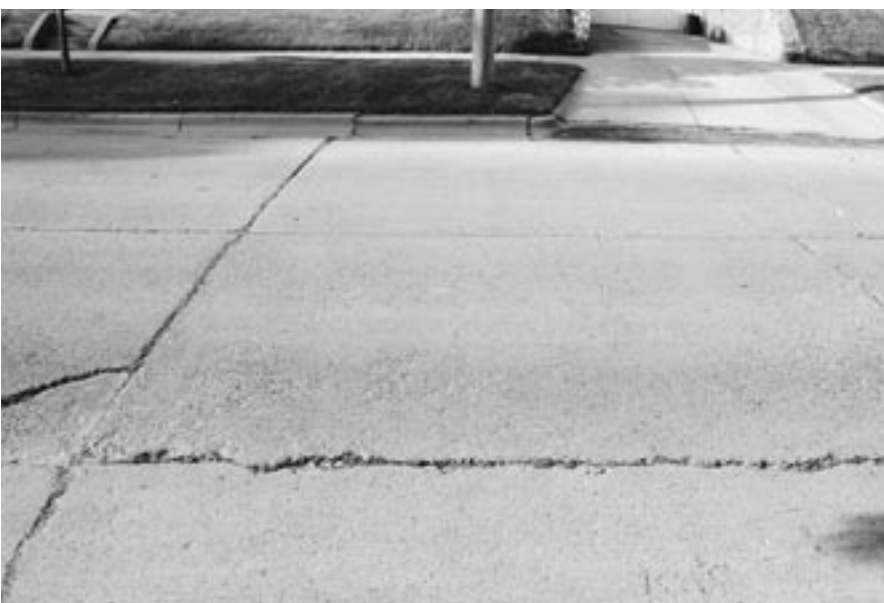
**First signs of transverse joint faulting. Grinding will improve ride.**

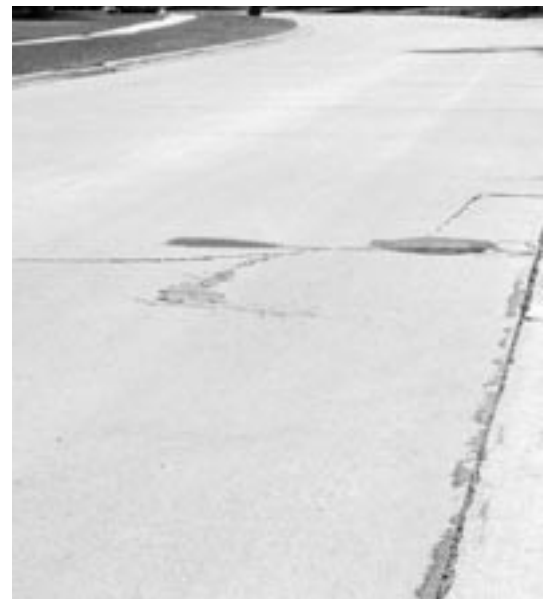
**▲ Isolated manhole problems and joint spalling. Full depth repair required adjacent to manhole.**

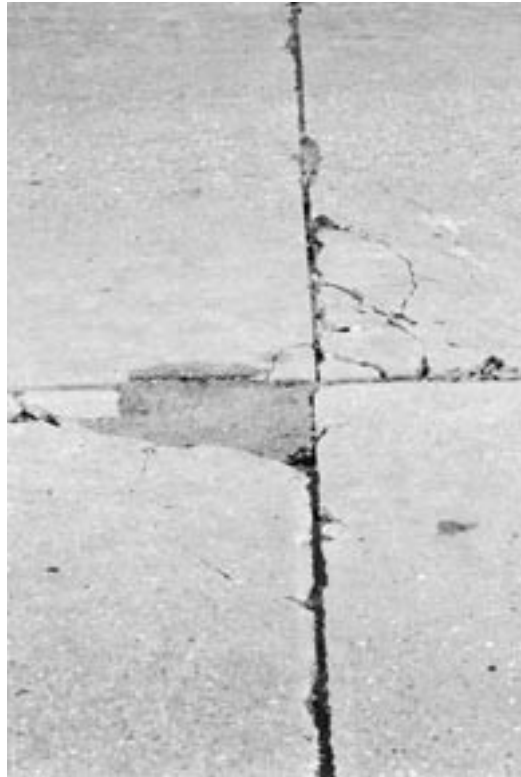
▶ Broken corner  
pieces. Some  
joint spalling.

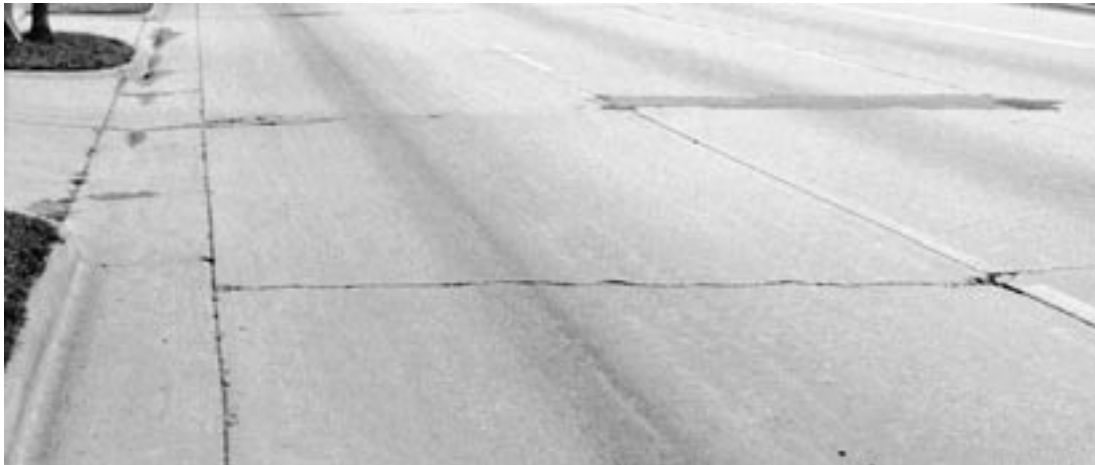
◀ All joints show some deterioration and spalling.

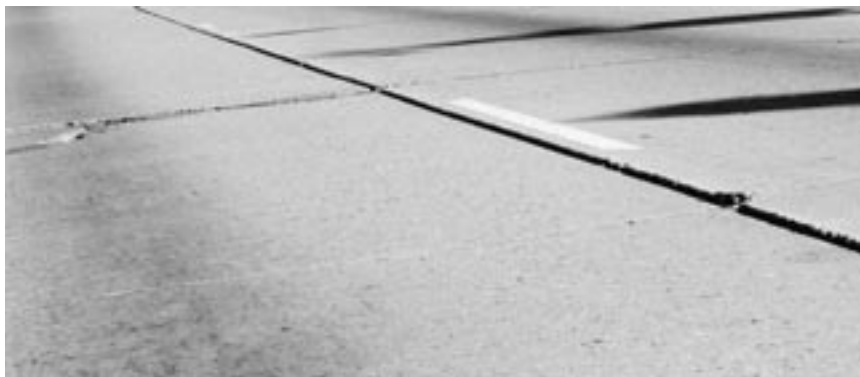
▲ Corner cracking developed into small hole; moderate spalling of transverse crack.

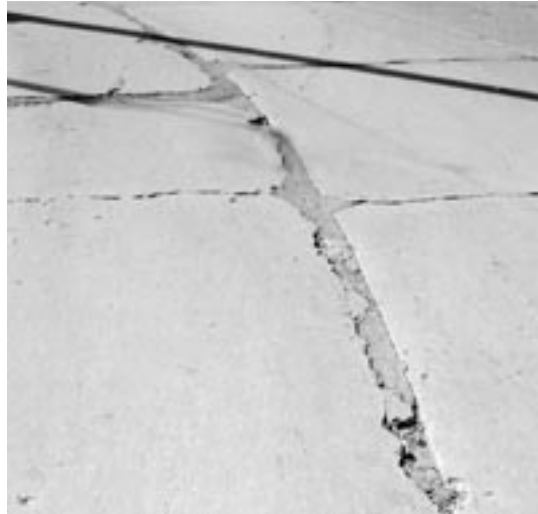
▶ **Joints and cracks badly spalled. Patching is failing. Full depth repairs required.**

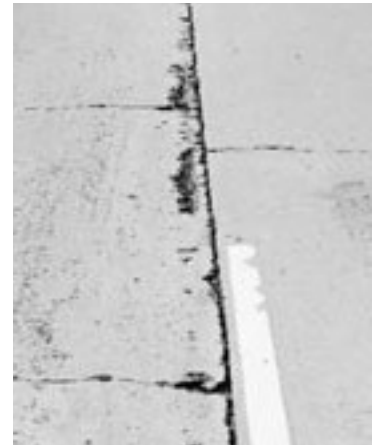
Multiple transverse cracks. Poor longitudinal joint with spalling.  
▼

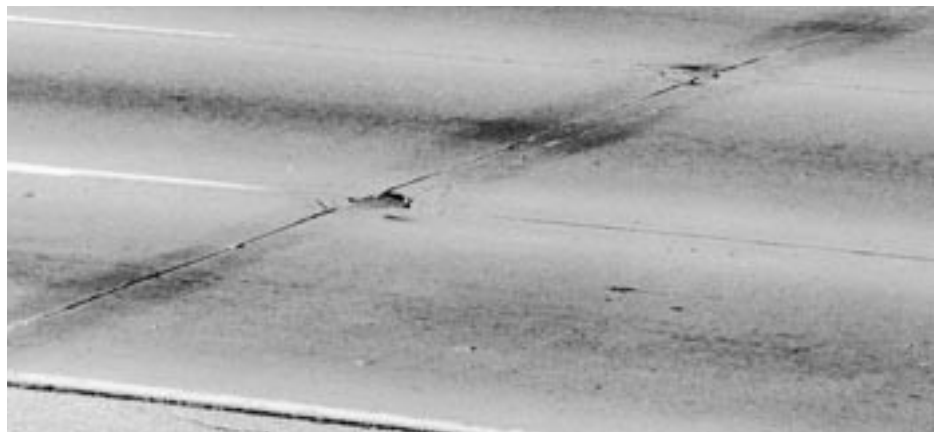
▶ **D-cracking (discoloration) at transverse joint and corner cracking. Needs full-depth repair.**

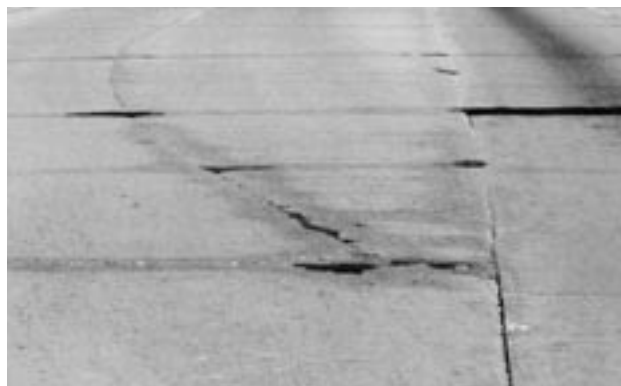
▶ **Discoloration at joints indicates D-cracking. Slab replacement needed.**

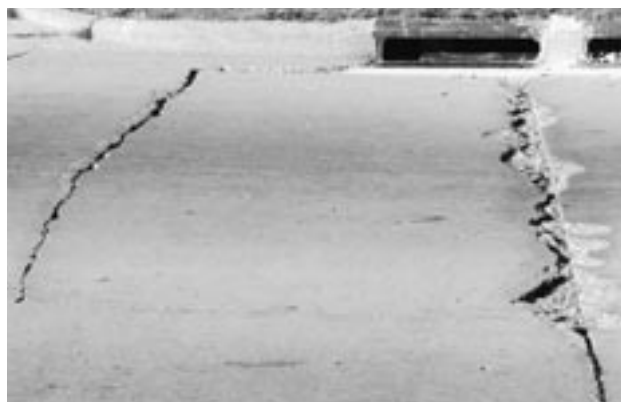
▶ **Badly spalled joint and open crack. Slab or joint replacement needed.**

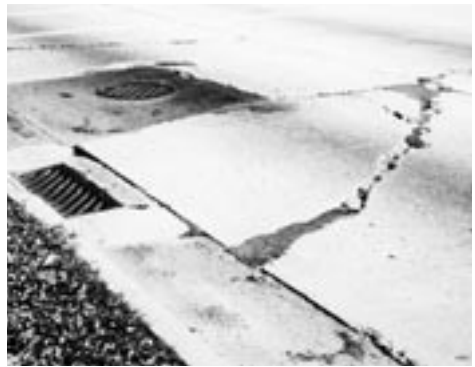
◀ Failed patches. Replace entire portion of lane.

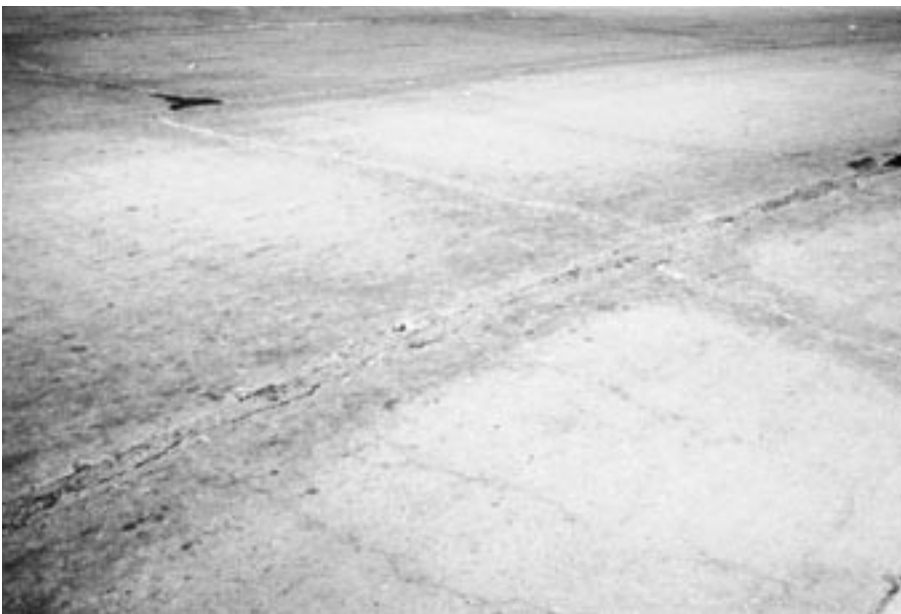
▲ Remove and replace pavement around manhole and inlet.

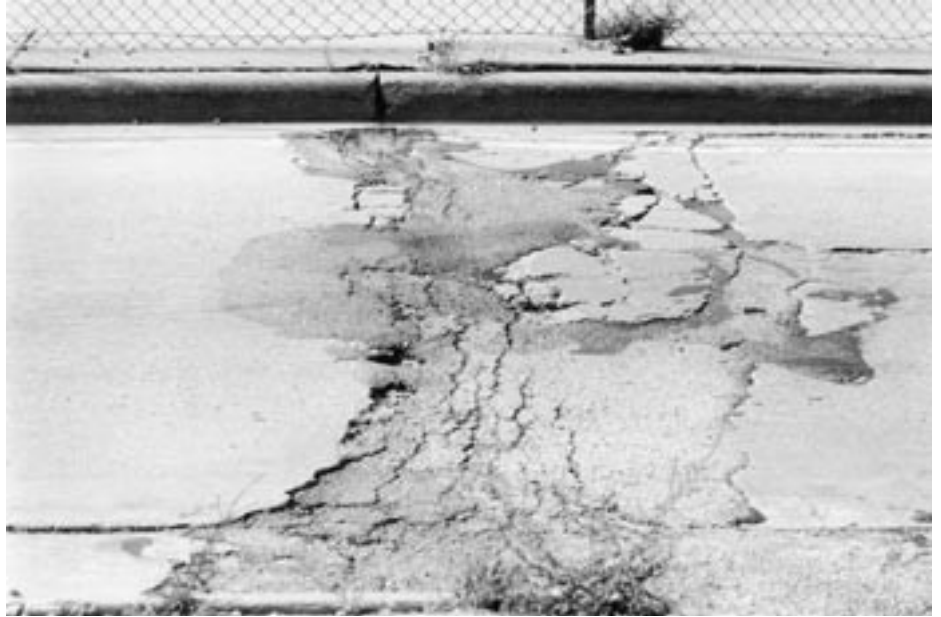
▶  
Slab and patch failure.

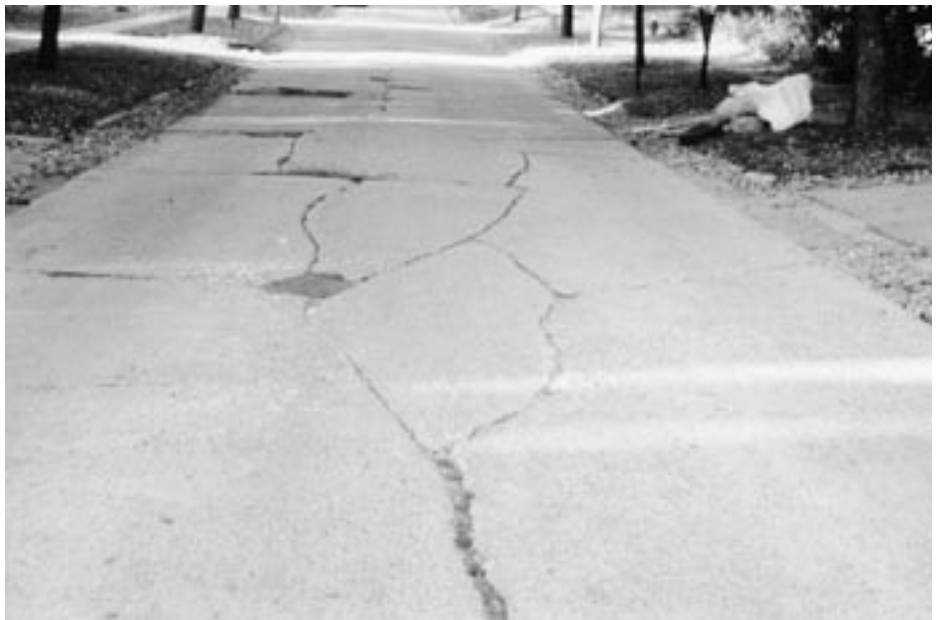
▶  
Broken slabs require complete rebuilding.

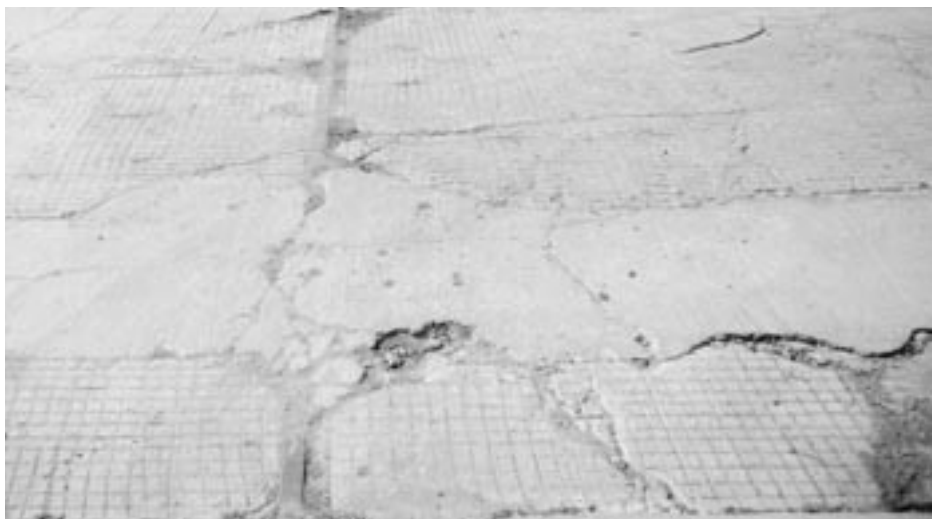
▶  
Total failure.

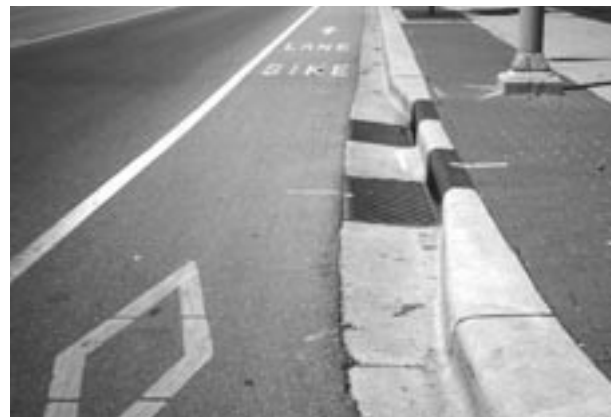
### ▼ Urban drainage. **RATING: Excellent**

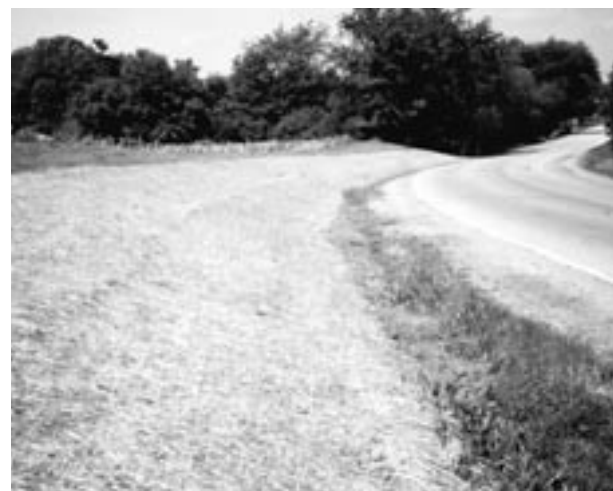
### ▲ Adequate rural ditch and good erosion control. **RATING: Good**

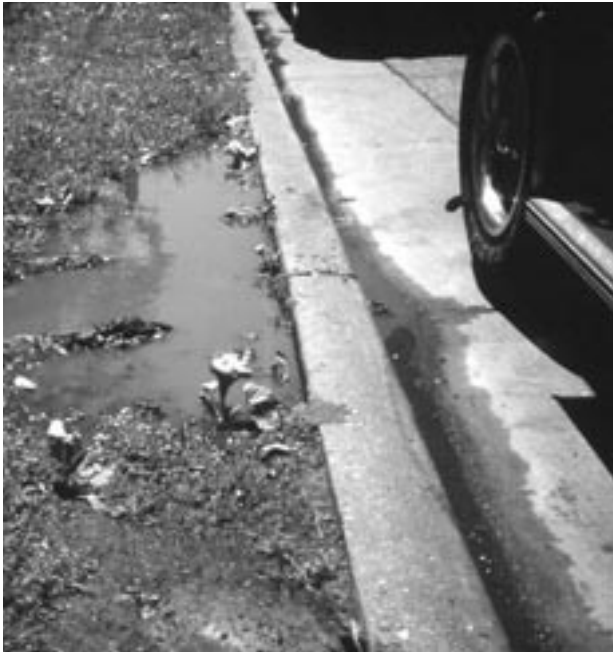
▲ Reshape terrace behind curb to restore drainage and prevent damage to curb and street.

RATING: Fair

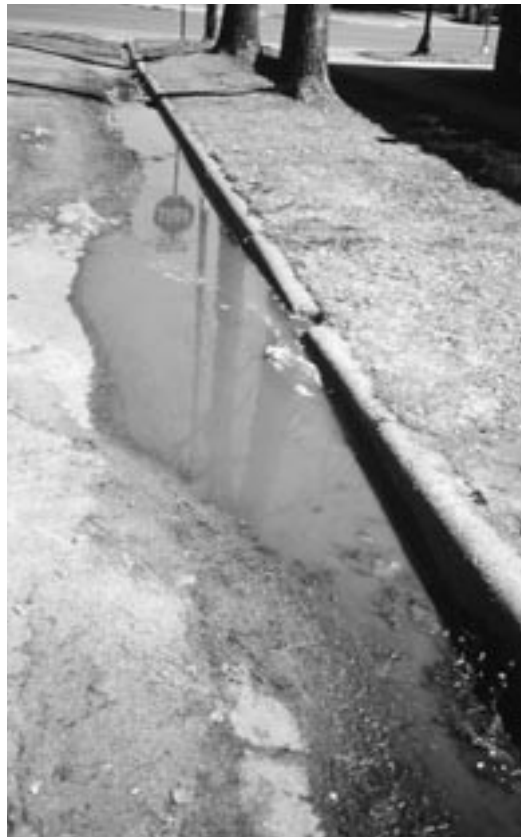
► Flooding. Curb and gutter need reconstruction.

RATING: Poor
