RE: Concrete Pavement Report

City of Chesterfield

Concrete Pavement Report

June 2023

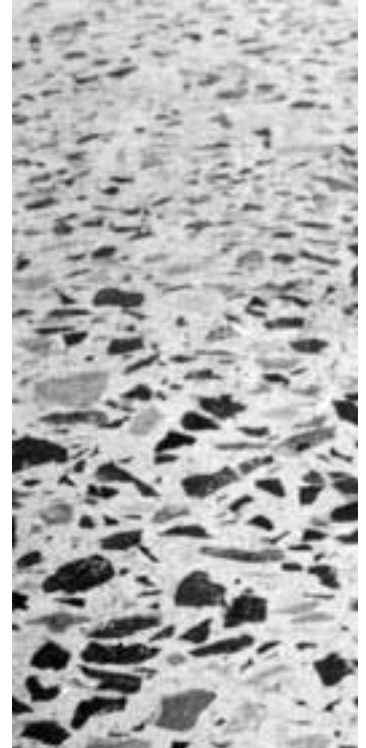
▶ **Surface mortar worn away exposing larger aggregate. Accidents or friction testing may indicate a slippery surface in need of improved texture.**

A worn or polished surface may appear from traffic wearing off the surface mortar and skid resistant texture. Extensive wear may cause slight ruts where water can collect and cause hydroplaning. Sometimes traffic may polish aggregates smooth, causing the surface to be slippery. An asphalt overlay or grinding of the concrete surface can restore skid resistance and remove ruts.

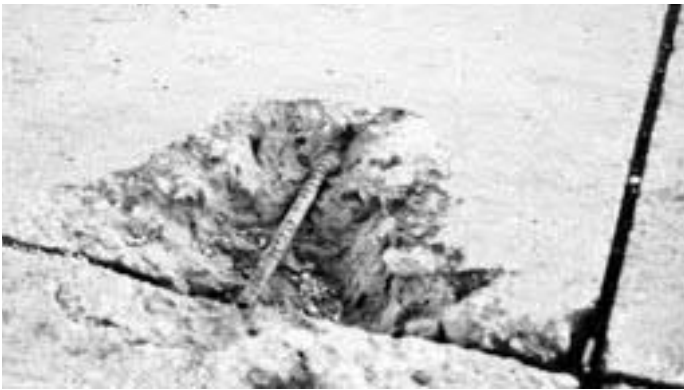
▼
Reinforcing bar exposed. Shallow concrete cover caused large spall to develop around it.

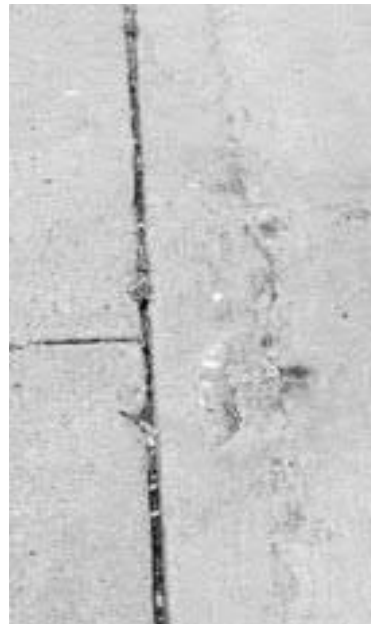
◀
Surface stain parallel to joint. Indicates reinforcing steel too close to surface.

◀
Wire reinforcing mesh placed close to surface. Corrosion of the reinforcing steel causes the surface mortar to spall. Very difficult to patch and repair.

break and dislodge the concrete. Often you can see rust stains in the surface cracks before spalling occurs. Can be temporarily patched with asphalt. Permanent repairs are difficult and usually involve replacing the steel and making a partial depth or full depth concrete repair.

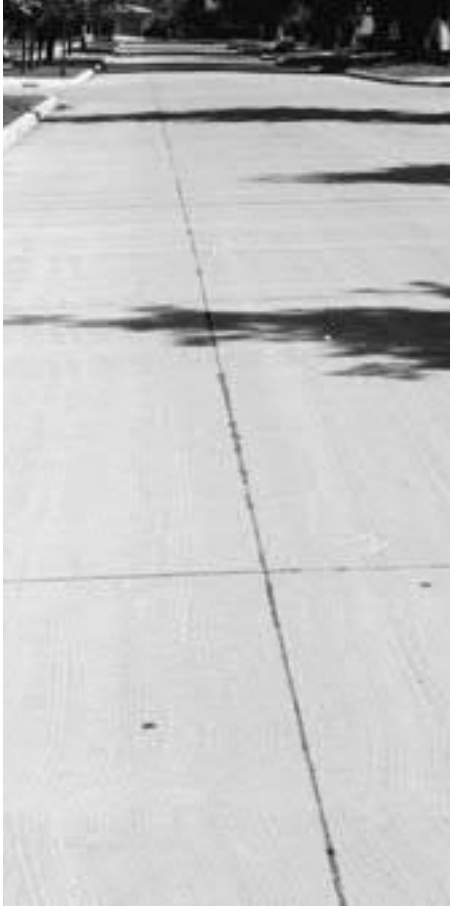
▲ Joint open about 1/2".

Maintaining a tight joint seal can prevent intrusion of water and reduce freeze-thaw damage and pumping. Severe joint deterioration may require full depth patching and replacement of the joint.

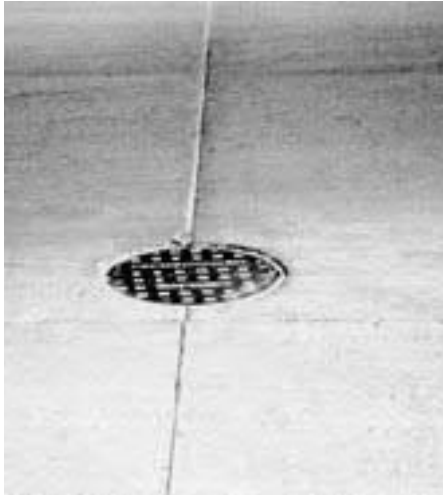
▼ **New, well-sealed transverse joint.**

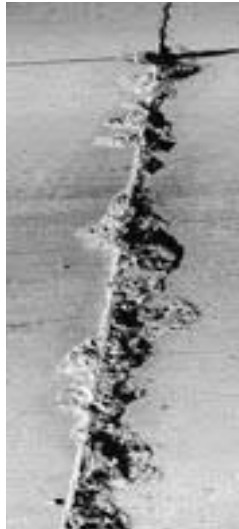
► **Severe spalling of a transverse joint.**

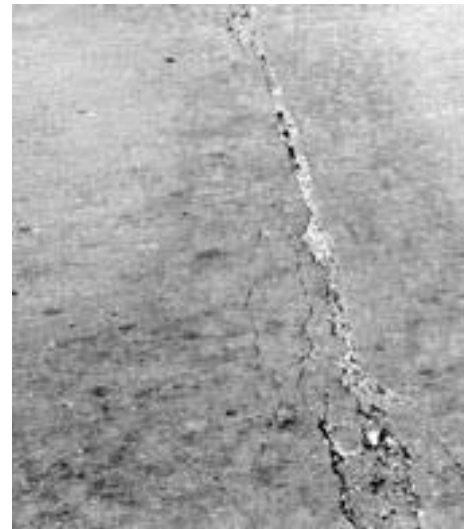
►► **Cracks parallel to joint. Dark color next to transverse joint likely indicates D-cracking and additional deterioration. Full depth repair required.**

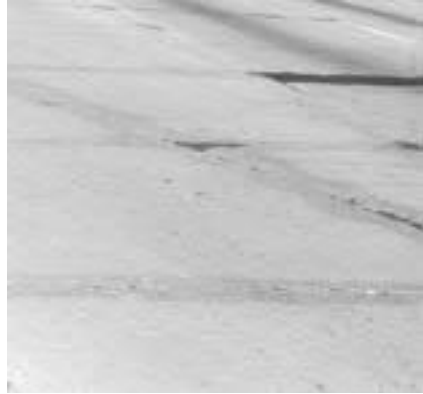
Surface discoloration near joints and cracks indicates D-cracking and severe slab deterioration.

Joint or crack sealing helps slow D-cracking deterioration. This is a serious defect because it may indicate a material quality problem throughout the pavement.

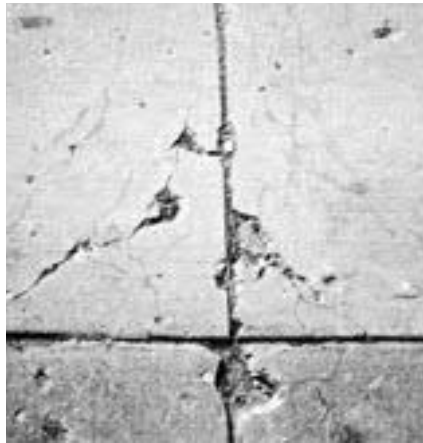
Multiple crack patterns adjacent to joints. Common D-cracking pattern.

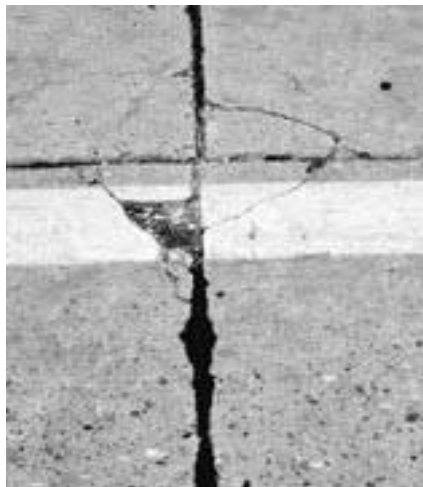
Corner cracking with broken concrete pieces.

First signs of corner cracking.

This may be a localized failure or may point to widespread maintenance problems. Partial or full depth concrete patching or full depth joint replacement may be necessary when corner cracking is extensive.

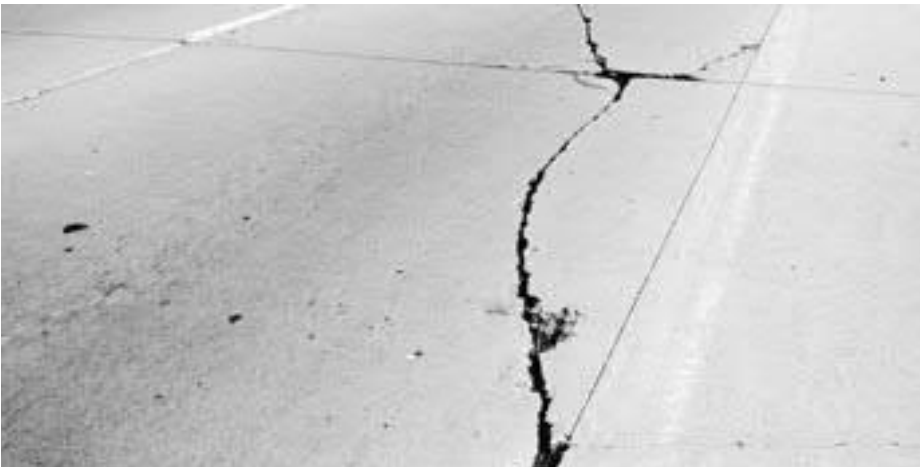
Meander crack roughly parallel to longitudinal joint.

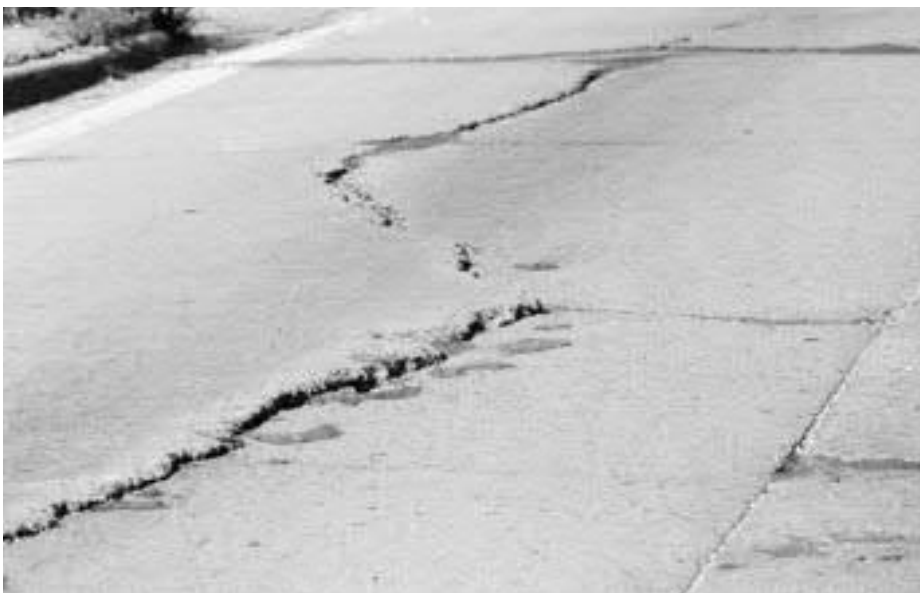
Meander crack caused by settlement. Lack of maintenance allows water to intrude and debris to collect in crack.

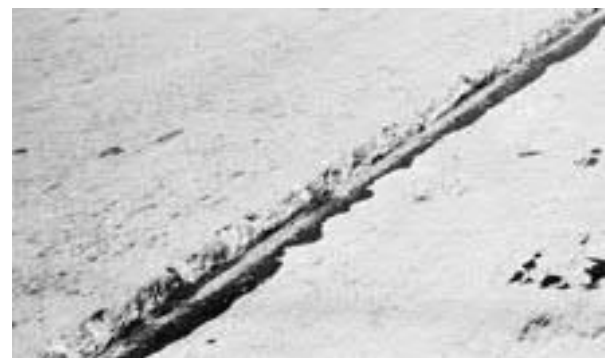
▲ Faulted longitudinal joint.

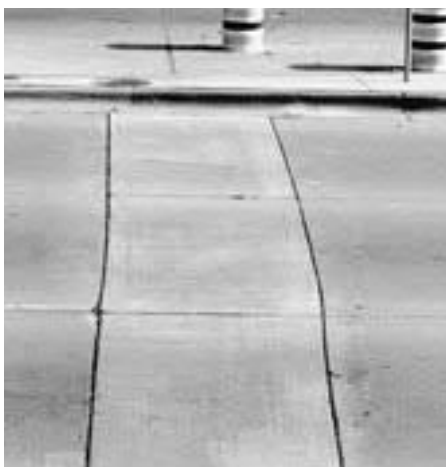
▲ Utility repair or full depth joint repair. Very good condition.

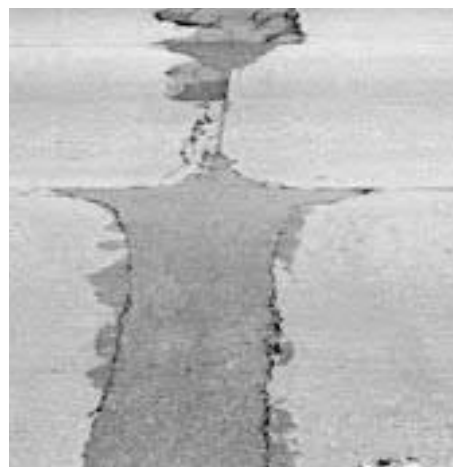
▲ Asphalt patches. Poor (top) and fair (bottom) condition.

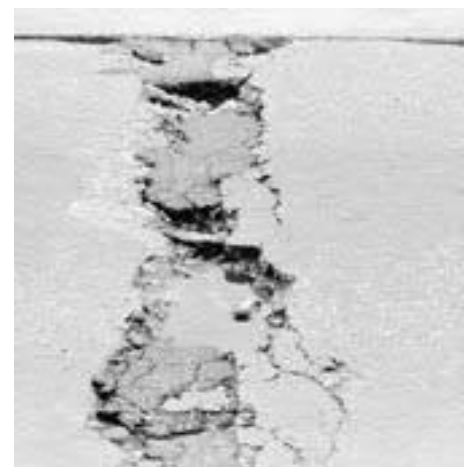
▲ Potholes caused by severe joint deterioration. Need repair.

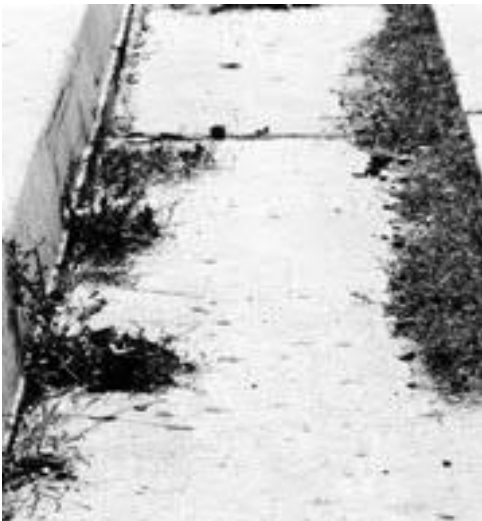
Settled gutter and joint filled with debris. Joint maintenance is needed. ▼

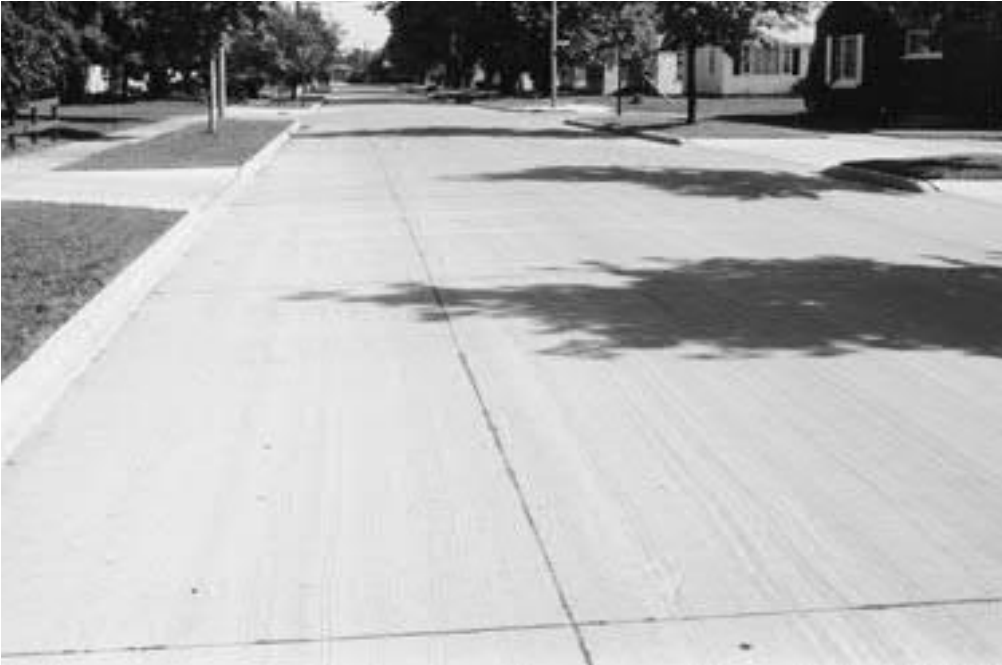
RATING 10
New pavement
with integral
curb.

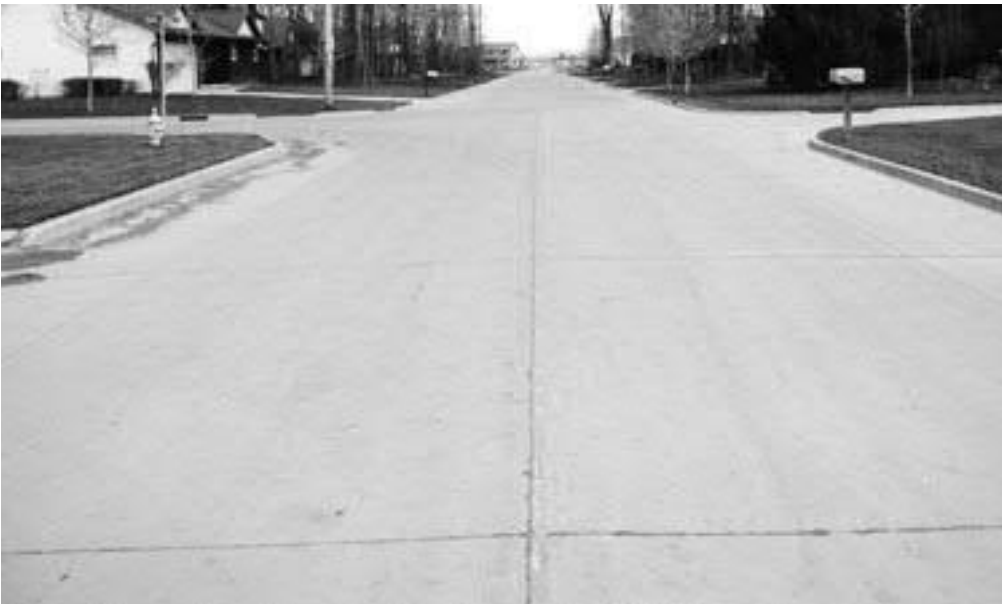
RATING 9
Like new
condition.

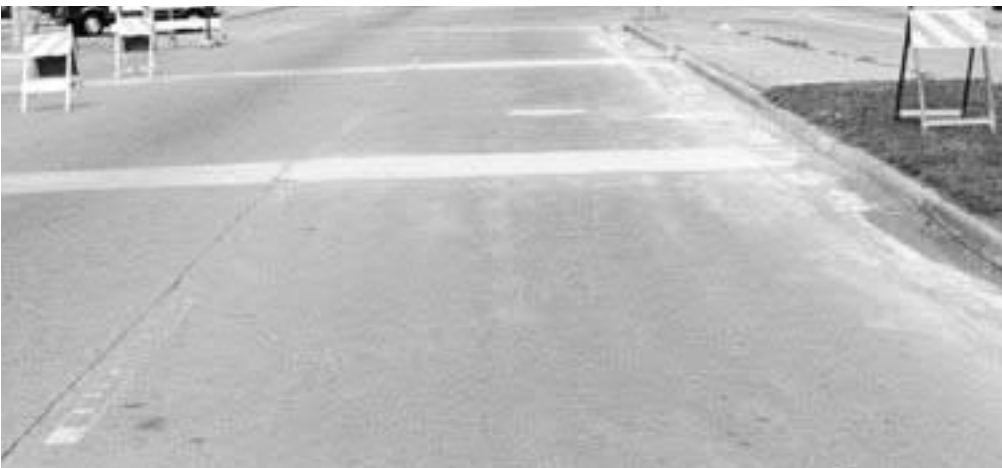
RATING 9
Recent joint
rehabilitation.
Like new
condition.

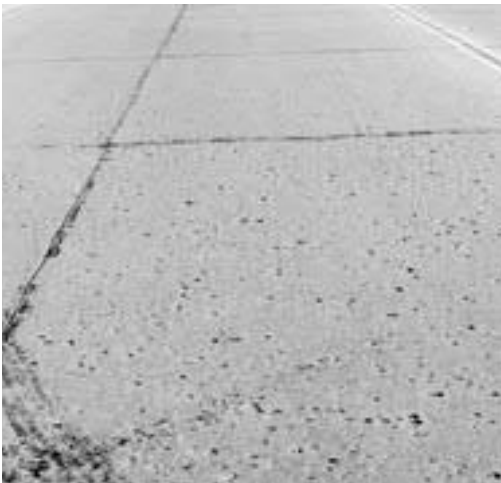
◀ **Extensive pop-outs. Pavement is unsightly but still provides good level of service.**

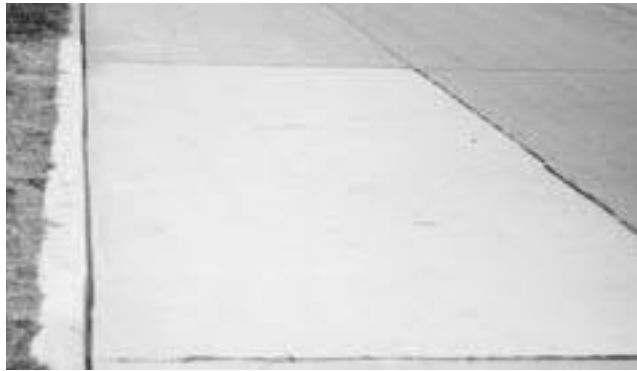
◀ **Recent full depth pavement repair. In very good condition.**

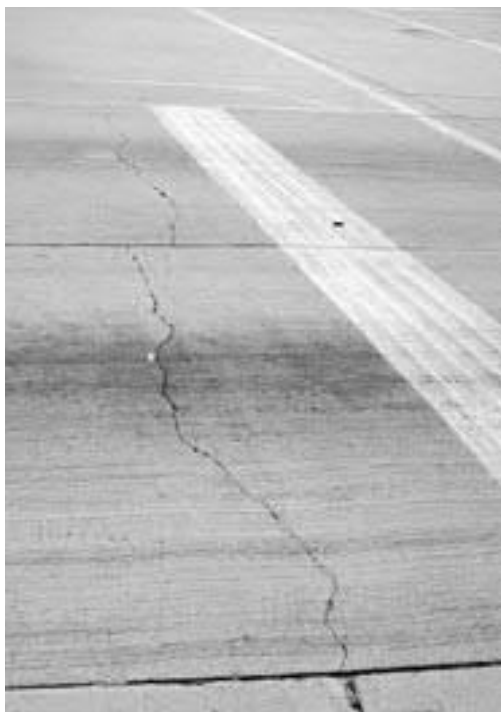
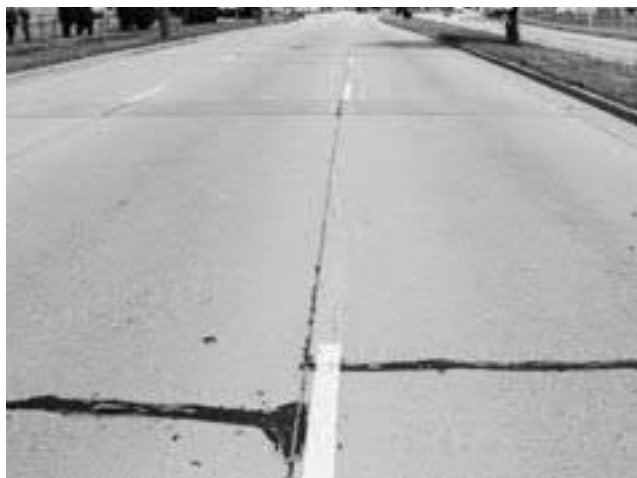
◀ **Well sealed transverse crack. Joint repairs in good condition.**

◀ **Transverse crack. Tight, sound pavement.**

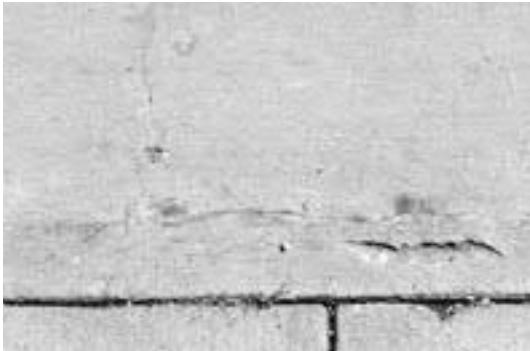
▶ Moderate scaling.

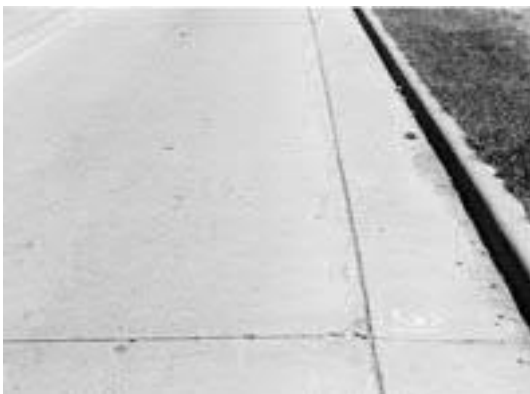
▲ First signs of corner cracks.

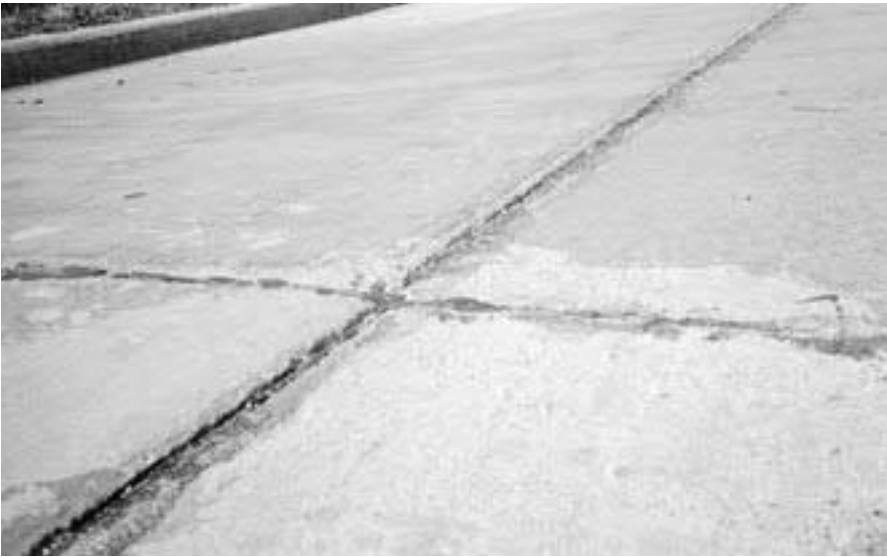
▲ Isolated, tight meander crack. Several pop-outs. Remaining joints and cracks all tight and sound.

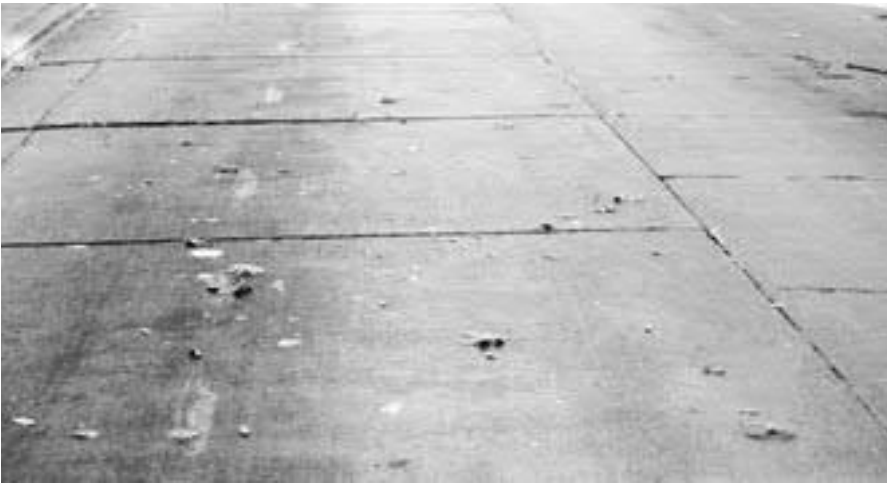
Faulting at longitudinal joint and spalling along joint edge.

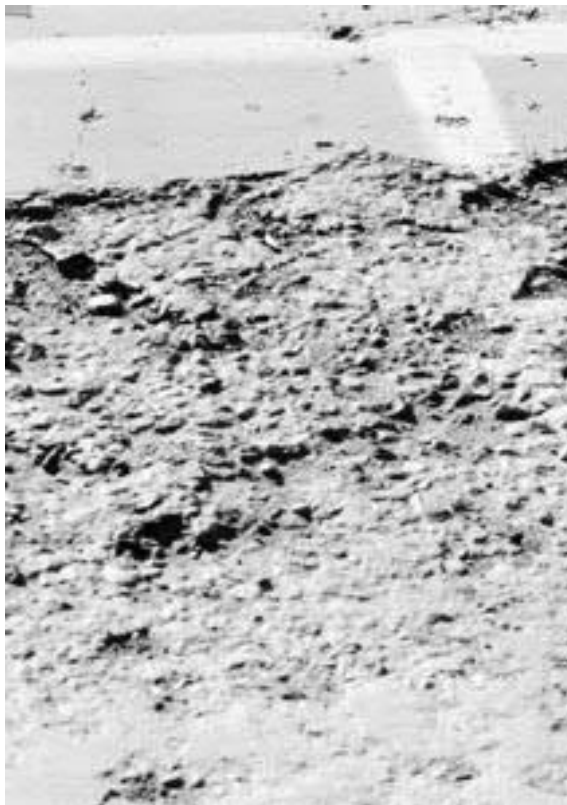
▲ Severe scaling over extensive areas.
Patching or overlay needed.

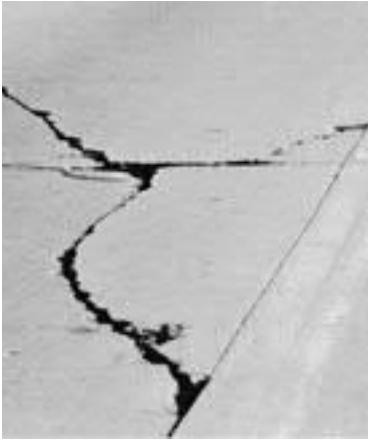
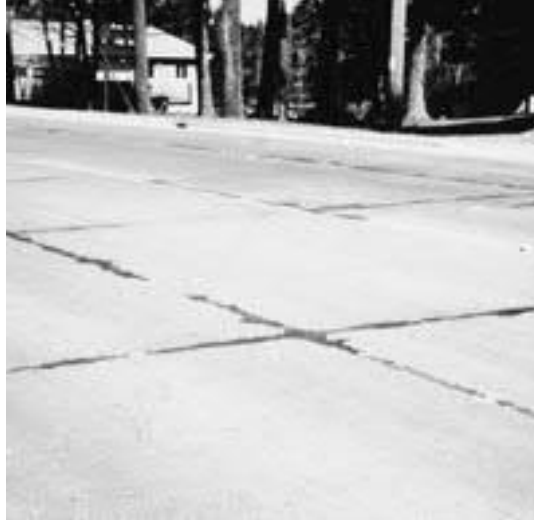
Wide open meander crack (1") with edge spalling.

▼ Corner crack with spalling.

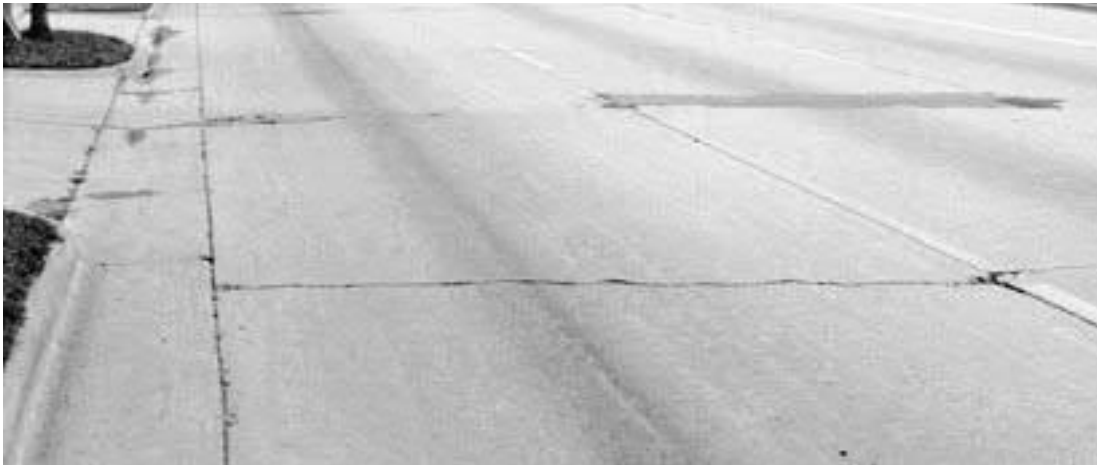
◀ **Multiple open transverse cracks. Failed corner crack. Patches in fair condition.**

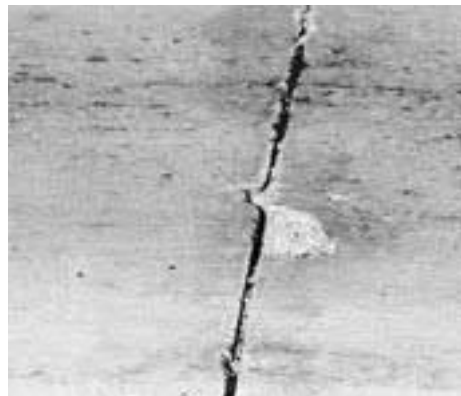
◀ **Moderate spalling at transverse joint.**

▲ **Corner cracking developed into small hole; moderate spalling of transverse crack.**

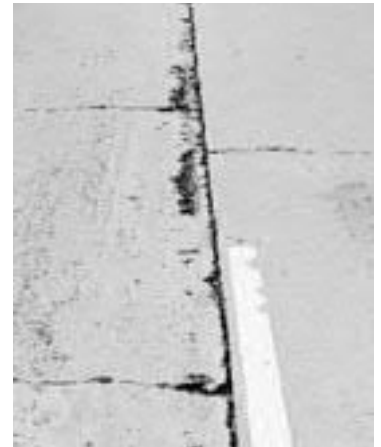
Multiple transverse cracks. Poor longitudinal joint with spalling. ▼

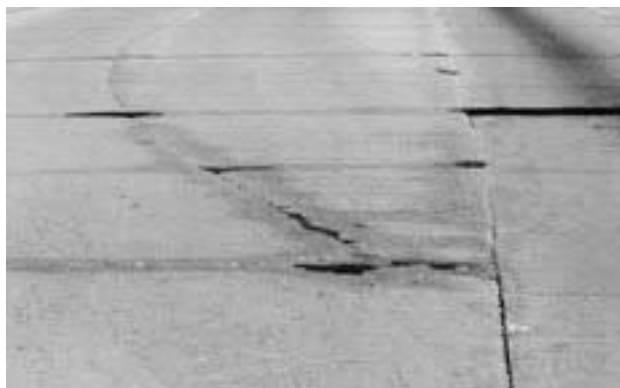
▶ **Badly spalled joint and open crack. Slab or joint replacement needed.**

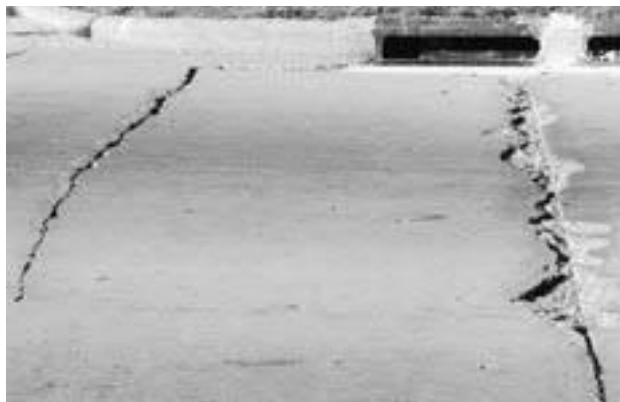
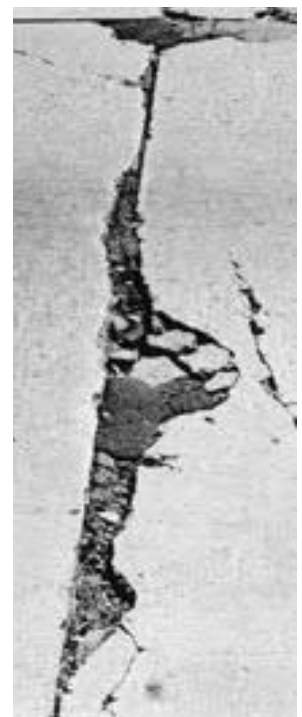
▲ **Failed joint needs replacement.**

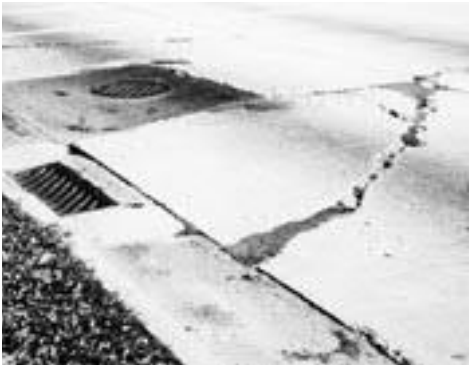
▲ Remove and replace pavement around manhole and inlet.

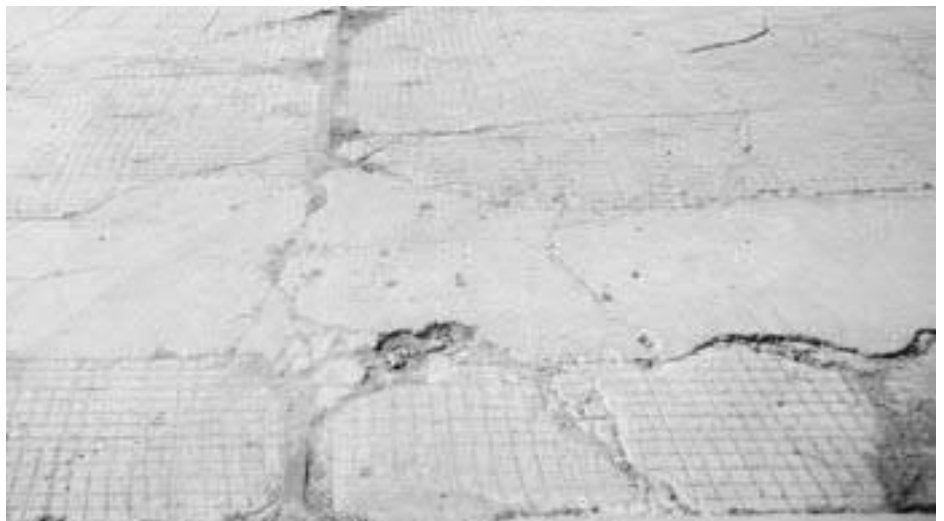
▶
Total failure.

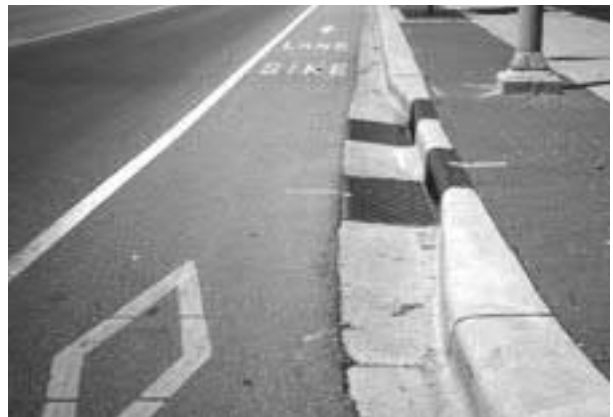
▼ Urban drainage. **RATING: Excellent**

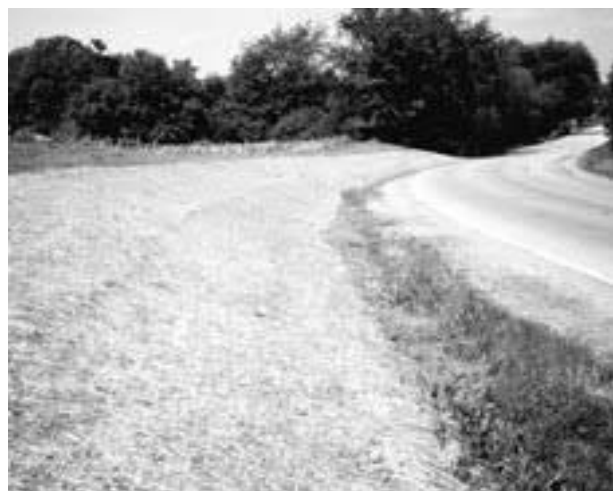
▲ Adequate rural ditch and good erosion control. **RATING: Good**
